REPAIR, REHABILITATION AND RETROFITTING OF ELEVATED STORAGE RESERVOIR (ESR) SITUATED AT THANE FOR THANE MUNICIPAL CORPORATION- A CASE STUDY

Abstract—This technical paper deals with Major Repairs and Restoration of Elevated Storage Reservoirs (ESR) under Thane Municipal Corporation located at Gandhi Nagar, Thane. Being an old structure, the Elevated Storage Reservoirs faced major problems of structural distress which lead it to undergo Major repairs. Then Thane Municipal Corporation asked M/s. Supreme Engicons(India) Pvt Ltd., a leading Consulting Civil Engineering firm appointed as Structural Consultant to undertake the Major Repair and Restoration of Elevated Storage Reservoir at Thane. The structure was difficult to get accessed due to the distressed pathway to reach the area of inspection of the ESR. The condition of the structure was poor due to age factor. However, the major RCC structures were inspected with the method of visual inspection as well as Non-Destructive testing. The paper illustrates the unique methodology of Restoration on Elevated Storage Reservoirs such as Micro concreting and Fibre Wrapping work for RCC members, Internal Waterproofing of ESR and Special anti

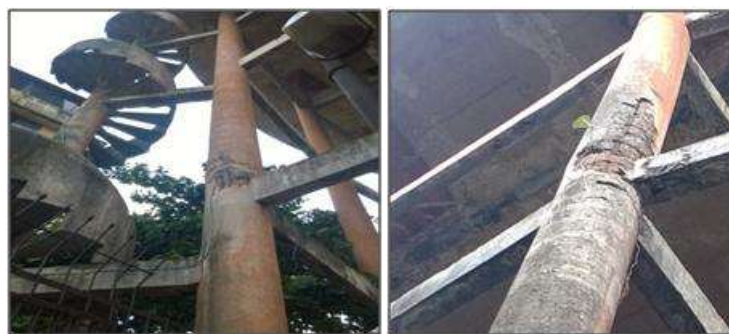
Fig.2&3: Observations

During our survey, we have observed lot of cracks and crazing on the external plaster of the ESR. Heavy Leakages were observed on the bottom of the tank. Steel exposure was observed on various RCC columns and beams indicating the severity.

Reinforcement bars of certain Columns are found exposed and even at some places found missing indicating the rate of corrosion is very high. The beams connected to the Service staircase also appeared with lot of major cracks. Cracks were observed on the staircase causing steel exposure. On the external surface of the sump house, lot of cracks and crazing was observed. The water proofing of the RCC Chhajjas was found to be failing gradually. The water proofing of the roof of the sump house is also found to be dilapidated. The overhead waterproofing of the underground water tank was observed to be in distress.
