# “STRUCTURAL AUDIT OF RESIDENTIAL BUILDING- SAINATH APARTMENT, VIRAR EAST”

**Abstract :** This study is being under taken to check the structural stability and integrity of the residential structure so as to keep in check any defects found and to safeguard the structure and human life. Structural stability also known as structural audit consists of two major activities. The visual survey of the structure and the NDT testings. The visual survey of the entire premises was being carried out along with tapping of the structural components to identify any structural as well as material defects in the structure NDT play a vital role in determining the compressive strength and working stats of the concrete also the status of the steel reinforcements. Thus the NDT's being carried out are Rebound Hammer test, Carbonation test, Half-cell potential test, Ultrasonic pulse velocity test and Core test. Thus based on the Visual survey and NDT testings a Proforma-B was being established and final report was being compiled. Thus based on all of he collected data and the test results an appropriate category is identified for the structure and based on the category it is being decided whether the s

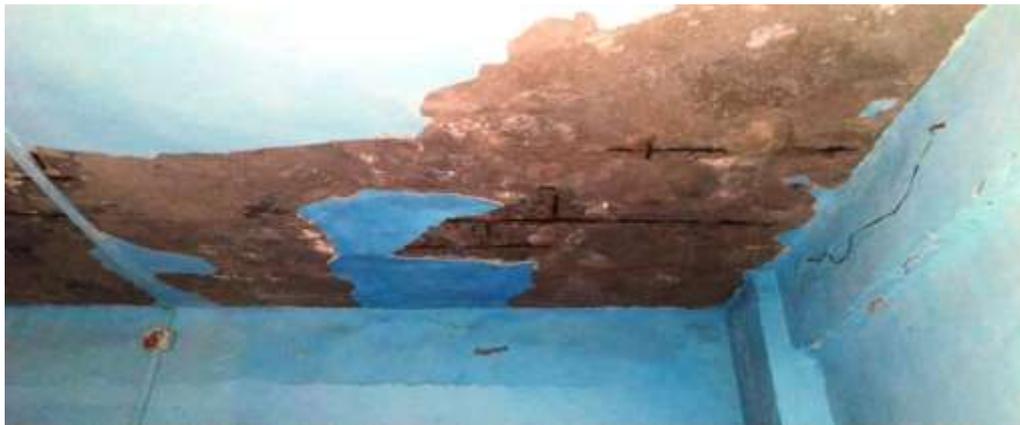
**Fig.4.1 Exposed steel reinforcement in flat no.003.**

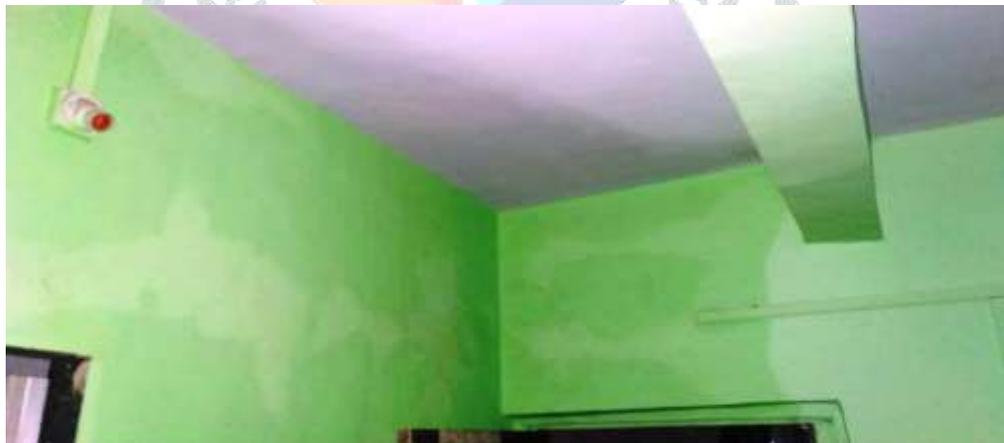
**Fig.4.2 Seepage of water into the internal walls of flat no.007.**

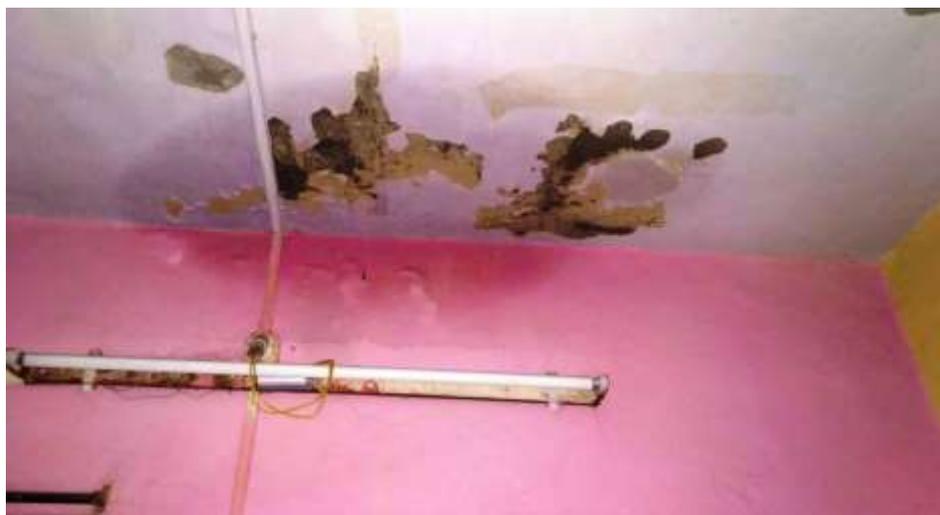
**Fig.4.3 Seepage of water into the internal walls of flat no.007.**

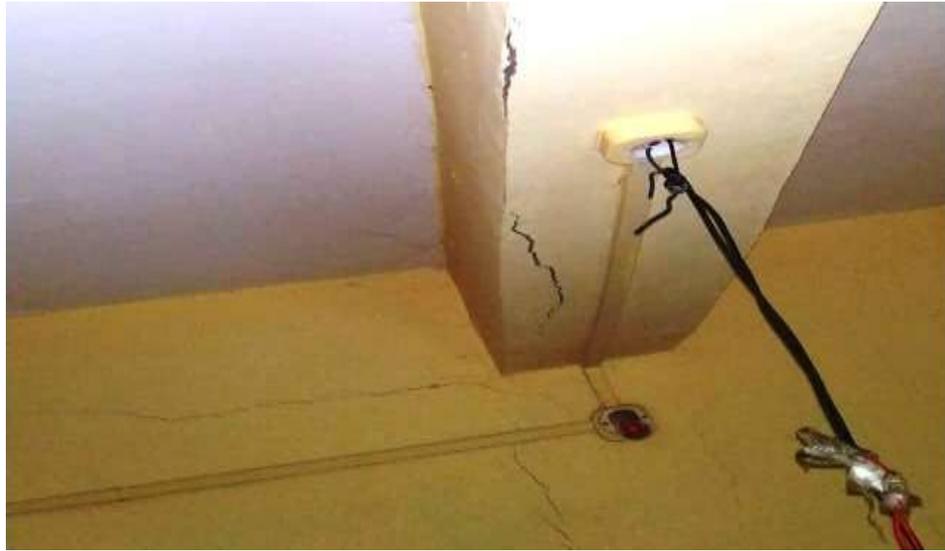
**Fig.4.4 Damaged R.C.C column of flat no.201.**

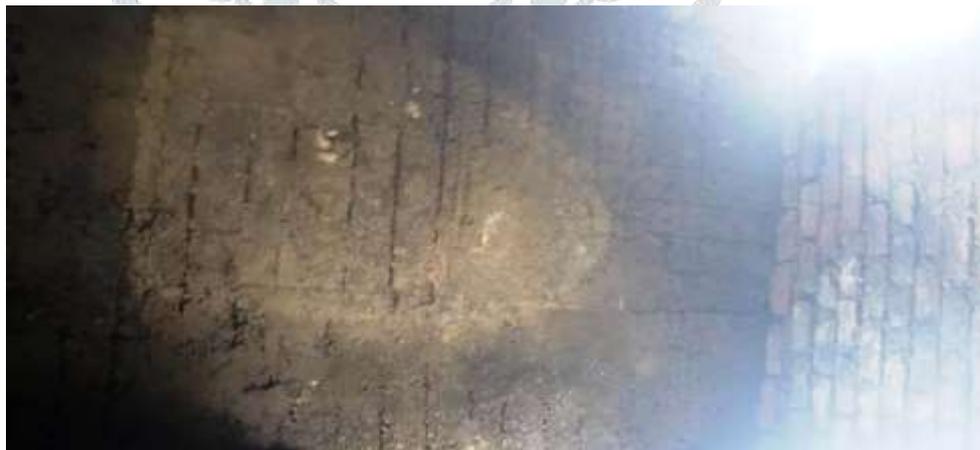
**Fig.4.9 O.H tank bottom slab steel reinforcements found to be exposed.**

| | ➤ Bottom Ceiling of Overhead Tank | Major repairs needed |
