THE ASSESSMENT OF NINE MILE LANDSLIDE AREA THROUGH GEOPHYSICAL INVESTIGATION IN EAST DISTRICT, SIKKIM.

Landslide in Sikkim has been reported since 1957, and Nine mile is one of them. It is at entrance gate of Gangtok- capital of Sikkim, along NH-31A. It possess disturbance to traffic movement along NH31-A, close to instable hill slope at western bank of Rohini chhua-tributary of Tista river. The various kinds of water has played typical role in triggering of nine mile landslide, in different seasons under neo-tectonic activity.

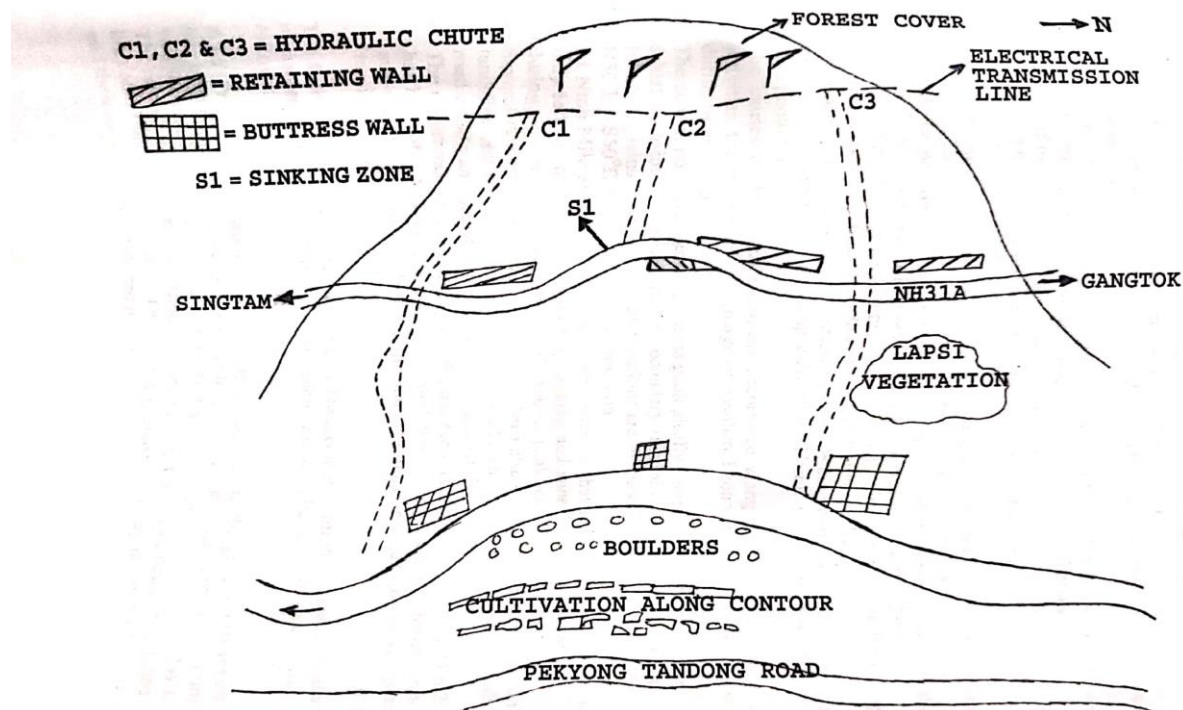
FIG.2 Panoramic view of Nine mile landslide area

The concave shaped meander of Rohini chhu has been active to western direction during monsoon and post monsoon period and prominent factor for toe erosion as well under cutting the base of NH 31A The panoramic view of it has been obtained through eastern bank along Peekyong-Tandong road and illustrated as Fig.2.

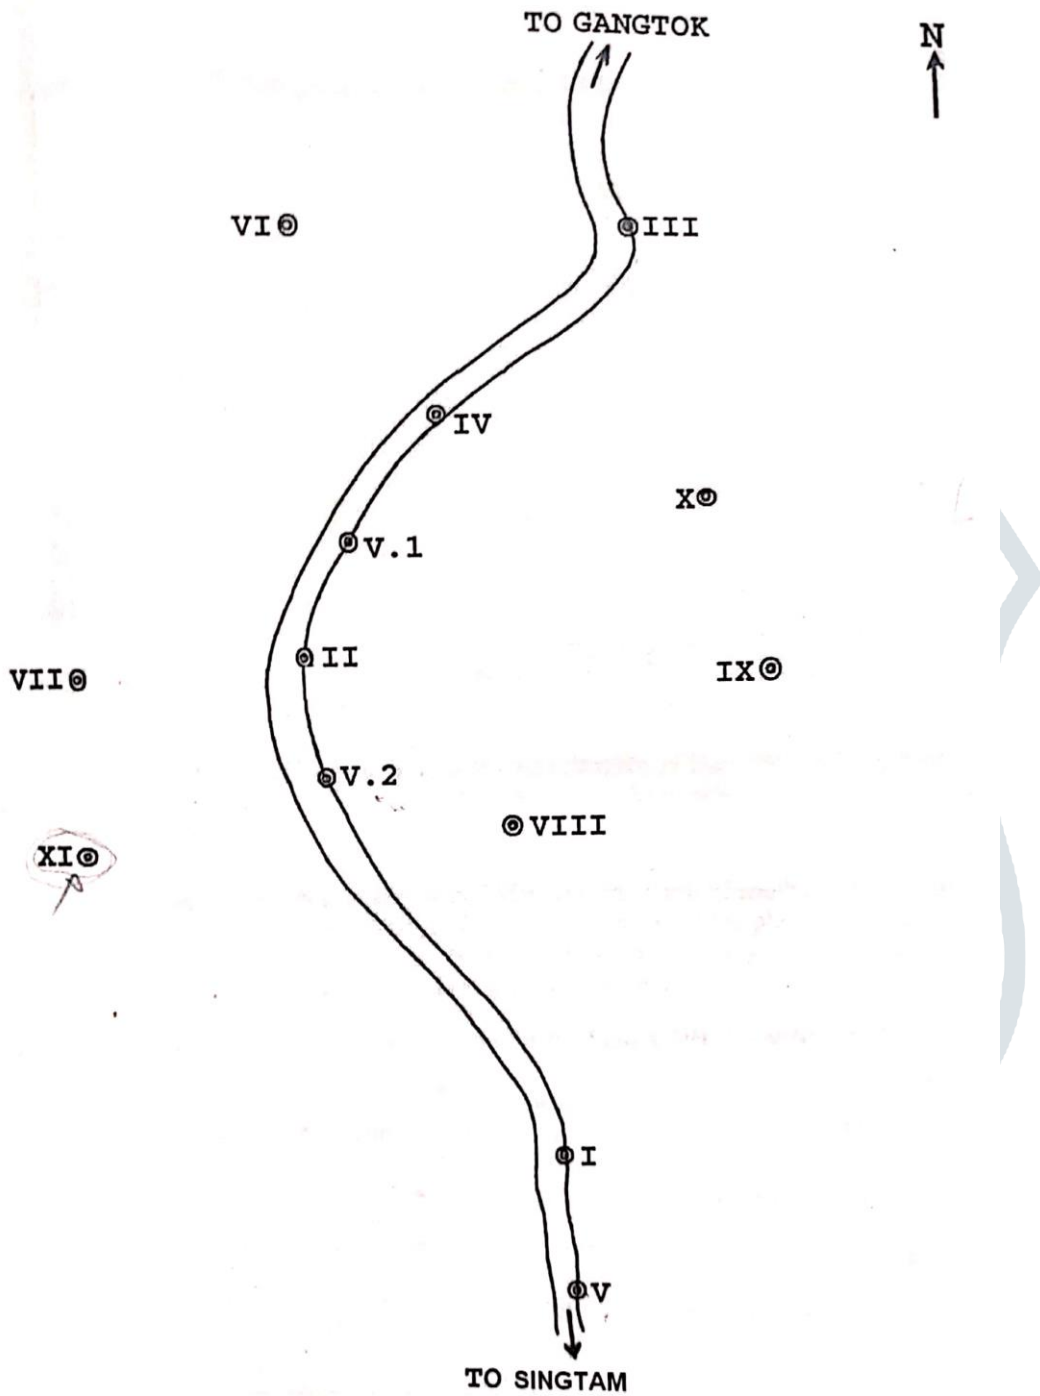
FIG.3 Location map of all twelve instrumentation sites

Geo-physically, the area of study has been investigated through temporal resistivity survey for successive pre-monsoon, monsoon & post-monsoon period. Twelve instrumental sites have been selected for entire area of study and illustrated as Fig. 3. [2]
