Air crash Investigation report, happened between two Boeing 747 at Los Rodeos Airport, Tenerife, Spain.

Let us jump to the main topic, summary for Aircraft Crash Investigation occurred in March 27, 1977, between 2 Boeing 747 i.e., B747-206B (KLM Flight 4805) and B747-121 (PH-BUF Pan American Flight 1736) at Tenerife, Los Rodeos Airport, Canary Islands, Spain.

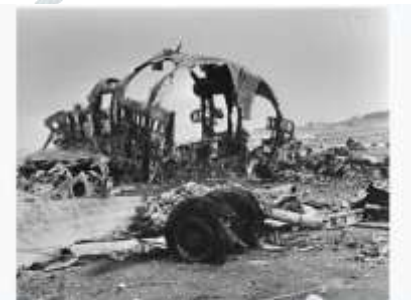
Wreckage of the KLM aircraft on the runway

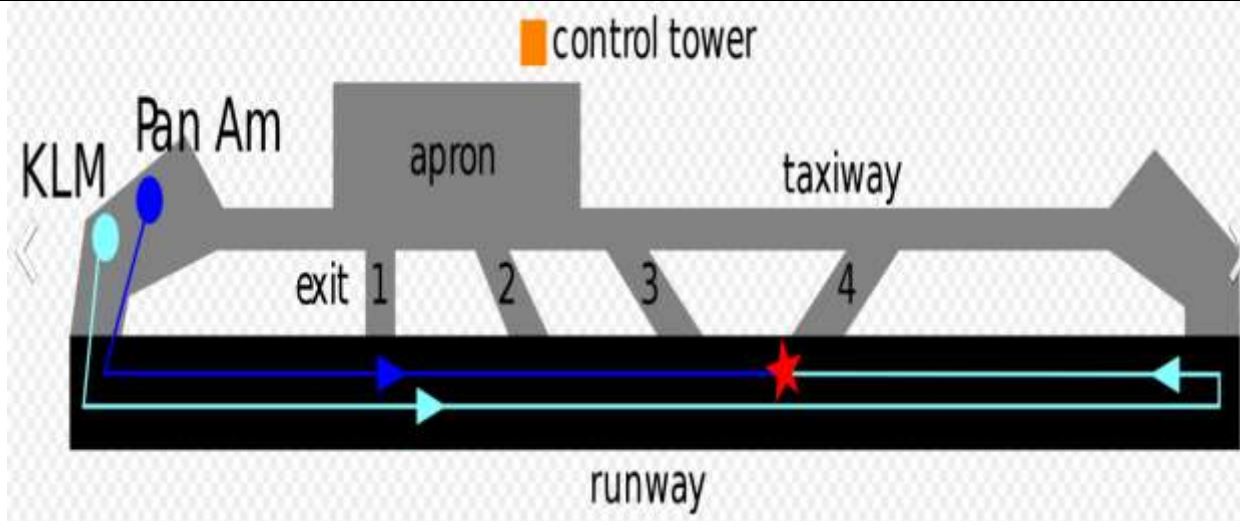
Then tower informed the PAA aircraft to continue on the runway 30 and then take 3rd exit to the taxiway, parallel to the runway. As PAA pilots were unclear about the 1st or 3rd exit, they asked again, and the 3rd exit C-3 was confirmed by the pilots. The pilots identified the first 2 exits (C-1 & C-2), but missed the 3rd exit as there was no clear indications about the C-3 location and also to, turn the aircraft on C-3 exit the aircraft have to make a 148-degree turn and come on the crowded taxiway and then again 148° degree turn to continue taxing towards the starting point of the runway, but C-4 was only having 35-degree turn. Due to the KLM aircraft, which was ready to take off tower requested PAA to take C-3 exit as it was the earliest exit.

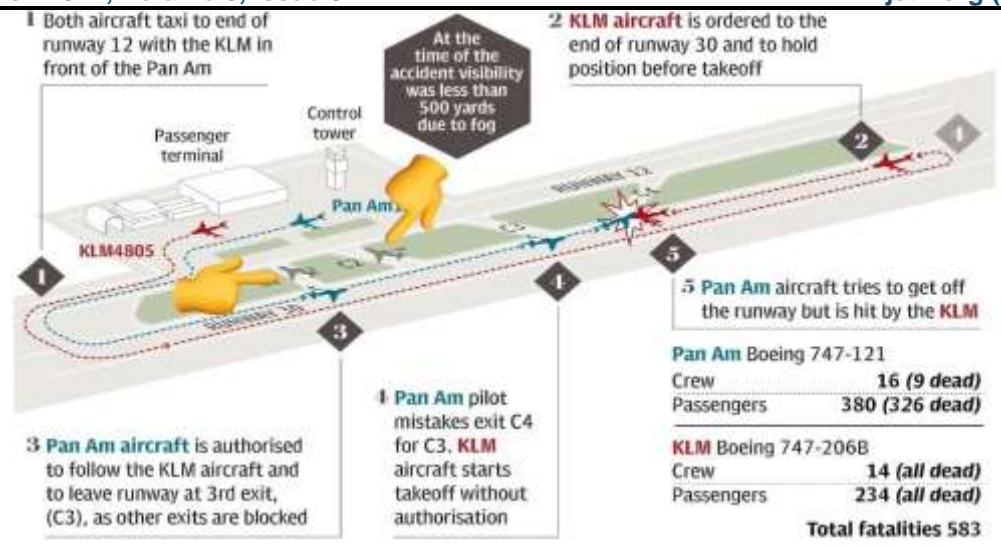
KLM aircraft's nose was up so it crossed the PAA fuselage, but the engines, the lower fuselage and the main landing gear struck on the upper side of PAA fuselage and ripped the entire top portion of the fuselage. The right engine crashed into the PAA's upper deck, just behind the cockpit. KLM was slightly Airborne, due to the impact on the engines, which leads to the damage on the wings also, leads the aircraft to stall at a speed of 140 knots, it rolled sharply, and hit the ground at about 150m from the collision, and slides down the runway for around 300m. due to the full load of fuel, it gets ignited immediately and started burning, and remained burning for several hours.

Due to the collision both the Airplanes were destroyed. Passengers and crew on board KLM plane was dead, i.e., all 248 passengers, and 335 passengers and crew on board PAA plane, due to the fire and the impact. Luckily, 61 passengers including, both pilots and flight engineer from PAA Aircraft survived the crash. The engines of PAA were running so the first officer tried to shut them, and extended his arm towards the roof the cockpit to turn them off, but there was no roof and the pilots were able to see the tail of the aircraft 200ft from the cockpit, so they were unable to turn the engines off which eventually blow off. One of the 61 survivors on PAA said “sitting near the nose part of the aircraft saved my life”, “we all settled back, and the next thing an explosion took place and the whole Port side was just torn wide open”.
