Analysis of Failure Encountered by IC Substrate and Plastic Package

Abstract—This paper presents the review on the work done on failure analysis mainly with respect to temperature and humidity. The pressure failure mode include package delamination ,solder abnormality and moisture ingress. After studying their impact,source prevented measures and improvements suggested have been studied.

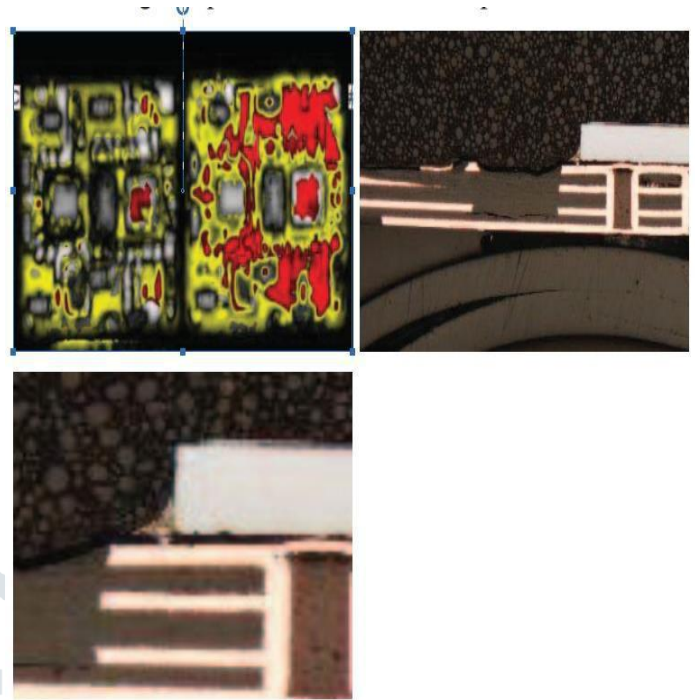
- molding compound and lead-frame separated

Fig.1. Displaying SAM found delamination and side cross-section confirmed molding compound and lead-frame separated, unstable curve during IV test[3].

Delamination and open bonding :always when along the delamination border(Fig.1&Fig.2), there should be affection end(whatever ball or stitch),the separated layers must have effect the connection between closeness and its leads(frame or pad),so this connection could be broken by the section.

Advices: facing to these circumstances, a proper time of sweltering would be a better solution to drive out the potential moisture whenever the resulting cases exist: a long period storage, the transfer from each process or company, de-solder or re-solder from PCB, return from customer, and etc. Or pay more attention to the loading environment at each process.

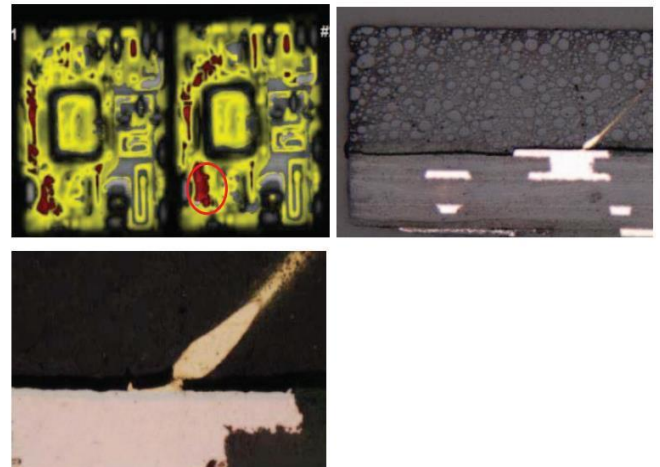
- Bonding stitch broken

Fig.2. SAM found delamination and side cross-section set bonding stitch broken, open signal probing for this connection[4].

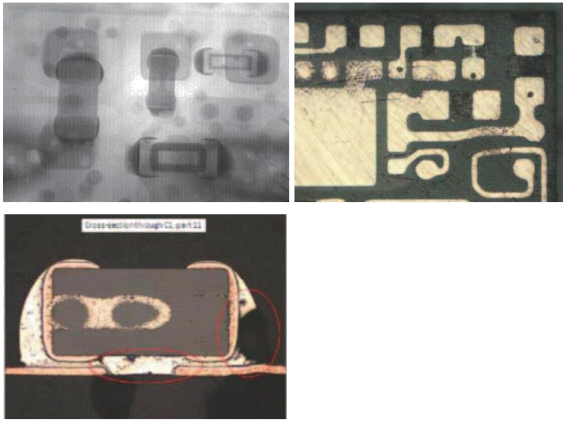
- solder reflow cause “SMD open/short”

Fig.3. Displaying X-ray found solder deviation on one SMD and behind polish and side cross section set SMD two terminal “solder short”, very high current to GND for FT result

The relative of delamination and solder reflow: for the substrate/SMD samples with solder on(Fig.3~5) ,after delamination happened , there came a sudden high temperature(like solder on board process:235℃ for Pb free)

the solder material melt down and re-soldered shape beside the delamination gap, so the lands of substrate would be solder –

linked which could even induce a heavy short, and lack of solder would break the original connection which make the circuit

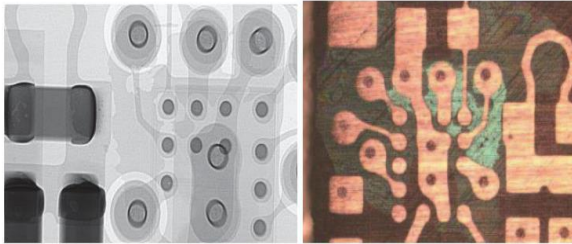
- solder reflow cause “lead short”

Fig.4. Showing X-ray found solder abnormality on one SMD [5].

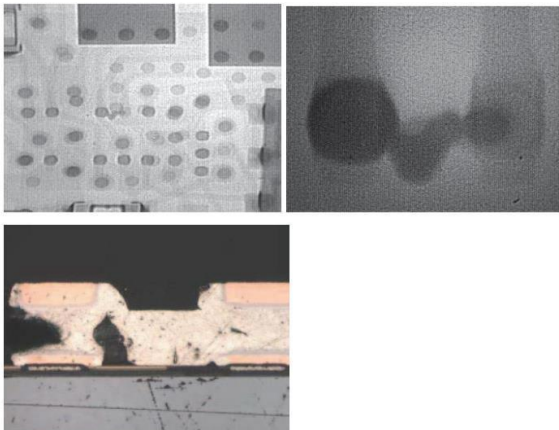
- solder reflow cause “solder ball melt and short”

Fig.5. Displaying x-ray found solder ball melt and lateral cross section confirmed two balls “solder short”, short curve during IV curve[8].

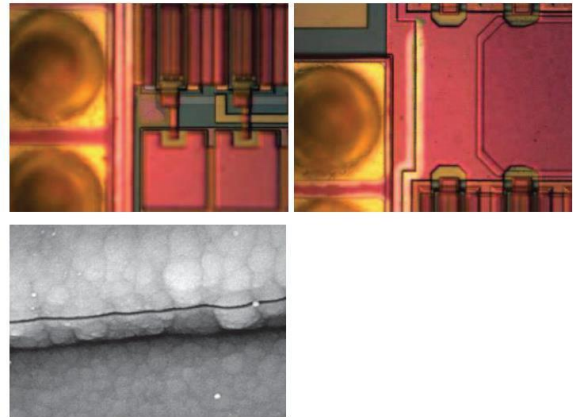
- die surface moisture ingress

Fig.6. Displaying OM found ingress moisture on edge of die surface and SEM found passivation crack proof, a marginal leakage on this pad during FT[7].

The relative of Moisture and electric damage :for electric damage samples after exposing to environment ,moisture maybe one of the root causes(Fig.6~8) .Humidity have invaded into at the package/die, when the bias applied, this potential voltage would accelerate this ingress. Sooner ,the relative circus was leak aged, with time goes ,this marvels would become serious and activates ESD/EOS damage which could cover the true cause. Moisture induced failure that is additional observed by using a thermal discharging equipment to match the result.

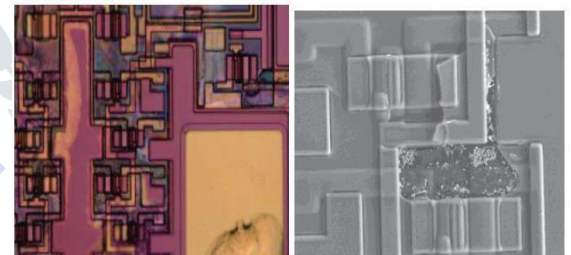
- die surface passivation crack

Fig.7. Displaying OM found moisture ingress on edge of die and SEM bring into being passivation crack evidence, various parameters fail during FT[6].

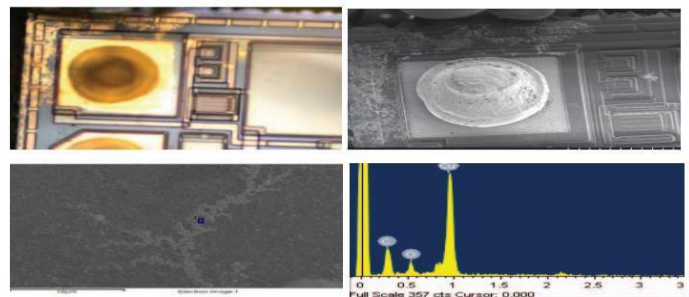
Fig.8. Displaying OM found discolor and relocation on edge of die surface and SEM(EDX) set Cu migration on surface , high leakage on this PAD during FT[1].

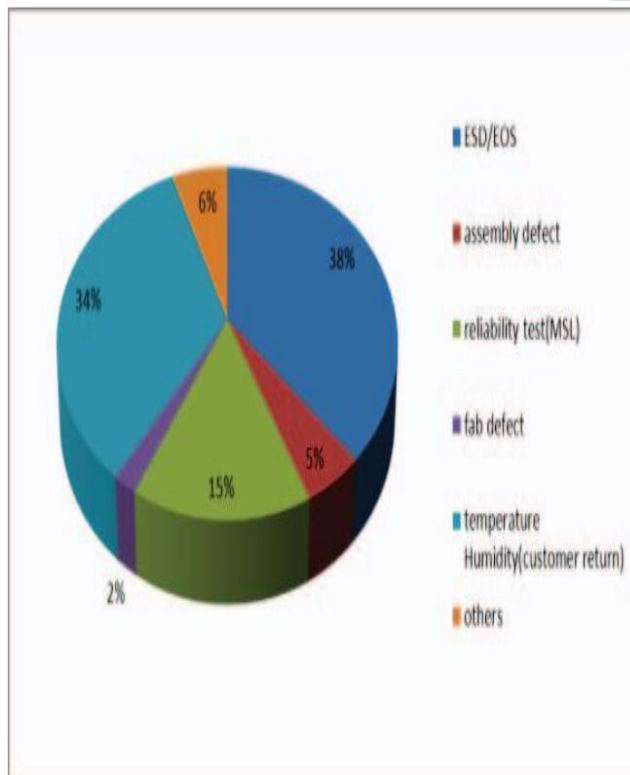
Two years' cases of their lab are brief from the stage of process monitor ,reliability test and customer return, the ratio of temperature and humidity bomb is shown below

Fig.9. Displaying each failure mode ratio in our company [1].

The temperature and humidity related issues are still our top test
