# Study and Analysis of Pin of Knuckle Joint in Train

**Abstract** - The current paper presents the problem of the failure of the knuckle pin in a railway coupling due to shearing. As per the functionality of the knuckle pin the pin is suitable for retaining of the knuckle and no loading conditions is determined over it but due to the manufacturability of the knuckle itself the failure of knuckle is undertaken thus the possible solution is presented in this thesis. The papers related this topic is studied for any recent advancement in the knuckle coupler pin while no relevant problem is defined and possible remedy is determined

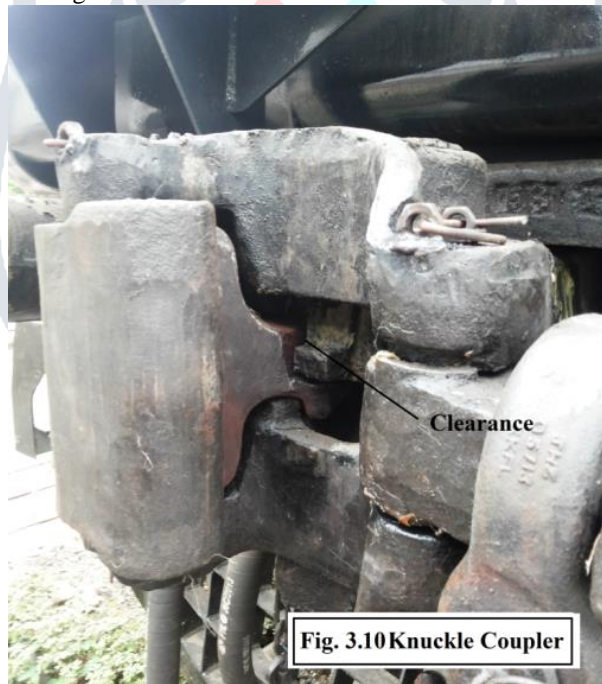
The figure 9 shows the actual assembly of knuckle coupler. The problem identified is within the knuckle where at the posterior of the knuckle at the contact at the guide way slot the clearance is providing the unnecessary displacement in the knuckle with respect to the coupler of approximate 5 mm. This defect is caused due to possible reasons including manufacturability of the knuckle and/or coupler. The another possible reason could be the sliding of the knuckle and coupler causing surface to be deformed and creating clearance.

**Fig. 3.10 Knuckle Coupler**

**Fig 9 Knuckle Coupler**

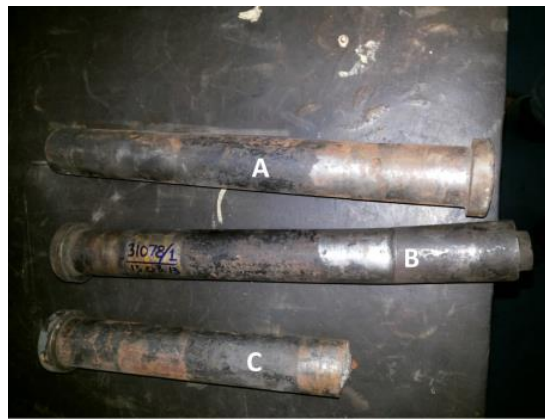
Thus due to the presence of the clearance the load is transferred to the knuckle pin and probably failing the knuckle pin due the shearing as shown in the figure 10.

Fig 10 Knuckle pin picture

The Knuckle pin shown in figure 10 are showing the failure of knuckle pin in shear. The further analysis of the problem is studied and possible solution is provided in next chapter.

The results and discussions determine the application of the alternate material availability for the knuckle pin with requirement of deformability of 5 mm without failure. A proper elastic material can be used instead steel to withstand the required condition and sustain the accurate functionality of the problem.

As per the defined conditions and analysis the present steel material can be substituted with a proper elastic material. The presently for the problem of shear failure of the pin alternatively plastic knuckle pin that will accept bending fatigue, thereby reducing pin failure can be used. The pin made of a plastic material having a flexibility that will allow it to bend and return to its original shape and to also be self-lubricating. Further, the pin eliminates rust and corrosion and produces a low coefficient of friction between the pin and the coupler body and knuckle, thus enhancing opening and closing of the knuckle by reducing rotational resistance, thereby promoting safety. It has been known that steel pins, either at the time of installation or after service, can cause a “lazy knuckle”, i.e., a knuckle that will not open all the way on decoupling. Thereafter, it is usually impossible for the knuckle to close in a coupling operation which necessitates a yard worker to reach in with his hand and pull the knuckle into fully open position, and usually when another car is coming to couple. While it is against the rules to pull open a knuckle under those circumstances, the worker often tries, which many times has resulted in the worker’s hand and/or arm being injured and even taken off.
