# CRACKS INVESTIGATION OF BASEMENT AND THEIR MAINTENANCE IN HIGH-RISE BUILDINGS

This Paper is study of **9 blocks** of a building and each block is (**G+11**) located in Kendriya Vihar, Jaipur.

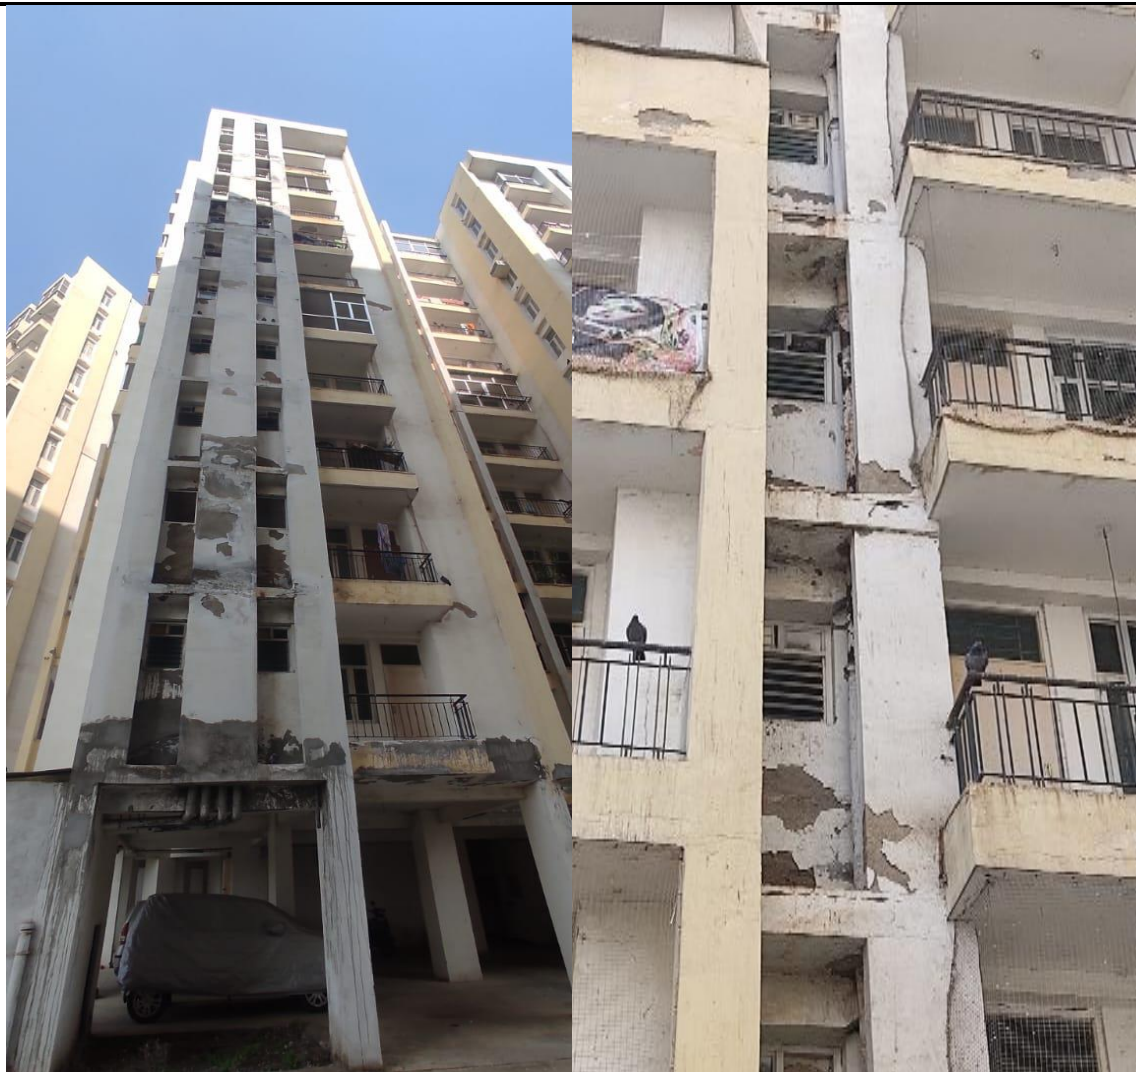
Fig: -1 Visual inspection of the building.

- The initial appearance of the building was very bad as there is multiple damage visible.
- Such visuals make the building aesthetically look bad.
- There were cracks in walls, derbies scattered around the blocks, dampness all over the basement section and failed plumbing system.

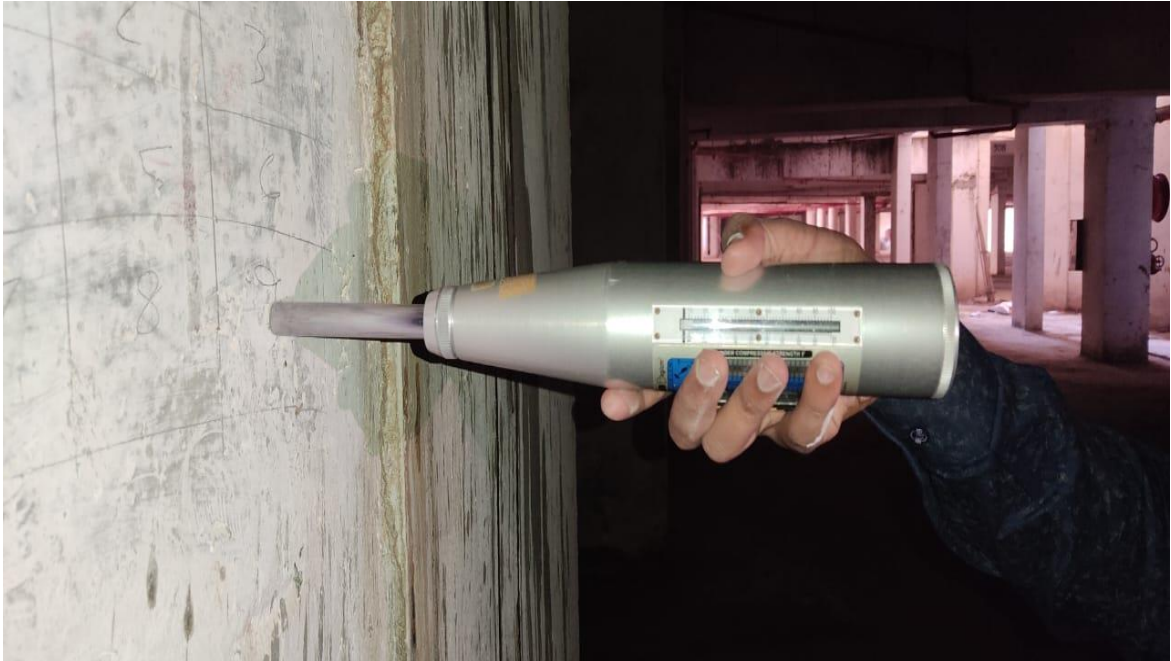
Fig-4 Rebound Hammer Test

S.No.	Name of instrument	Uses
1	Depth Gauge	Usage to gauge depth under a surface serving as a reference. They consist of engineering tools for measuring the depth of holes and indentations from a reference surface as well as depth gauges for underwater diving and related applications.
2	Rebound Hammer	Check the stability and strength of rock formations for geological and geotechnical applications. These distinctive models assess the age, strength, and weathering of rock formations or predict the speeds at which tunnel boring equipment will penetrate the ground.
3	Concrete Cover Meter	A cover meter, also known as a rebar finder, is a gauge used to determine how much concrete is covered by metal pipes and steel reinforcing bars. The diameter of the reinforcing bar (also known as rebar) as well as its depth and placement and orientation may all be determined using the cover meter.
4	Digital Vernier Calliper	High-resolution measurements of an object's breadth or diameter are possible with digital Vernier-type callipers. Final measurements appear on clear LCD panels, eliminating any opportunity for interpretation.

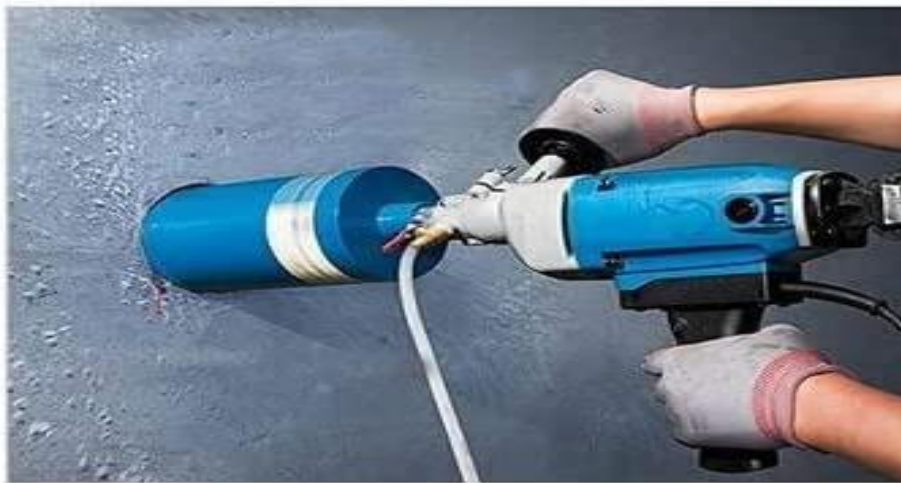
Fig-7 Core Cutter tool.

5	Core Cutter	Using a core cutter, it is possible to calculate the dry density of soil and its cohesion. Using core cutters, it is possible to swiftly calculate the soil's density. The void % is determined first. Poor soil compaction is indicated by a high vacancy percentage.

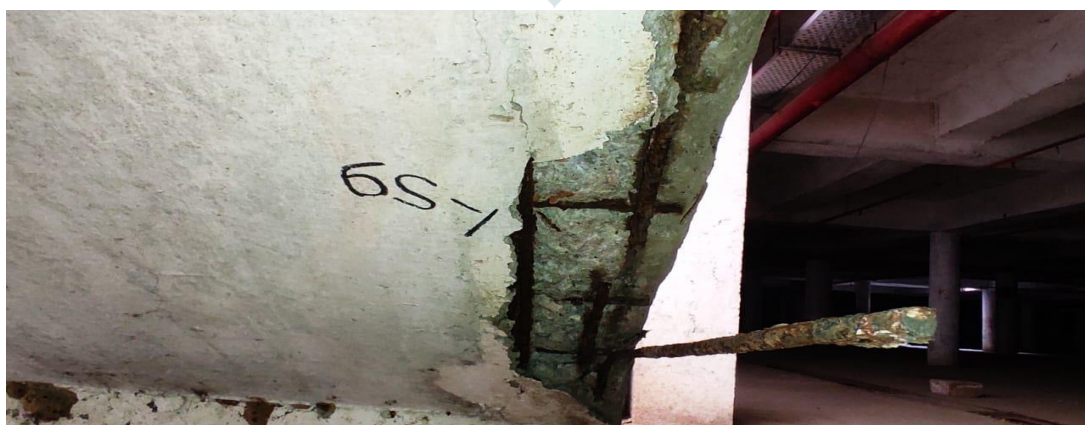
Fig-8 Staircase with exposed reinforcement

S. No.	Type of Structure	Original Size of Reinforcement (mm)	Present Size Left (mm)	Comments
1	Column	Main Bar is of 32mm. Stirrups are of 10mm.	Main Bar size is now 30.17mm left. Stirrup's size is varying between 6.43mm to 8.93mm.	The bars are exposed to open atmosphere, there is no proper cover provided at the time of construction also there is seepage of water by which the bars get corroded and their
2	Beam	The stirrups are of 12mm.	Now the stirrups left only 10.04mm.	The stirrups are exposed and there is no cover provided in the beam. Due to seepage of water the bars get corroded and reduced in area.
3	Stairs	The main bars are of 16 mm and 12 mm somewhere.	The 12mm bar left only 9.01 mm, while the 16 mm bar left between 13.62 mm to 14.28 mm.	There is excessive corrosion in the bars. There is no cover provided at the time of construction, so the bars are now exposed and severely damaged.

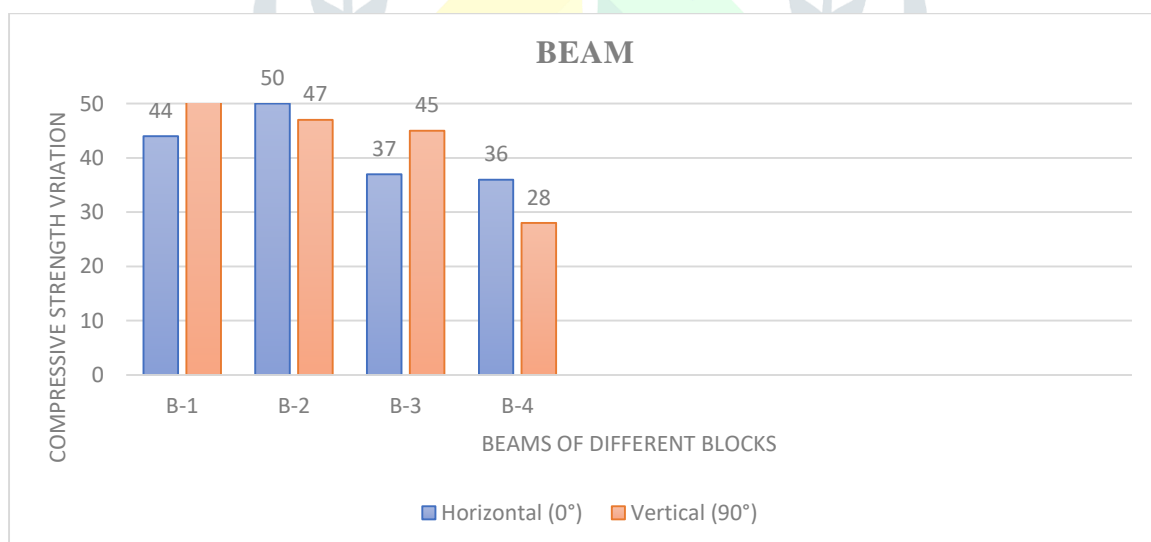
Graph: - 1 Point of Test on Beam v/s Compressive Strength of Beam

S. No.	Rebound Number		Compressive Strength		Description
	Hz (0°)	Vt (90°)	Hz (0°)	Vt (90°)	
B-1	42	50	44	50	This beam seems to be fine, as there not very much deterioration.
B-2	45	47	50	47	This beam seems to be fine, as there not very much deterioration.
B-3	38	46	37	45	As per the value of horizontal and vertical direction we can say that concrete is in good category.
B-4	37	37	36	28	As per the value of horizontal reading we can say that concrete is in good category. But in vertical direction the quality is fair only.

- From the readings of Rebound Hammer Test 85% Stairs are under the category of below average category, out of which the horizontal part is most severely damaged.
- For the beams of the 9 blocks an average of 44% beams are considered under below average category and needs to be repaired.
- For the columns of the 9 blocks an average of 30% columns are considered under below average category and needs to be repaired.
- For the retaining walls of the 8 blocks an average of 25% walls are considered under below average category and needs to be repaired.

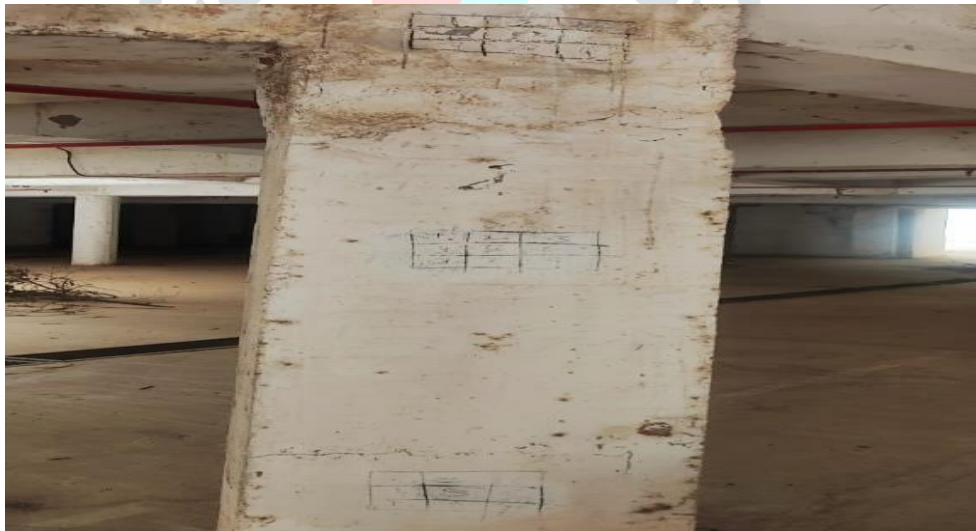
Fig: -9 Rebound Hammer Testing on Column

S. No.	Rebound Number			Compressive Strength			Description
	Top	Middle	Bottom	Top	Middle	Bottom	
C-1	40	44	38	41	48	37	The bottom part of the column is little weaker than the whole column, but still it is considered as good in condition
C-2	36	45	48	34	50	56	The top part of the column is little weaker than the whole column, but still it is considered as good in condition.
C-3	46	47	43	52	54	46	The columns in this block are in excellent condition.
C-4	40	42	44	41	44	48	The columns in this block are in excellent condition.
