Model Study on Slope Failure Subjected to Rainfall

Abstract— Purpose of the paper is to present a scaled model of slope to study the infiltration process subjected to rainfall. To observe the infiltration process on slope, artificial rainfall is applied to model using sprinkler system at a rainfall intensity, ie, 133mm/h. Pore-water pressure (PWP) and displacements are measured using sensors, which are installed within the model at various locations to monitor the changes in suction. The aim is to study the slope movements of the soil water content, pore-water pressures and displacement with and without placing geotextile in the slope. The study tries to predict slope failure caused by monitoring these parameters. Based on these results, the time for first failure can be evaluated.

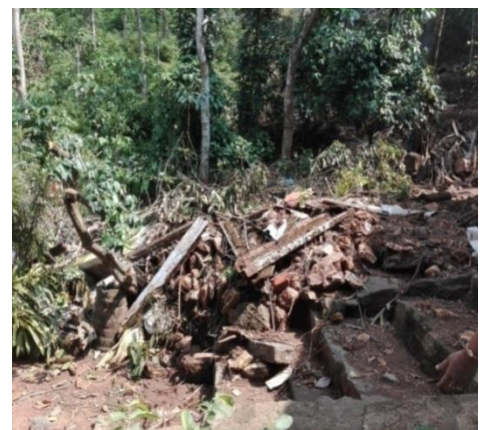
Fig.:1: Slope failure that took place at Kullanpadi- Muttakuzhi, Konni

The major occurrence for slope failure is due the change of climate, increase in water level, improper drainage facilities and lack of study at the site. Initially, soil at the toe of the slope saturate faster at a higher rate and then saturate further area of slope which led to slope failure. Slope stability analysis is based on balancing of forces, moments or energy where failure is assumed to occur along slip surface. Fig. 1 shows the slope failure that took place at Kullanpadi-Muttakuzhi at Konni, Pathanamthitta.

Soil was collected from Kullanpadi- Muttakuzhi in Konni, Pathanamttitha district. Soil sample was collected from depth 1m from ground surface. Soil found from the location is laterite soil. Slope subjected to failure is hilly region where rubber, teak and plantation are the main cultivation at that location. Collected soil sample are meant for preparation of laboratory model. Table I shows the preliminary properties of soil collected from site.

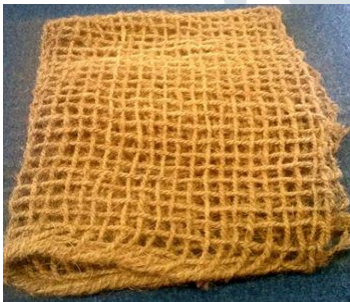
Coir geotextile of 3mm thickness was collected from Alapuzha Coir Institute. Fig. 2 shows the geotextile collected from Alapuzha Coir Institute.

Fig. 2: Coir Geotextile

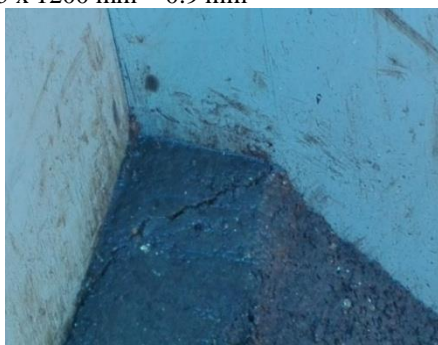
1) *Case 1- Slope angle= 38.6° , Rainfall intensity= 133mm/h:* On considering, case 1, with rainfall intensity of 133 mm/h. There is sudden increase of pore-water pressure (PWP) within 15 minutes after applying rainfall. PWP gradually increases leading to initial failure in the slope. Due to the downward infiltration of the rainfall, maximum or initial failure was experienced at the head or crest of the slope, further leading to sliding surface of the slope. PWP value was measured as a value near to zero and as the initial failure was observed as 1kPa with elapse time of 50 minutes. Initial elapse failure is shown in Fig 6. In this case, test was conducted for 3 hours and there was a vertical settlement of 20 mm from the initial position, which under the case of failure as shown in the Fig 7. Fig 8 shows the failure in slope after 3 hours. From the strain gauge, value for strain is obtained as 0.00075 and corresponding horizontal displacement is obtained as 0.9 mm which determined from formula, $\text{strain} = \frac{\text{horizontal displacement}}{\text{original length}}$

Fig. 6: Initial failure in slope at 50 minutes

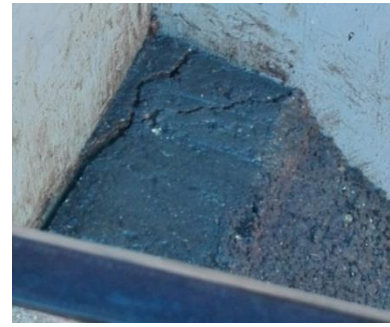
Fig. 7: Progress in failure on PWP increase at 133mm/h rainfall intensity

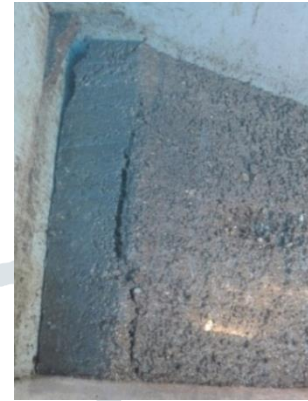
Fig. 8: Failure of slope after 3 hours

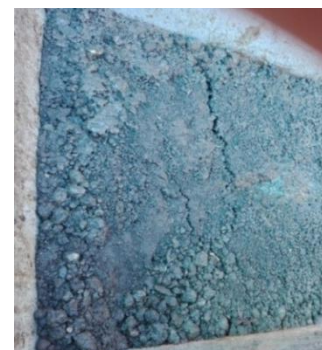
2) *Case 2- Slope angle= 45° , Rainfall intensity= 133mm/h, without geotextile:* Now, considering, Case 2 for the slope with slope angle 45° , thereby providing rainfall intensity of 133 mm/h to the slope. Here also, due to the downward infiltration of the rainfall, maximum or initial failure was experienced at the head or crest of the slope, further leading to failure at sliding surface of the slope. PWP value was measured as a value near to zero. As the initial failure was observed, PWP is observed as 1kPa with an elapse time of 30 minutes. The slope experienced a horizontal displacement of 0.6 mm at middle of toe and centre of slope with a strain of 0.000631 having slope length of 950 mm, that is, strain in case 2 is observed as 0.000631. Therefore, $\text{strain} \times \text{original length} = \text{change in length}$, that is, $0.000631 \times 950 \text{ mm} = 0.6 \text{ mm}$. Fig. 9 shows the initial failure of slope and fig. 10 Failure of slope after 3 hours

Fig. 9: Initial failure of slope at 133 mm/h rainfall intensity for slope angle 45°

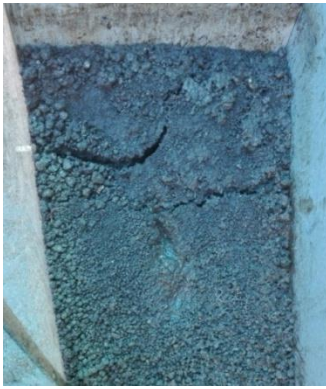
Fig. 10: Failure of slope after 3 hours at 133 mm/h rainfall intensity

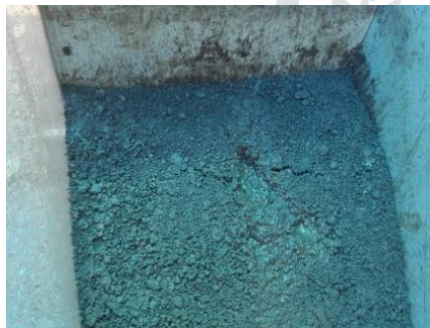
3) Case 3- Slope angle = 45° , Rainfall intensity = 133 mm/h, With geotextile: On considering, this case by constructing slope of 45° on providing 75 mm thick geotextile in two layers, each at 30 cm from the base of slope. Rainfall intensity of 133 mm/h was supplied to the slope. Due to the downward infiltration of the rainfall, initial failure was experienced at the crest of the slope. PWP value was measured as a value near to zero. As the initial failure was observed, PWP is observed as 1 kPa with an elapse time of 50 minutes. From the observation, it is seen that initial failure for elapse time increases by 20 minutes on providing geotextile to the slope with same slope angle. The slope experienced a horizontal displacement of 0.43 mm between the toe and centre of slope with a strain of 0.000453 having slope length of 950 mm. Therefore, strain \times original length = change in length, that is, $0.000453 \times 950 \text{ mm} = 0.43 \text{ mm}$. Fig 11 shows the initial failure of slope on stabilizing with 75mm thick geotextile at 133mm/h rainfall intensity.

Fig. 11: Failure of slope on stabilizing with 75mm thick geotextile at 133mm/h rainfall intensity

- PWP gradually increases due the lack of proper drainage.
- It was observed that elapse time for initial failure increases by 20 minutes on providing 75 mm coir geotextile in two layers for same slope angle.
