# Investigations on potholes distress in bituminous pavement: A case study

The data for study of different roads is collected. After surveying certain sections of road which are highly distressed are selected for further investigation to find out the cause of distress on the road. The following sections are selected after visual examination:

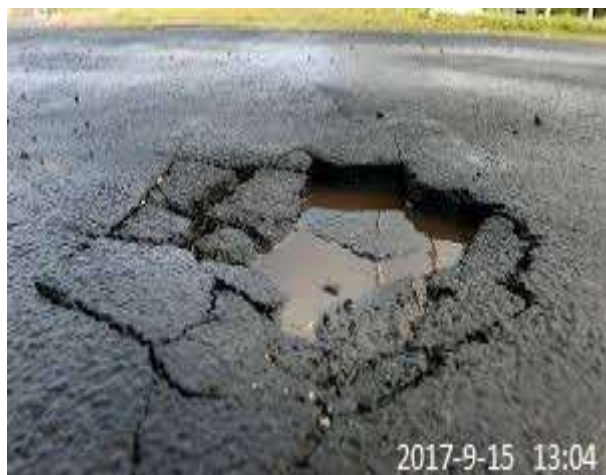
**Figure 1:** Chengicherla to Medipally Main road. **Figure 2:** Medipally to Ghatkesar (NH163)

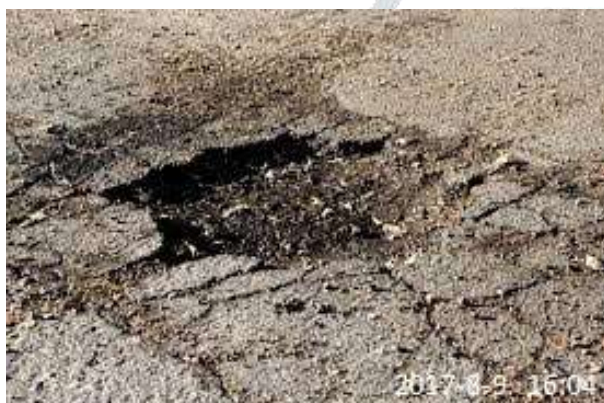
**Figure 3:** Narapally X Road to Korremula **Figure 4:** Cherlapalli to ECIL X road

The condition of R3 road *i.e.* road from Narapally X Road to Korremula is poor. A number of potholes can be seen. Lack of lateral confinement which results in loosening of total mass and formation of alligator cracks is the possible cause. Also, the traffic load on this road has increased tremendously over the years. The improper gradation results in opening up and loss of pavement material forming potholes. For the Industrial road such as R4 Cherlapalli to ECIL X road increasing number of vehicles cause relative movement of pavement resulting in fatigue failure and improper drainage leading to accumulation of water further amplify the problem resulting in pothole initiation. The inadequate binder content and inferior type of binding material used is the main causes for distress in pavements.

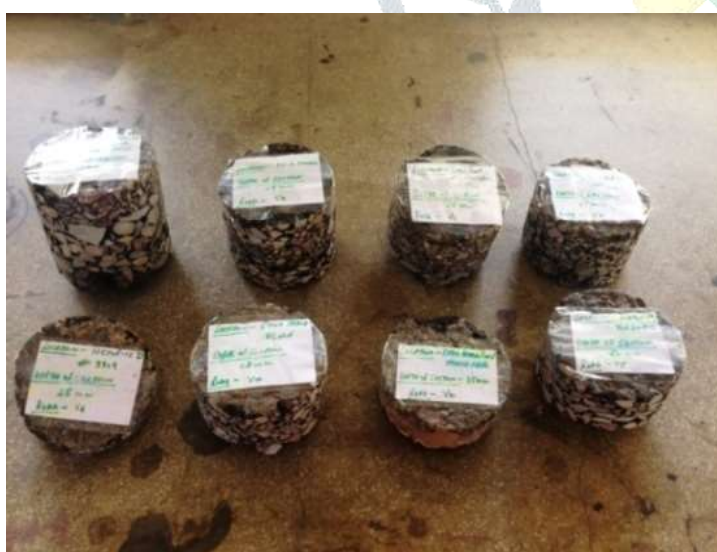
**Figure 5:** Road Samples Collected Using Core Cutter **Figure 6:** Soxhlet Extractor

Once the roads are selected after visual examination, the selected sample of road is collected for checking the bitumen content and carrying gradation test to identify the cause of occurrence of Pothole. The samples are collected using core cutter alongside the pothole to examine the samples in the laboratory. The core sample is removed using the core retrieval unit and the core samples are immediately

wiped dry and the identification number is marked. Total 8 samples were collected from four different locations.

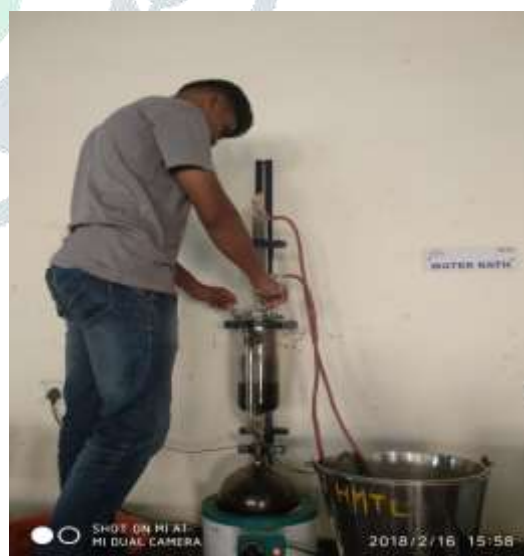
**Bitumen Extraction test** - In this study bitumen extraction test is conducted by using ‘Soxhlet extraction’ method. The binder from the mixture shall be extracted in accordance with AASHTO T 164. This test is useful for determination of bitumen binder content in the mix and for checking gradation of aggregate in the mix.
