Experimental Investigations on GFRP Cantilever Beams due to Different Types of Notches Closed to Fixed End

Abstract : The aim of experiment is to analyze the vibration of undamaged and damaged Glass Fiber Reinforced Polymer (GFRP) beams. Experimental free vibration of GFRP cantilever beam will be investigated by dynamic tests. Total three different types of notches are made artificially on the beams closed to fixed end. A comparison will be made of the experimentally extracted frequencies at each damage level and in relation to the single positions of the accelerometer. A comparison between natural frequencies due to different types notches have been investigated. The present experiment illustrates the envelope of Frequency Response Functions (FRFs) obtained by the experimental dynamic tests and the changes of natural frequency values correlated to the damage degree of GFRP beam. Numerical data is found out and discussed in comparison to the experimental results.

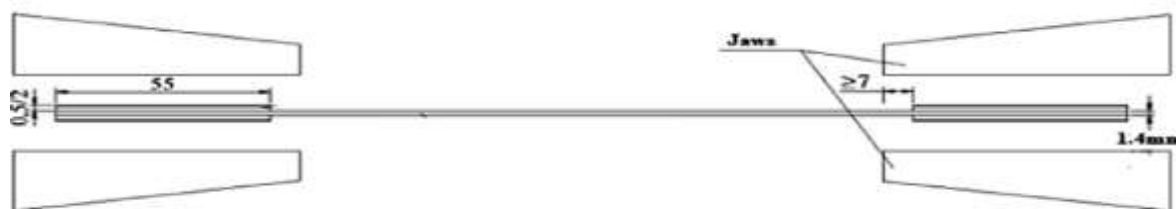
Fig. 1. Experimental setup for tensile test of a GFRP cantilever beam

Experimental tensile tests on specimens were carried out in the laboratory in order to evaluate the strength of GFRP laminas and Young's modulus before vibration tests aimed at determining the frequency values of undamaged and damaged GFRP cantilever beam elements. Tensile test beam element dimensions are 250mm*20mm*2mm (thick) and 55mm aluminum pads for gripping purpose while testing at the end of the beams. Table 1 shows the tensile test results of GFRP Cantilever beam. Figure 1 shows the test setup of GFRP cantilever beam. Figure 2 shows the tensile test result of GFRP cantilever beam.

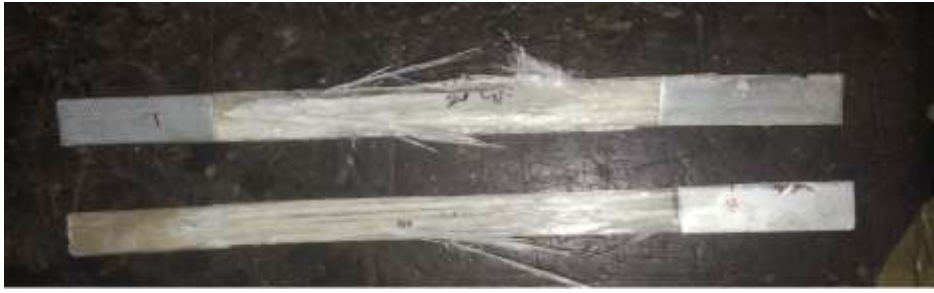
Fig. 2. Experimental setup for tensile test of a GFRP cantilever beam

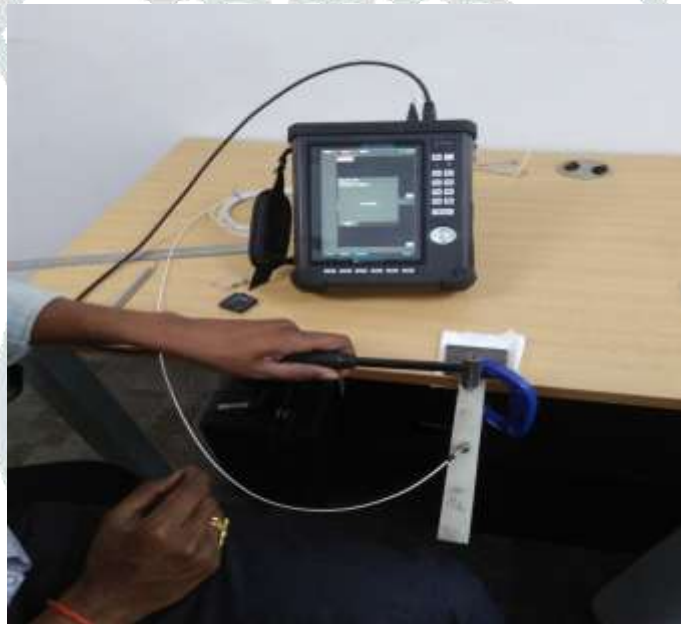
Fig. 3. FFT analyzer (Crystal Coco 80x)

The Instrument used for determining the frequency values are crystal instruments Coco 80x, Impact Hammer and its Property is 0.9944mv/lbf, Sensor name is P20, weight is 3 grams, and its property is 10 mv/lbf. Fig. 3 shows the FFT analyzer. Fig. 4 shows the impact hammer and the sensor.

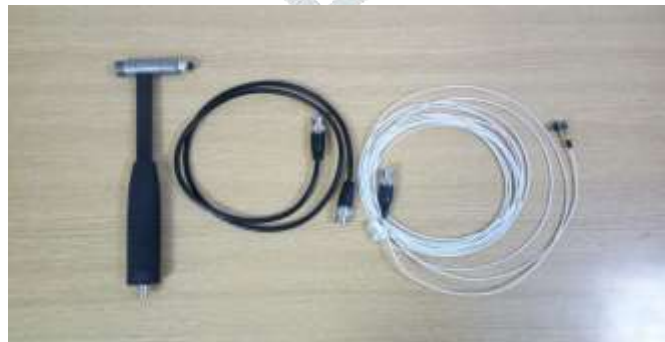
Fig. 4. Impact hammer and P20 sensor
