# Investigation of Physical Environment of a Gully Network of Sahson Village of Etawah, Lower Chambal Valley.

## Abstract

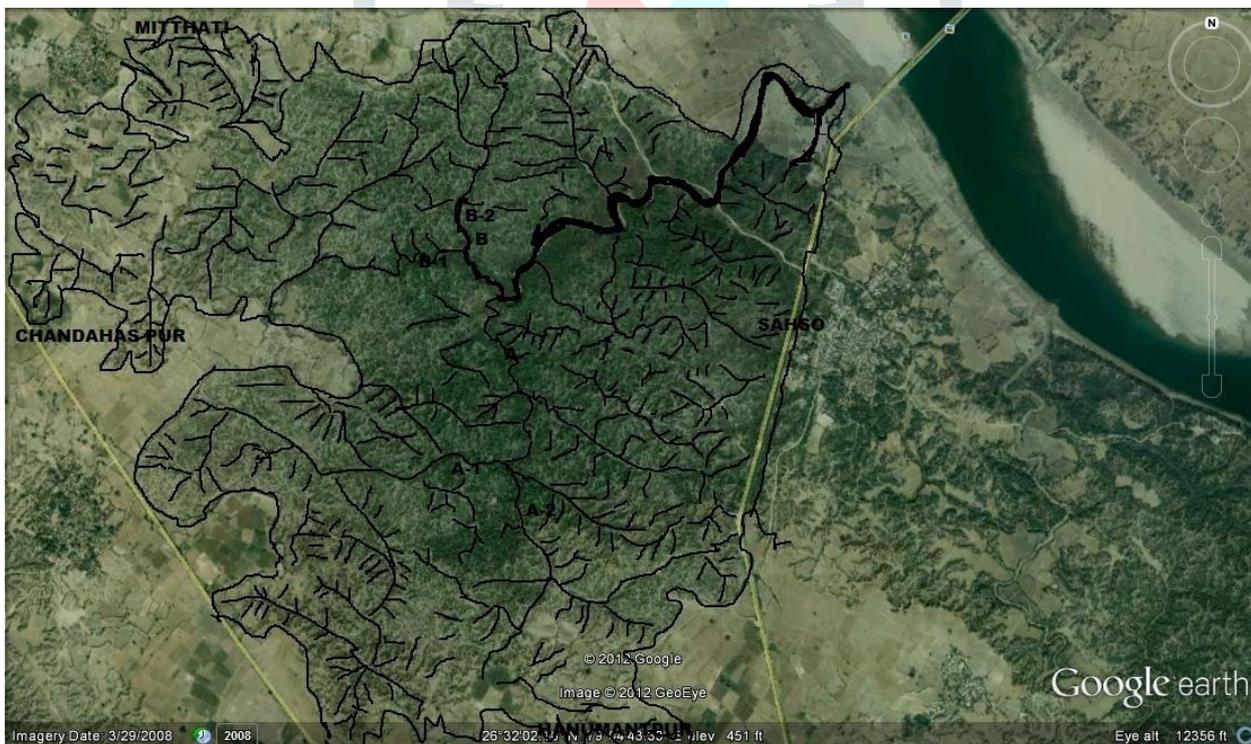
Fig 2.0

Gully is locally known as Khar. The surveyed gully is spread in a large area having many braches on upper reaches. At the distance of 1.70 kilometers away from mouth to upper reach, it is divided in two major branches. The right side brach (branch A) is reaching to Hanumantpura,. The length of this brach is around 1.94 kilometers. At the distance of 1.24 kilometers away from mouth of this sub branch, it again divided in two branches. Several small branches has been developed from both sides of these braches and actively eroding a huge area.

Another main branch (branch B) of Khar is also divided in two parts at the distance of 0.26 kilometer from its junction with main gully. These two sub-braches are spread in a big area and affecting the mithati, chandhaspur villages of the region. There are many branches in upper reaches. These all are combined in a single Khar and finally meeting with Chambal. Although some sub-branches are

developed in parallel pattern, particularly in area of branch A, The pattern of gullies is very much dendric here.

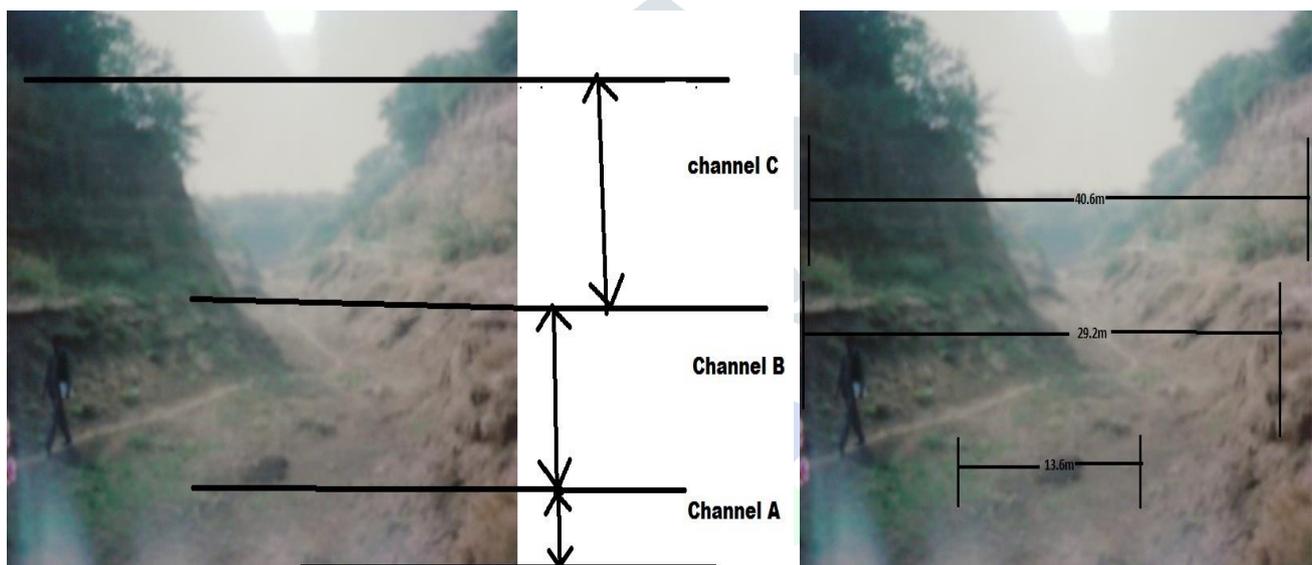
**Fig 3.0**

Due to heavy discharge of water and sediments, the mouth of this gully is very wide and its channel is narrowing toward upper part of the catchment. At the mouth of this gully, three distinct stages of development of this channel can be seen. The lower channel (channel A) is very narrow one (13 meters). See figure 3.0 and 4.0.

A wider channel's footprint can also be seen here. That is clearly visible by an alluvial terrace. The width of this channel is 29 meters (channel B). Just above this terrace the width of channel becomes 40 meters (Channel C). Such feature could be outcome of following conditions.

The Erodibility of soil material of various layers is different here. With change in rainfall amount, channel discharge amount reaches to different heights. In case of heavy rainfall, heavy discharge of water will push the literal wall erosion and maximum erosion will be occurred at top layers of high erodibility. The presence of kankar layer at lower strata restricts erosion of soil material. At the distance of 0.75 kilometers to 1.70 kilometers from its mouth, a thick layer of unconsolidated canker has been observed in the bottom of the gully channel. Such kankar layers are exposed at many places here(Fig 5.0).

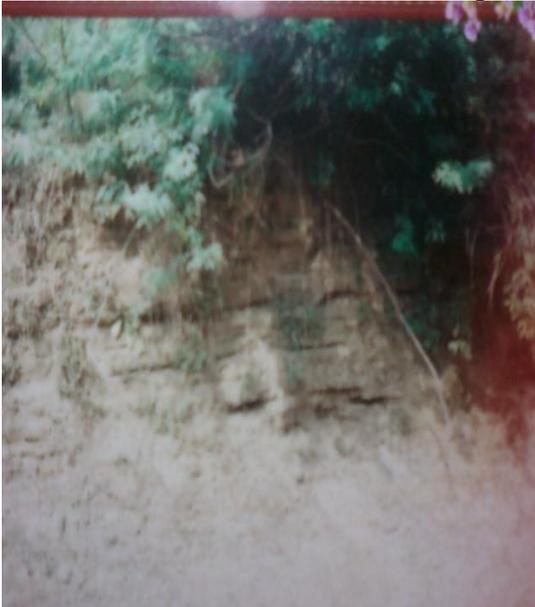
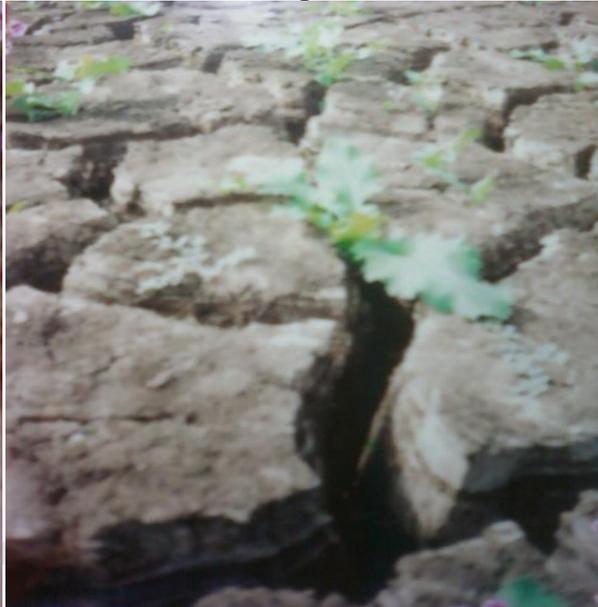
Fig 6.0

Huge fine silt and clay content are spread near the mouth of the gully. It is spread over a big area. Due to high amount of clay and less moisture content (in dry season), cracks has been developed in this soil. The average width of these crakes is 2 inches. These crakes developed up to the depth of 10 to 12 inches. (Fig 6.0 and 7.0).

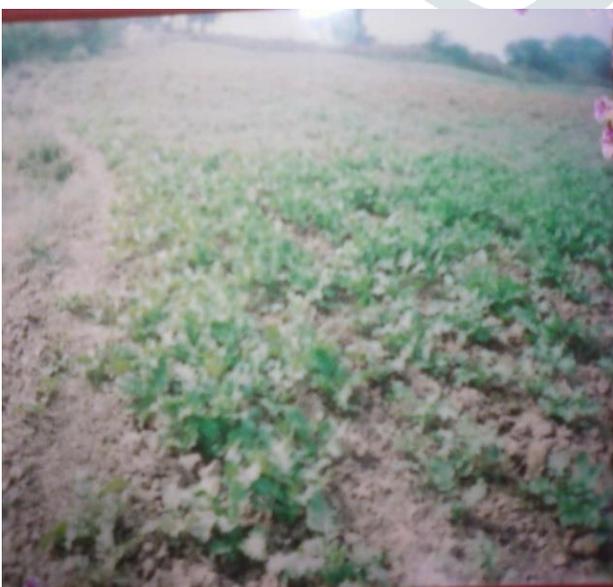
Fig 8.0

Area of this gully network is several kind of land use here. There is forest cover, agricultural land, settlements and a huge area is left as barren land. Near the mouth of surveyed gully, undulating land is under cultivation practices. Due to undulating shape, land is not suitable for intense agriculture. It is under use of cultivation of mustered and gram. Crop plants are grown in patches and a big area of these fields can be seen with bare soil cover. Soil is clayish in nature and soil clods can be seen in each part of these fields. An average diameter of these clods is 2-4 inches (Fig 8.0).

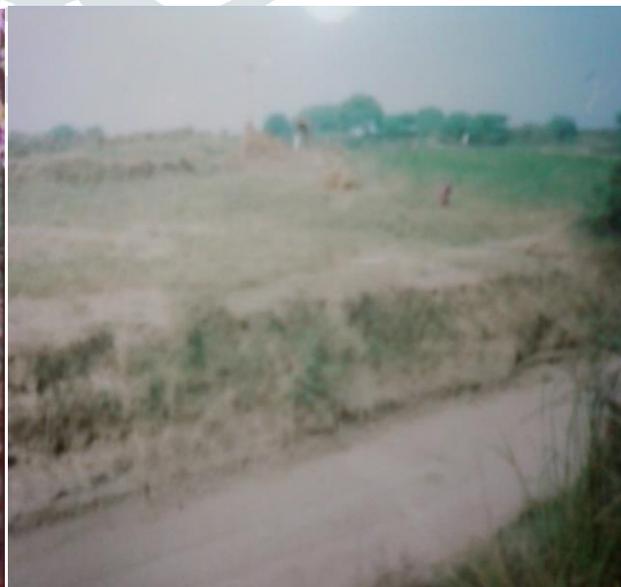
Fig 9.0

Source: Taken by author during his field visit in 2013

On other hand there is few properly leveled agriculture fields are developed toward the upper reaches at the distance of 1 kilometer from the mouth. These fields are properly covered with fans by using locally available bush material. Working people are found there while it was totally deserted near the mouth of this khar. Usually wheat is sown in this area. The gully (Khar) is around 3meters deep in this part of the region (Graph 9.0).There is almost continues forest cover at the right side of this khar. Most of the trees are *vilayati babul* (*prosopis juliflora*), Khair (*Acacia indica*), *Capparis deciduas*, *Capparis sepiaria*, *Balanites aegyptiaca* etc. Due to post monsoon period, small bushes and grasses has been developed here.
