A RESEARCH PAPER ON IMPROVEMENT AND DEVELOPMENT OF GEARBOX IN THREE WHEELER VEHICLE

Abstract: - This Study investigated the method of improvement and development for the gearbox of three wheelers four stroke diesel engine by analysis through field complaints, observation and finding root cause of gearbox failure. As the problem arises gear box failure. After some time running of vehicles, excessive play occurs between parts needle bearing and cluster gear, which disturbs the alignment at cluster gear with the gearbox of diesel engine. Deep improvement aiming at describing the influence of method and processed improvement to maintain bearing position wrt. main housing of gear box. Needle bearing pressing mandrill special tool outer diameter decreased to maintain bearing position wrt. Bore depth in main center housing. Also ball bearing pressing special tool modified. While pressing with cluster gear references are changed from outer ring to inner ring of a ball bearing. The impact of development reflects on performances and engine smooth gear shifting.

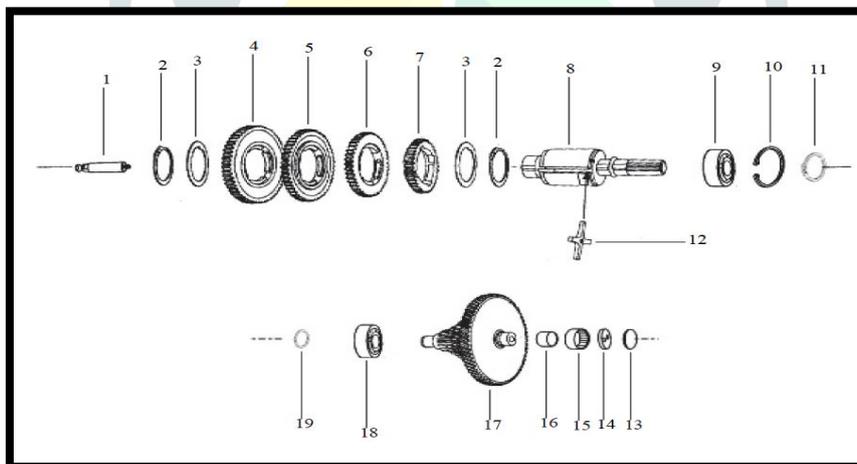
Fig 1.1 Dismantling Gear Box

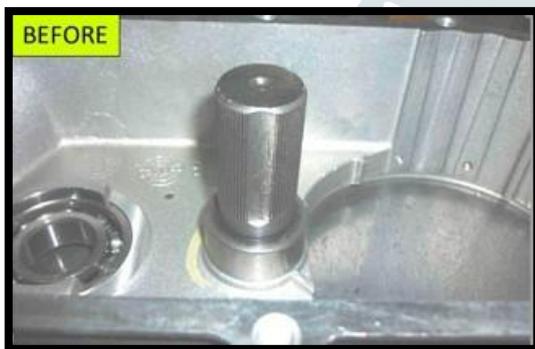
Fig 1.2 Before modifying NRB Pusher

- 1) **NRB PUSHER MODIFIED:** NRB pusher butting face diameter was 39.5 which is modified to 28.5 mm parallel to bore diameter. Before modifying chances to face resting on MS Housing. Rib and bearing position could be up side, after modifying bearing position always maintain wrt. to bore depth.

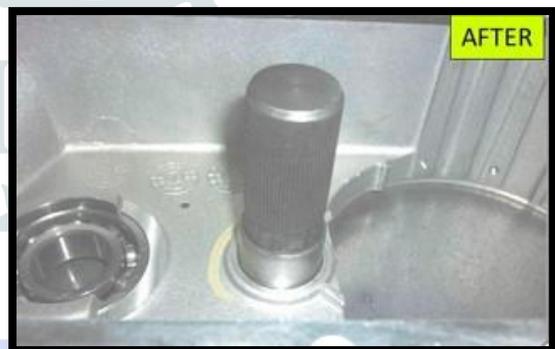
Fig 1.3 After modifying NBR Pusher

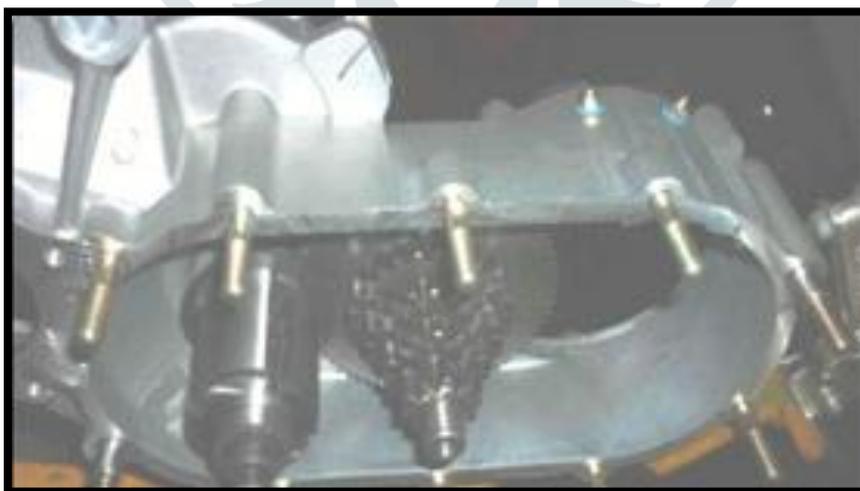
Fig 1.4 Main Shaft ES Cover

- 2) **ES COVER ASSY. ON MS HSG:** Ball bearing pusher modified. While assy. of engine side cover on main center housing, hammering required on ball bearing to fix on cluster gear. Before hammering reference was outer ring of bearing with possibility to create excess play between inner ring and outer ring. After hammering reference started on inner ring of bearing and now no load coming on ball or outer ring of bearing while assy.

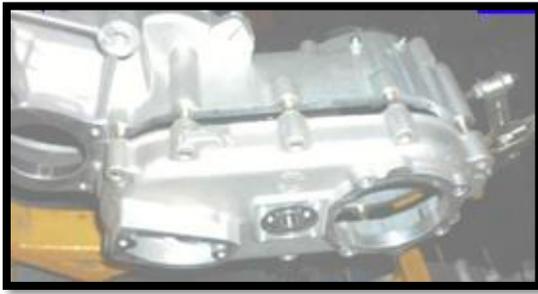
Fig 1.5 ES Cover Assembly

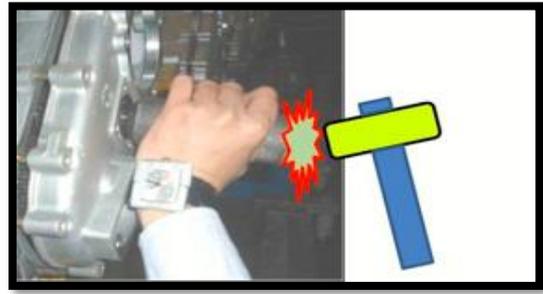
Fig 1.6 Hammering Reference on inner ring of bearing

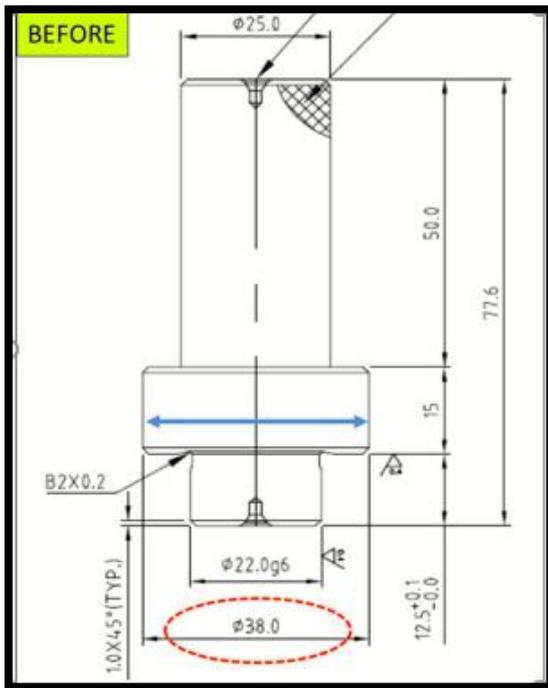
Fig 1.7 NRB Pusher Before

- 3) NRB Pusher modified: NRB Pusher modified, before the pusher butting diameter was 38 mm which is modified after to 28.0 mm diameter with clearance of -0.15 to +0.20 mm.

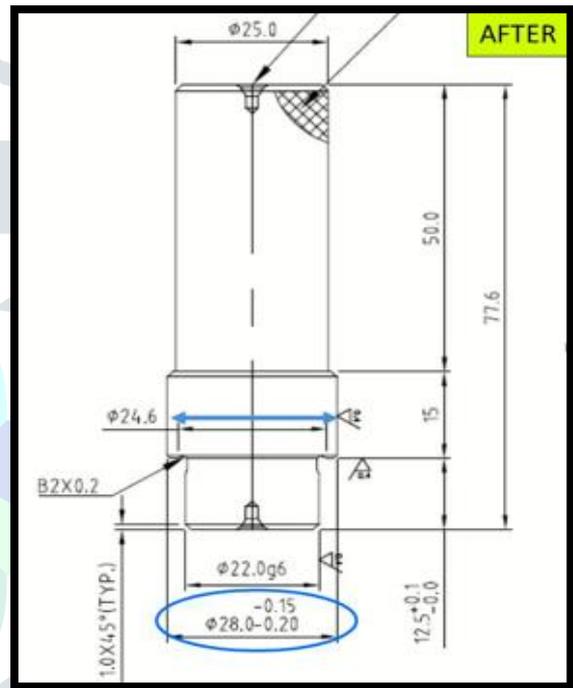
Fig 1.8 NRB Pusher modified

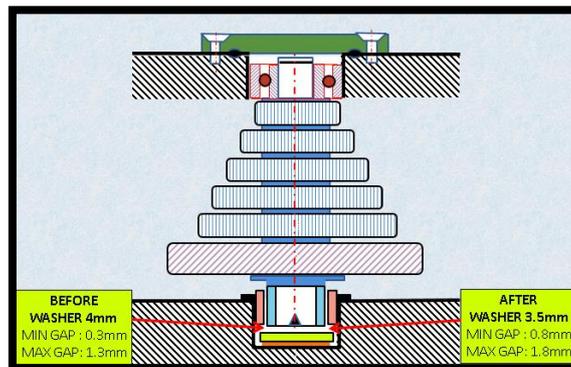
Fig 1.9 Cluster Gear Modified

- 4) Gap between cluster gear face and washer (NRB Side): Washer Thickness changed from 4mm to 3.5 mm. this will create more clearance between Washer and Cluster gear face at needle bearing end. The washer placed in housing of cluster of NRB side gap between cluster gear face and washer before was 4 mm thickness with minimum gap of 0.3 mm and maximum gap of 1.3 mm. After modified washer the thickness decreased to 3.5 mm with minimum gap 0.8 mm and maximum gap of 1.8 mm.
