# NON-DESTRUCTIVE TESTING AND LINEAR DYNAMIC ANALYSIS OF EXISTING RC FRAMED STRUCTURE

*Seismic Evaluation of Existing RC Framed Structure using Response Spectrum Analysis*

<sup>1</sup>Sushant. S. Desai, <sup>2</sup>Dr. Chandrakant. B. Pol

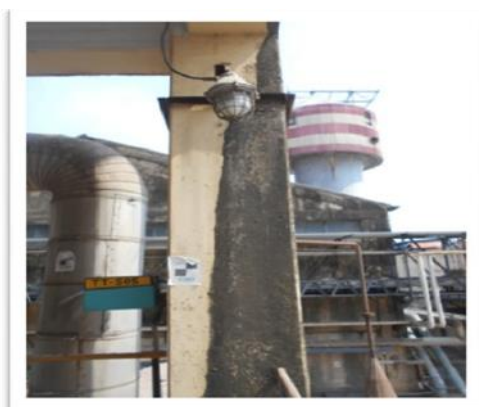
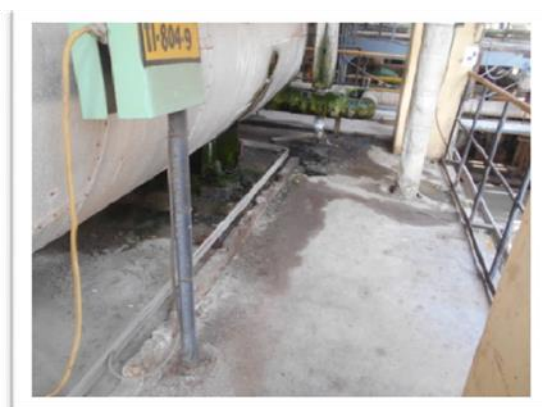
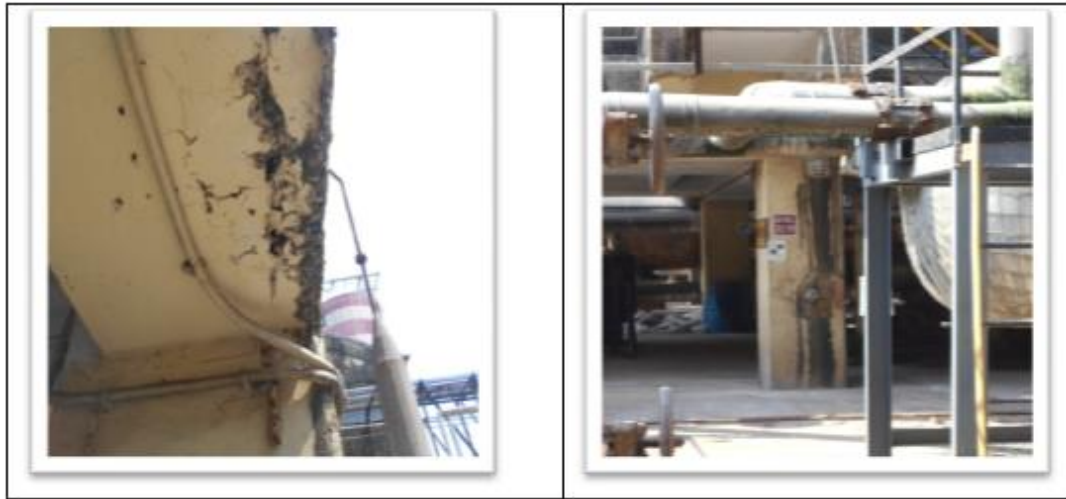
- Honey combing and localised cracks due to the corrosion of the reinforcement were observed.
- Moss growth, water logging etc. were noted on the floor slab
- Weathered surfaces were noted on the RCC columns and beams.
- Unfinished cut-outs noted made in the existing RCC slabs so as to accommodate process pipes.

| Sr. No | Name of Structures | Distresses | Recommendation |
|---|---|--|---|
| 1 | Adequacy check of existing Cooled condenser structure | 1.Honey combing and localized cracks due to the corrosion of the reinforcement were observed | Cement grout and patch repair with the use of Polymer modified mortar as per standard methodology |
| | | 4. Unfinished cut-outs noted made in the existing RCC slabs so as to accommodate process pipes. | Unfinished cut – outs should be filled properly using micro- concrete of an approved brand |

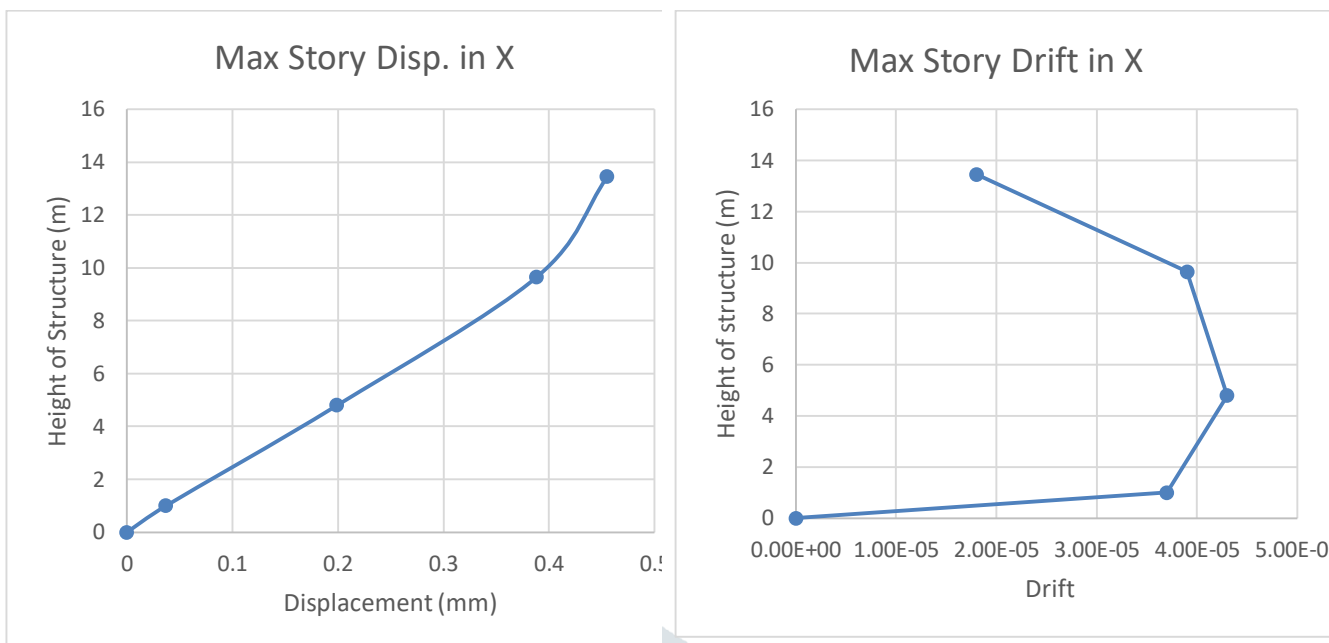
(a) Max Story Displacement

Linear Dynamic Analysis of structure is carried out for current loading along with earthquake force as per IS 1893:2016. Analysis is carried out using ETABS software. Following graph (a) compares the absolute displacements which are calculated by software and maximum permissible displacements ( $h/100$ ) at different heights. It indicates that maximum permissible displacements are higher than absolute displacements. Also graph (b) representing story drift is obtained, where permissible story drift is 0.4% of story height as per IS code. Later graph (c) shows the story shear at different story of the structure.
