# ASSESSMENT OF WATER QUALITY OF HOLY RIVER KSHIPRA AT RUDRA SAGAR

Ar. Kinzalk Chauhan, Ar. Siddharth Mishra, <sup>3</sup>Name of 3<sup>rd</sup> Author

<sup>1</sup>Assistant Professor, <sup>2</sup> Assistant Professor,  
Amity school of Architecture and Planning  
Amity University Madhya Pradesh, Gwalior, India

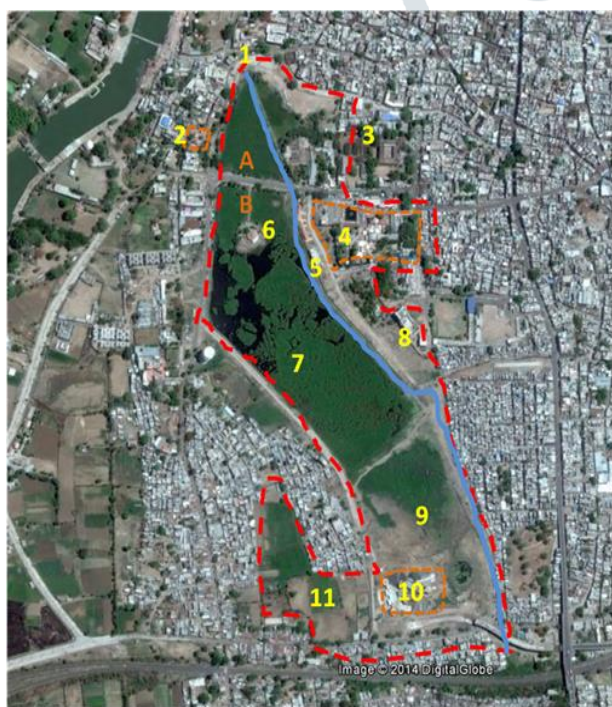
Figure 3: Rudra Sagar and surrounding

--- Mahakal van area  
--- Significant sacred site

1. An open drain carrying effluent runs along the eastern side of the lake from the south and crosses it to the north, from where it empties into the river. It is unsightly and a source of noxious smells and pollution.
2. The Harsiddhi temple sits on the western side of the northern part of the lake.
3. Substantial remains of an ancient wall and mound.
4. The Mahakal temple complex sits on raised ground, overlooking the lake. The Shikara is visible from most parts of the lake.
5. Public spaces in the streets to the east of the temple complex are well used, but the land between the complex and the lake is just dusty waste ground.
6. Vikramaditya Teela on the island reached from the causeway.

7. Most of the water surface is covered in water hyacinth due to excess nutrients, caused by untreated effluent flowing into the lake. The very little water surface is visible.
8. Location of old earth terraces with probable ancient remains - to be preserved.
9. The southern part of the lake is now permanently dry, except during the monsoon, and used for grazing.
10. Dargah under large old relict Imli tree (Tamarindus indica).
11. Existing agricultural fields and grazing land, proposed for park, car parking and camping ground.

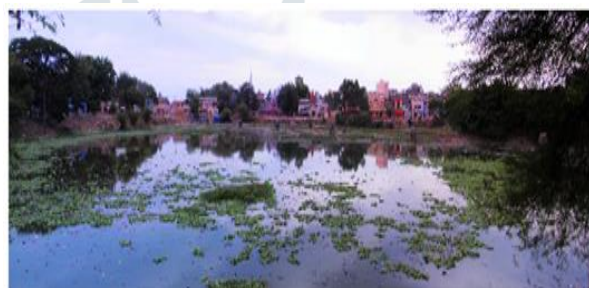
Figure 4: The north part of Lake from the causeway (Point A)

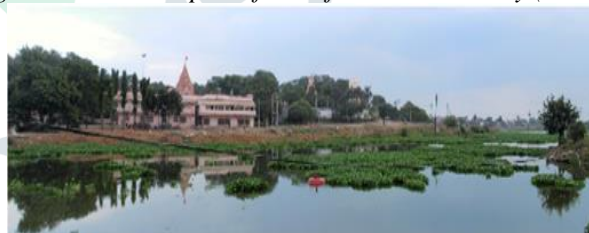
Figure 5: The lake from the causeway, looking southeast towards the Mahakal Temple. This photograph shows the water surface partly clear after manual removal of water hyacinth growth. (Point B)

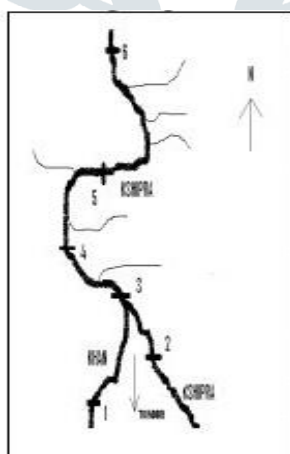
Figure 8: Water Sampling Map

Sample Station	1	2	3	4	5	6
Description	At Khan river (before confluence with Kshipra River)	At Kshipra river (before confluence with Khan River)	At Triveni Sangam	At Gaughat	At Rudra Sagar	At Siddhwat Ghat

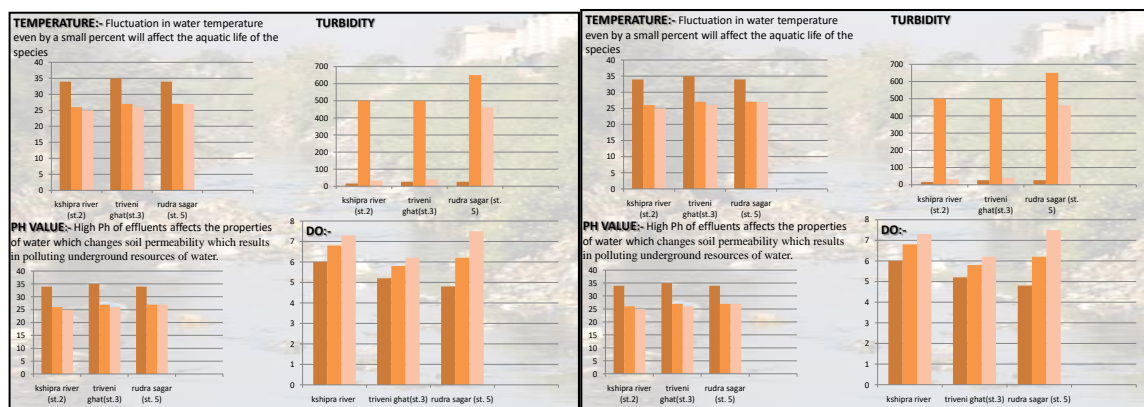
Figure 9: Result of water quality test (Source: www.iwrs.org.in, journal 2012)

CONCLUSION: WQI for kshipra river water in Rudra Sagar ranges between 36 and 49 representing their poor quality. The study additionally confirmed that Khan river entirely and drains to some extent is accountable for water quality deterioration in river Kshipra. The water is inappropriate even for bathing because of unacceptable amount of pH and DO present in it even BOD and FC values are extremely beyond the minimum acceptable limits. A serious action has to be taken for the preservation of the river and its stream.
