RECONDITIONING OF BUSHES IN WIRE ROD MILL OF VSP

The main objective of this project is to reduce the inventory cost by reconditioning of bushes in wire rod mill. In this research work, the damaged bushes are reconditioned by using metal coating (Two wire electric arc spraying)method.

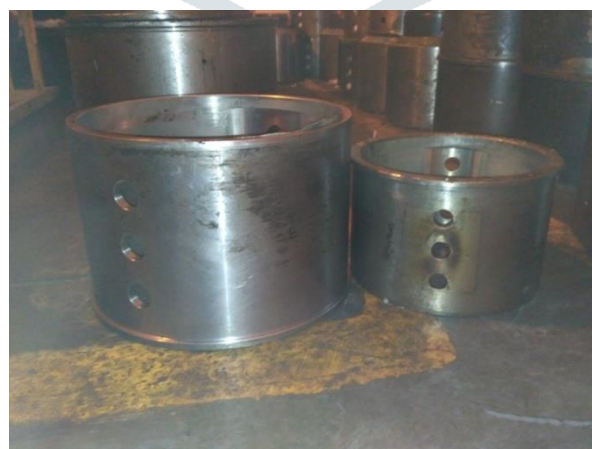
Figure 1.1 : Bush

The bush is a stationary element in the bearing assembly. It is designed in the form of a babbitt–metal lined steel shell. The babbitt metal is a one type of soft metal used in bush is to perform operations with most effective. Reasonably long eye bolts are screwed into the tapped holes provided in the flange faces of the bushing. Bending and deformation of the eye bolts are counteracted by means of a “spreader” or “separator “ type element provided with V-notches on either side being located between the two bolts. After the bushing has been properly cleaned and provided with an oil film, it is slowly lowered into the roll chock bore without any under forces being applied. The structure of the bush is same at both drive side and operation side.

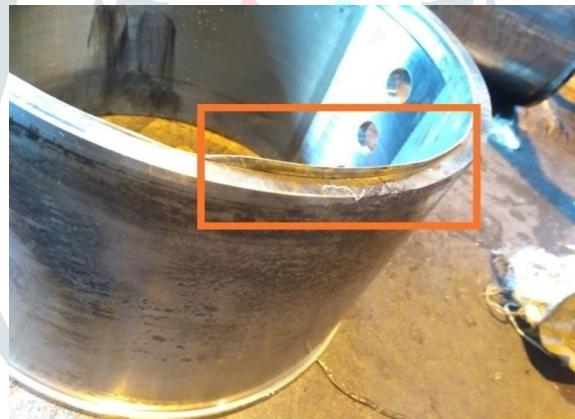
Figure 3.1 : wear out of the babbitt material

- Babbit metal wear out is a major problem of bearing assembly in wire rod mill. While performing the operations the sleeve is continuously rotating in the bush through motor shaft in the mill. The lubricant is supplied in between the sleeve and bush in the bearing assembly while rotating.
- If there is any problem occurs in the supply of lubrication in between the sleeve and bush while rotating, it causes more friction in between the sleeve and bush. Later on the babbitt layer which is coated on inside of the bush is wear out because the babbitt metal is a soft metal. Sometimes the load conditions are also effects the failures of the bush in the mill.

- First clean the bush and degrease the area which is to be coated.
- Check the dimensions of the bush which is to be repaired.
- Undercut the damaged the area by blasting with angular steel grit to a maximum depth (0.2 to 0.5), after masking the sides which are not to be coated.
- The blasting ensures that roughen the surface and provides good bonding for the coating.

- Preheat the part about 600C by using blower.
- Arrange the bush on lathe and apply a bond coat of nickel aluminide as a base metal while bush is rotating on lathe.

- The babbitt wires are arranged at a hole in the center of the tip on torch.
- The molten babbitt material is blown with compressed air force, which causes the interlocking with surface irregularities.
- During spraying, the temperature would not exceed 900C. If necessary, interrupt the spraying and keep the part to cool down up to 600C and repeat the process until we get the required thickness.
- Measure the dimensions of the bush while performing the operations and we maintain over thickness of 0.5 to 1 mm for machining operations on it.
- By spraying metal on the parent metal there is an increase in porosity, compressive strength and hardness.
- After completion of the process, remove the bush from lathe and measure the dimensions.

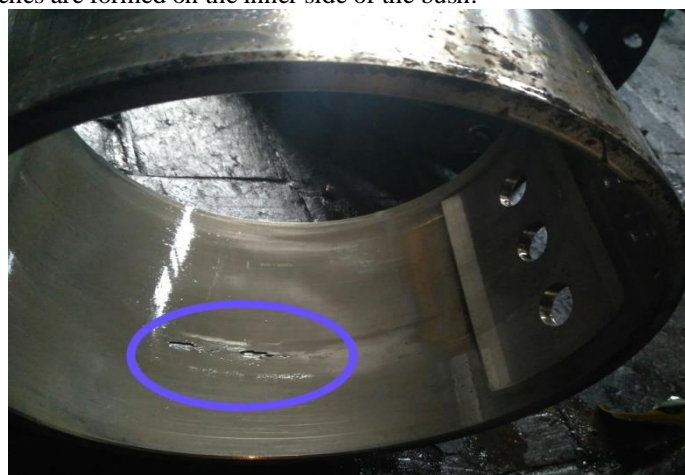
Figure 3.2: Scratches on inner side of the bush

The scratches are formed on inner side of the bush while performing the operations. The sleeve neck is wear out while friction takes place in between the sleeve and lock nut. The sleeve neck metal is wear out in the form of small discontinuous chips. These chips are entered into the inner side of the bush through the lubricants. If the chips are enter into the inside of the bush, the inner side of the bush is a soft metal so a scratches are formed on the inner side of the bush.

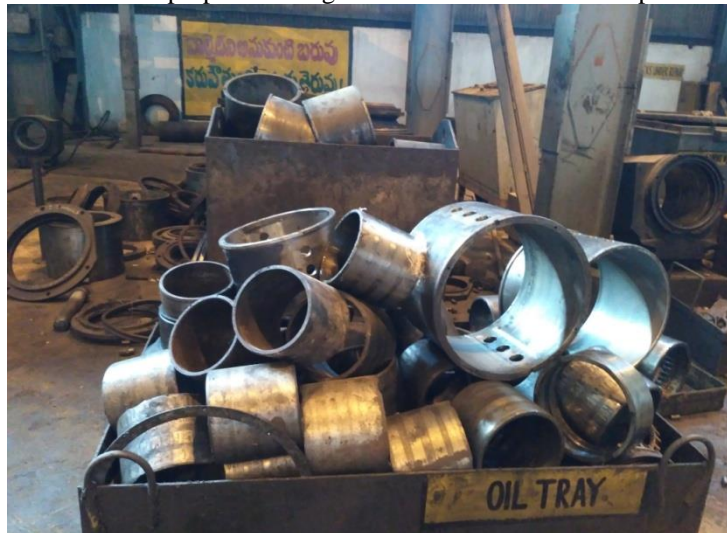
Figure 3.3 : Bushes at scrap area

While assembly, the bush is inserted in a chock bore by worker. If the bush is not positioned exactly in the chock bore ,the worker is hammering on it. This causes the damage of the babbit layer. Do not rotate the bush inside the chock bore. Before assembly the parts should cleaned by using oil and maintain proper handling to reduce the failures of the parts.

In my observation nearly 35 to 40 damaged bushes are kept aside for send to the scrap area. So I’ m concentrating on reconditioning of damaged bushes to reduce the inventory cost for the mill.

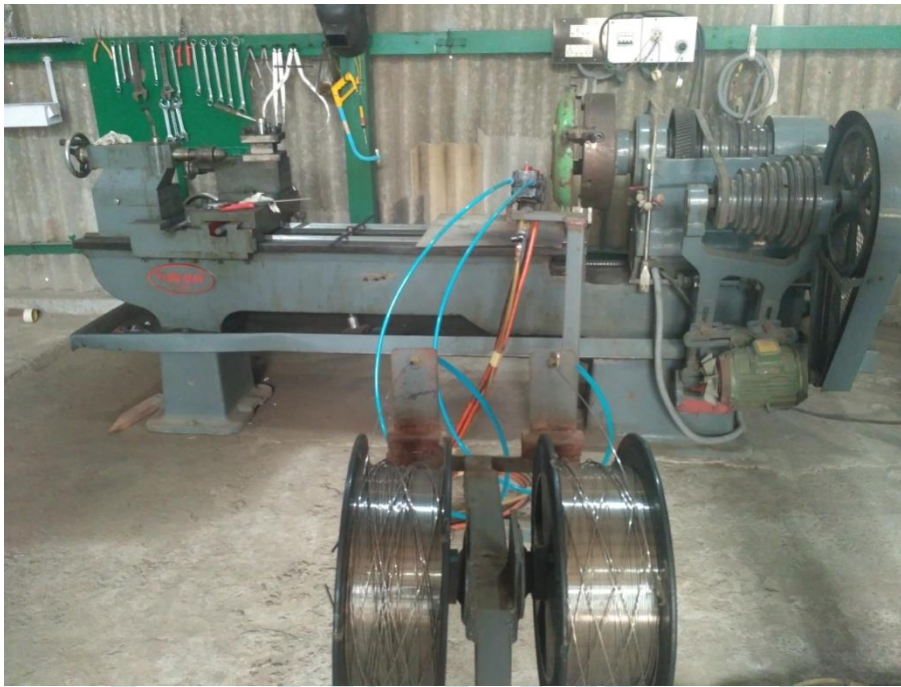
Figure 6.1 : Layout of Two wire electric arc spraying

The Two-wire electric arc spraying method utilizes an arc point which is created between two wires which are electrically conductive. Melting will occur at the point where the wire are connect. The arc allows for heating the wires and creates deposition on the parent metal by the use of torch. A compressed air is used for spraying the coatings. This method is popular due to its cost effectiveness. The base material used for this process is either zinc or aluminum.
