Health Monitoring of Existing Reinforced Cement Concrete Structures Using Non-Destructive Tests and Repair Methodology

RCC building (P-21) located at Udhampur J&K, India was selected to carry out the investigation. The building was around 32-35 years old. Detailed visual inspection was carried out to scrutinize the type, extent and source for damage. An investigation was carried out to check the concrete quality, corrosion in reinforcing bars, carbonation of concrete and ingress of salts in concrete. The concrete quality was found out by using Ultrasonic Pulse Velocity and Hammer Rebound method. The carbonation depth was determined by use of Phenolphthalein test. The plan of building is shown in Figure 1. The detailed investigation plan is shown in flow chart.

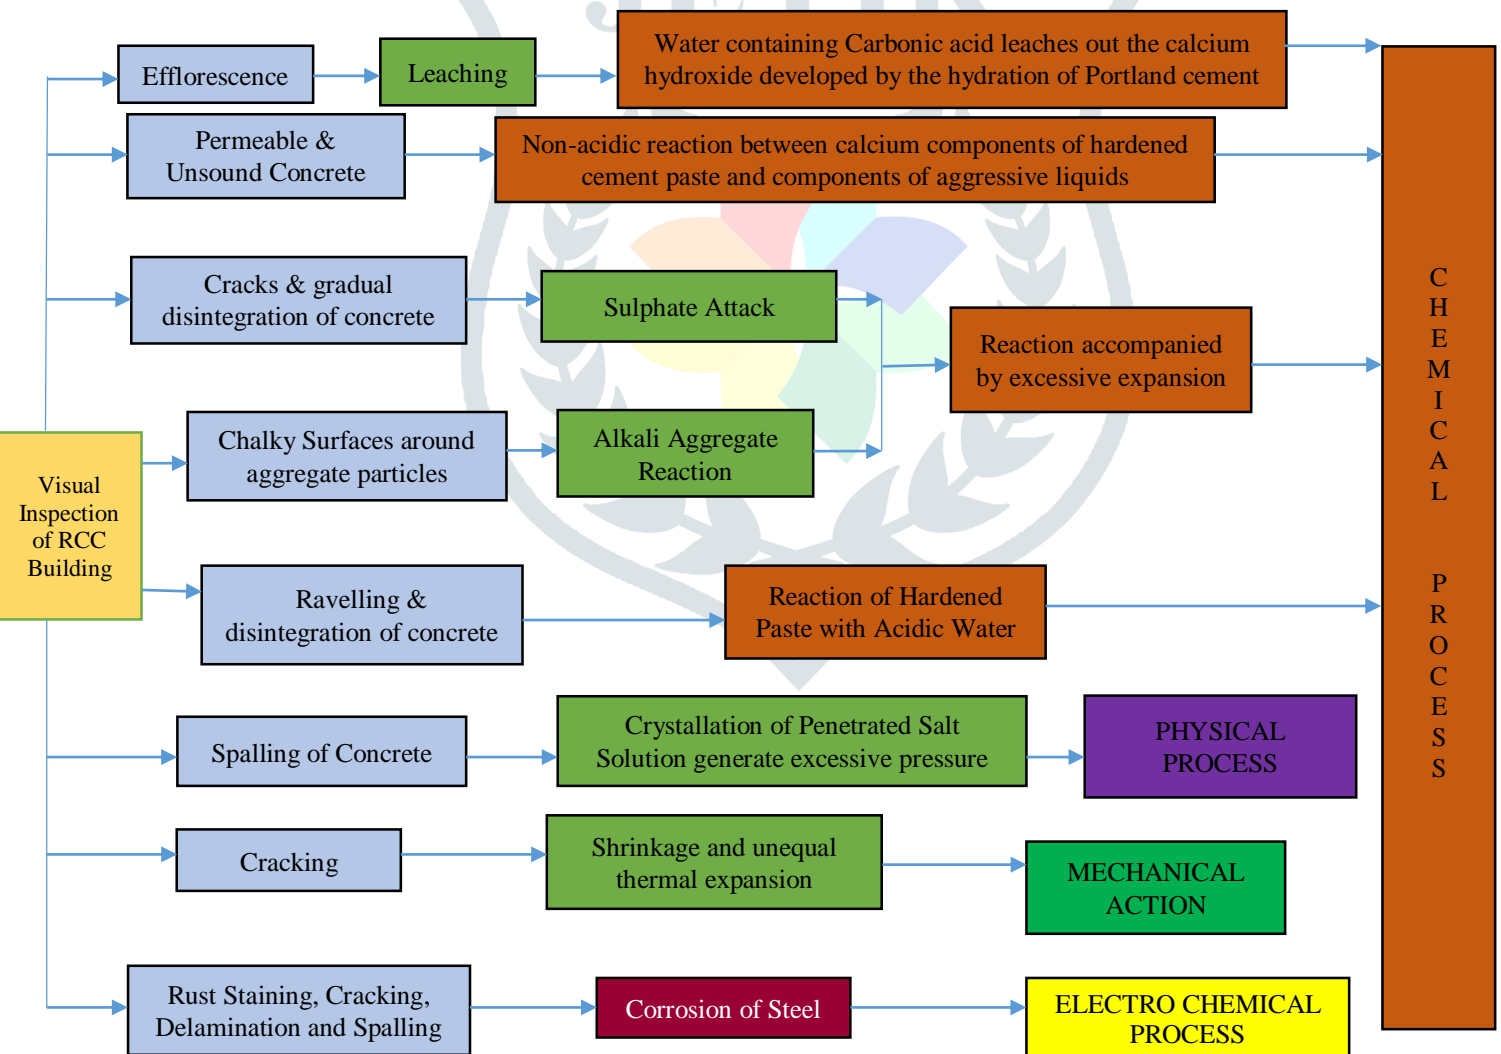
Figure 2: Flow chart

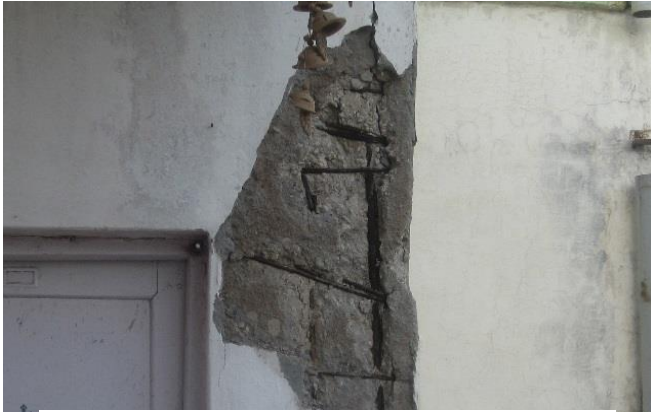
Figure 3 Corrosion in steel

1. Cracks: Major throughout cracks was observed at few locations in outer columns of the buildings. Minor cracks near openings of windows and doors in most of the locations. Cracks were also observed on parapet of terrace.
2. Rusting of bars: The corrosion was observed at few locations due to spalling of concrete or carbonation of concrete.
3. Spalling of concrete: spalling of concrete is observed in outer columns of the buildings.
4. Dampness & Efflorescence: Dampness and efflorescence have been observed in most of the houses especially at ground level, near sunken area & near staircase areas.
5. Railing: The present railing is damaged and need to be replaced.

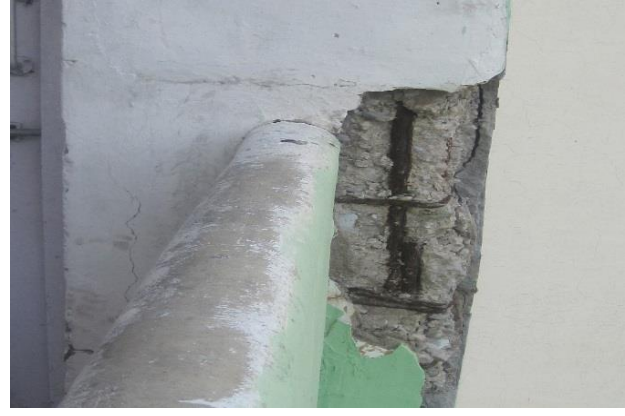
Figure 4 Spalling of Concrete

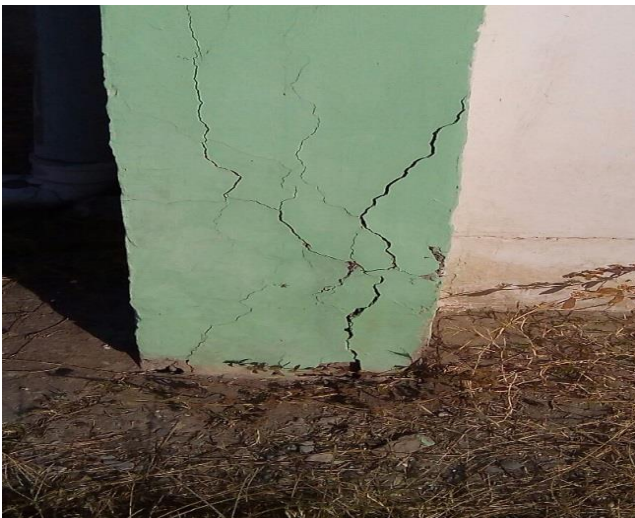
Figure 5 Hair Line cracks in column

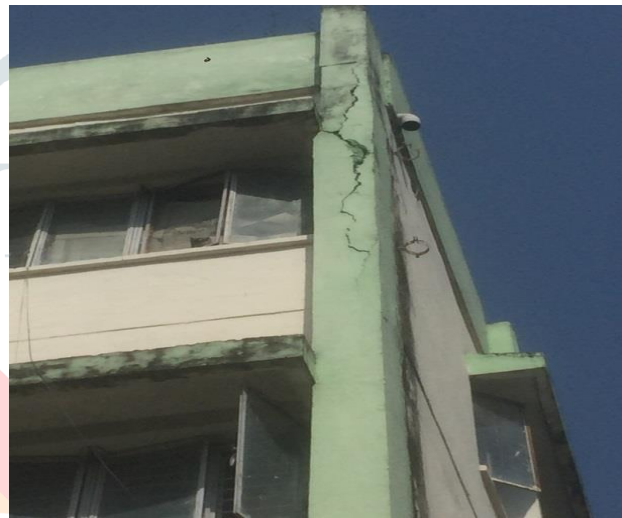
- a) It was observed that the exterior columns of the building having vertical cracks and spalling at some of the locations.
- b) Dampness and efflorescence on walls as also observed specially at the lower level of the building.
- c) Some minor cracks along the openings of the windows and doors.
- d) Damaged staircase of servant quarter entrance from the backyard of the building.
- e) Spalling of concrete and exposed corroded reinforcement in exterior columns of the both the buildings.
- f) Termite attack on the ground floor and 1st floor of the building.
- g) Backside staircase along with the servant quarter of building is completely damaged.
- h) Brick tiles on the terrace of the building are damaged which leads to the ingress of water through them.
- i) Plantation growth on the terrace of the building and the rainwater pipes are damaged.

Figure 6 Vertical crack on column

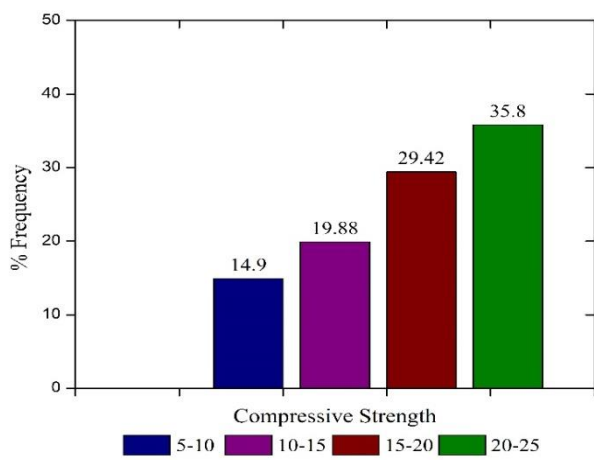
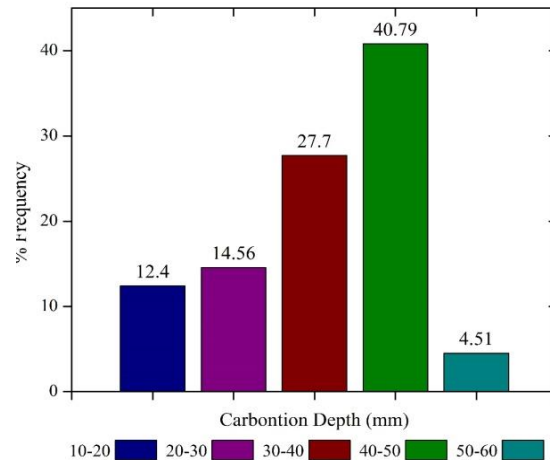
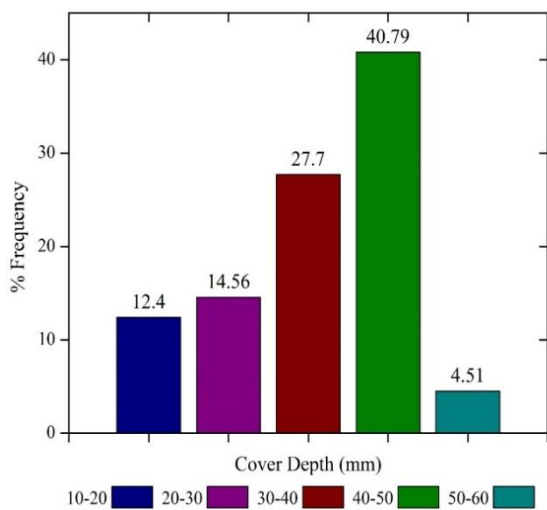
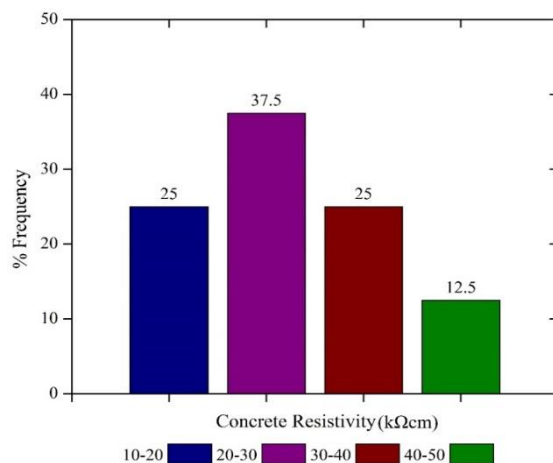
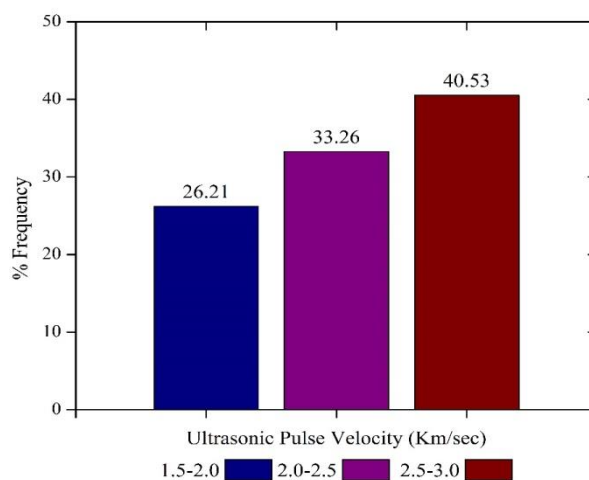
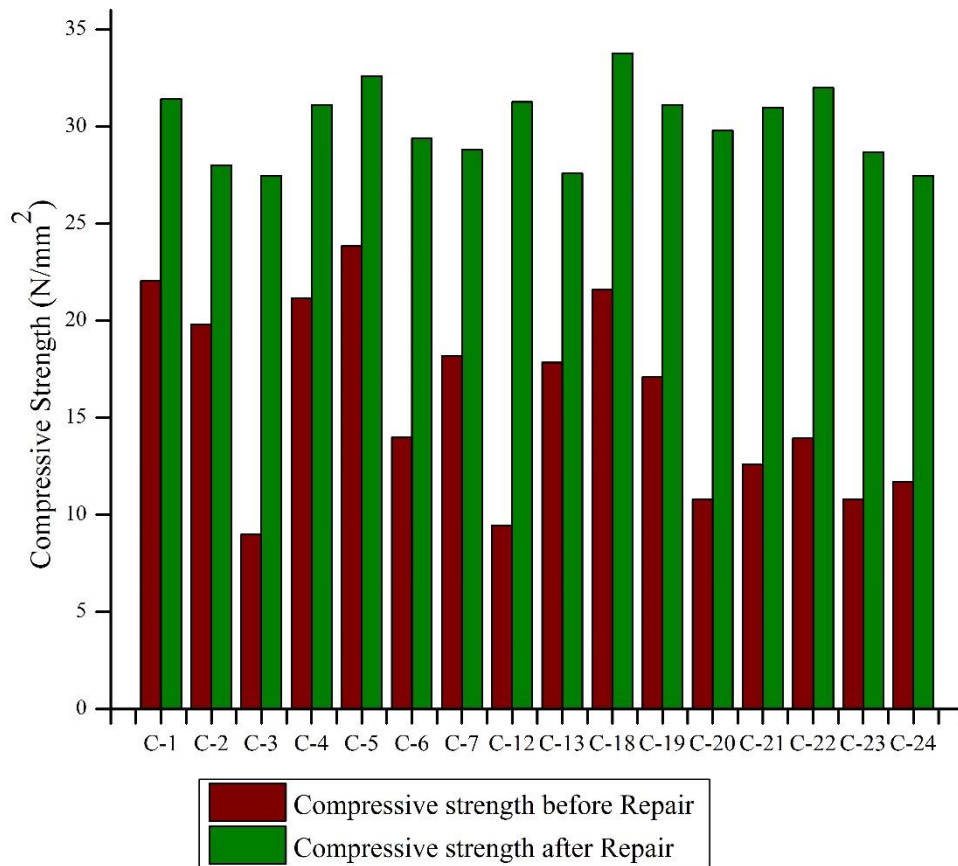
The NDT carried out after repair showed that the concrete strength was in the range of M25 to M30 grade of concrete. The ultrasonic pulse velocity also showed the quality of concrete improved from poor to good. The fig no- & fig no- shows that after repairs the strength and quality has got enhanced which will also result in improvement of durability of structures in the long run.
