Review paper on Pump shaft failures

Abstract : In this explore, we are going to understand different ways of shaft failure and there reasons. researchers worked on different pump shaft failures to know reasons that why shaft failure occurs. They conducted different test to identify regions where most of the pump shaft failure occurs. Tests like Chemical analysis, micro structural characterization fractography hardness measurement tensile and Chirpy impact tests were used for the analysis. most of the failure occurs due to corrosion, torsion load & erosion. These problems are identified and can be solved by means of changing material, by providing radius at sharp edges, by avoiding stress concentration on weaker regions, change in design.

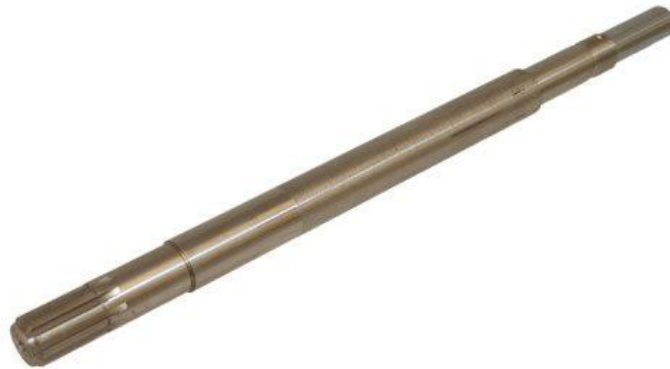
FIG.PUMP SHAFT
