Structural Auditing of residential building

VII. CASE STUDY OF RCC BUILDING.

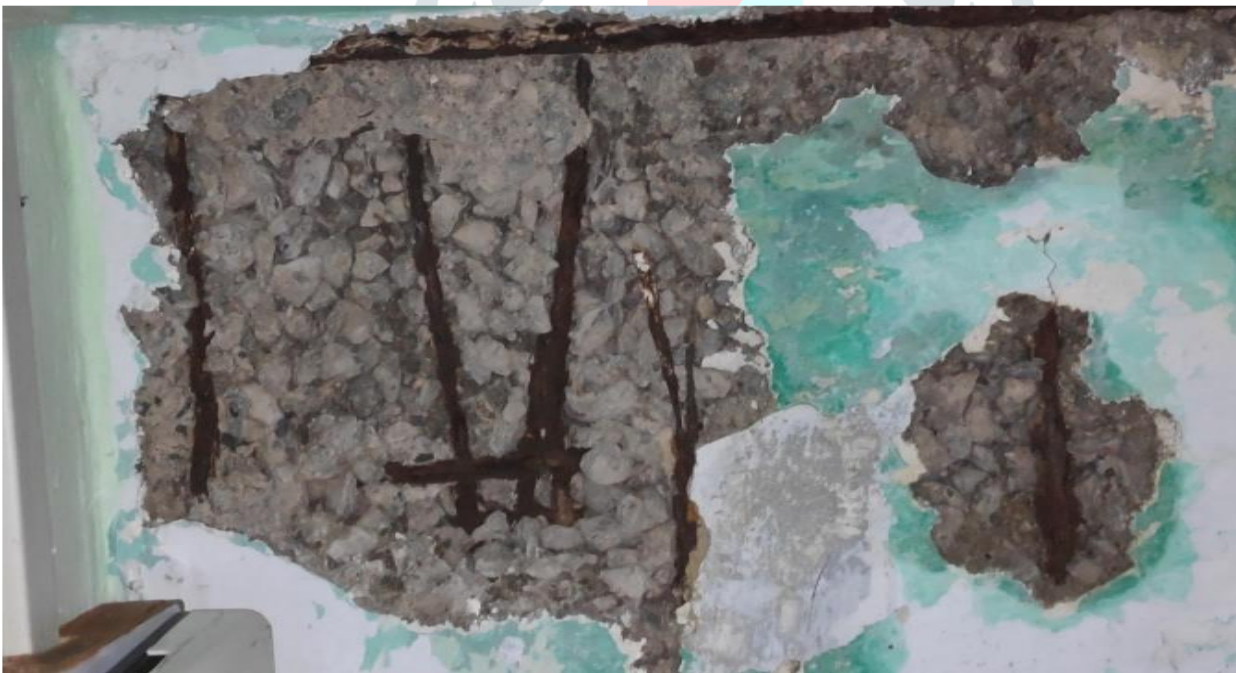
1. Slab

Fig.1– Totally damaged slab

From above photos we can clearly see that condition of slab is extremely poor and steel of the slab is completely rusted due to water. At the current situation it can be fall at any time. Slab is heavily damaged because of poor quality of concrete, workmanship and careless supervision during the construction Even proper cover is not provided during the construction of slab.

The advanced composite materials especially Fiber Reinforced polymer (FRP) systems in the field of structural engineering. FRP composites as construction materials have been largely used in civil engineering recently. FRP composites are lightweights, which have high strength and this is non-corrosive as well as non-magnetic materials. FRP has extensive use of recent, current and potential applications of these materials that cover both new and existing structures.

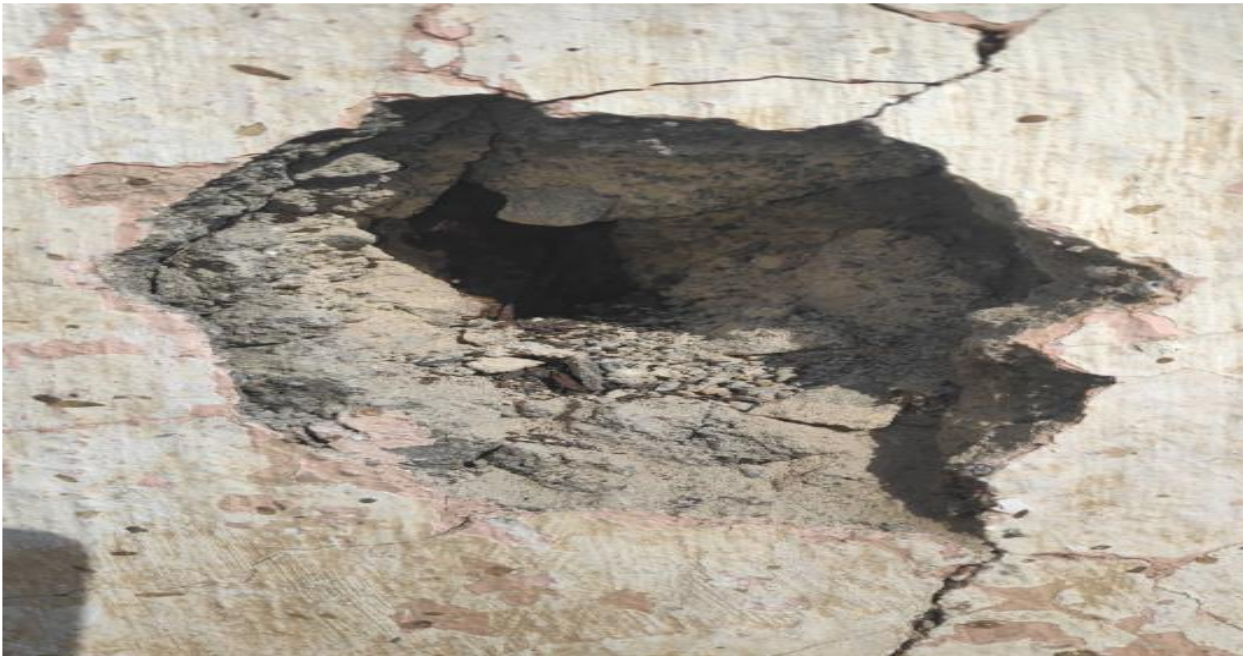
2. columns-

Fig.2– Totally damaged Column

The fig shows us that the cracks on column are caused because of seepage of water inside the column through cracks and continued to increase column damage. The vital reason of columns being cracked is leakage. The concrete has totally separated from steel and column also the main bars along with stirrups are rusted. The concrete has no hardness as it has become in the powder form. This has caused poor appearance to columns and reduced strength.

There are 4 Columns which have large Vertical cracks which is dangerous. For extra safety of columns and also increase load bearing capacity of columns reinforced concrete jacketing method can be used in which old column will be covered by new column.

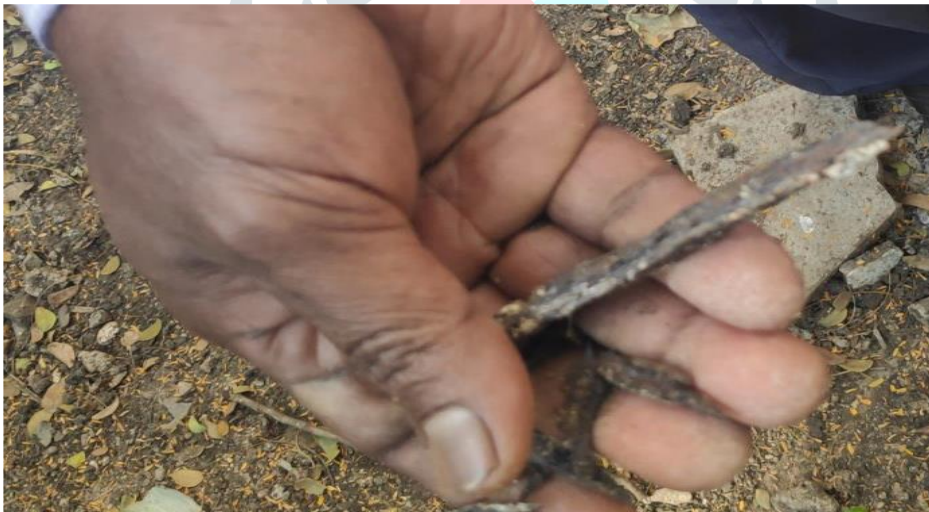
Fig.3– Rusted steel of column

The above fig shows that steel has corroded totally and has lost its strength. While performing rebound hammer test the steel specimen had come out. Appearance looks like wood due to corrosion caused by leakage.

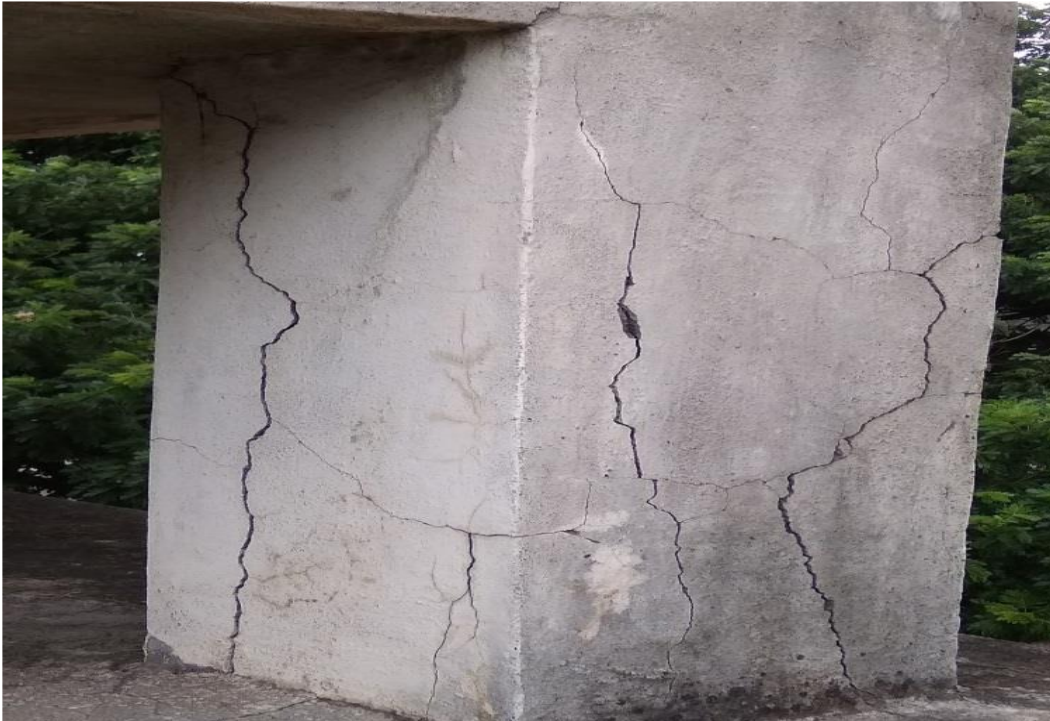
3. Water tank columns –

Fig.4– Cracks in water tank column

In this photo we can clearly see that the large amount of cracks are produced in water tank columns. The cracks are induced in the column because of swelling action of concrete takes place ultimately the diameter of steel inside the column get increased.

Large cracks are produced on water tank columns so it's better to dismantle that overhead water tank and provide GI sheets on top staircase to protect staircase from Rain and heat.

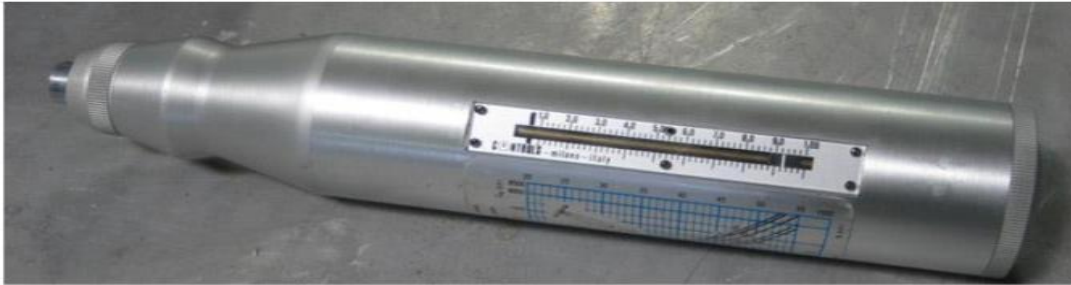
A. Rebound Hammer - Rebound hammer test is the most useful testing methods for comparing the relatively weaker and stronger areas of structural members.

Fig.5- Rebound Hammer

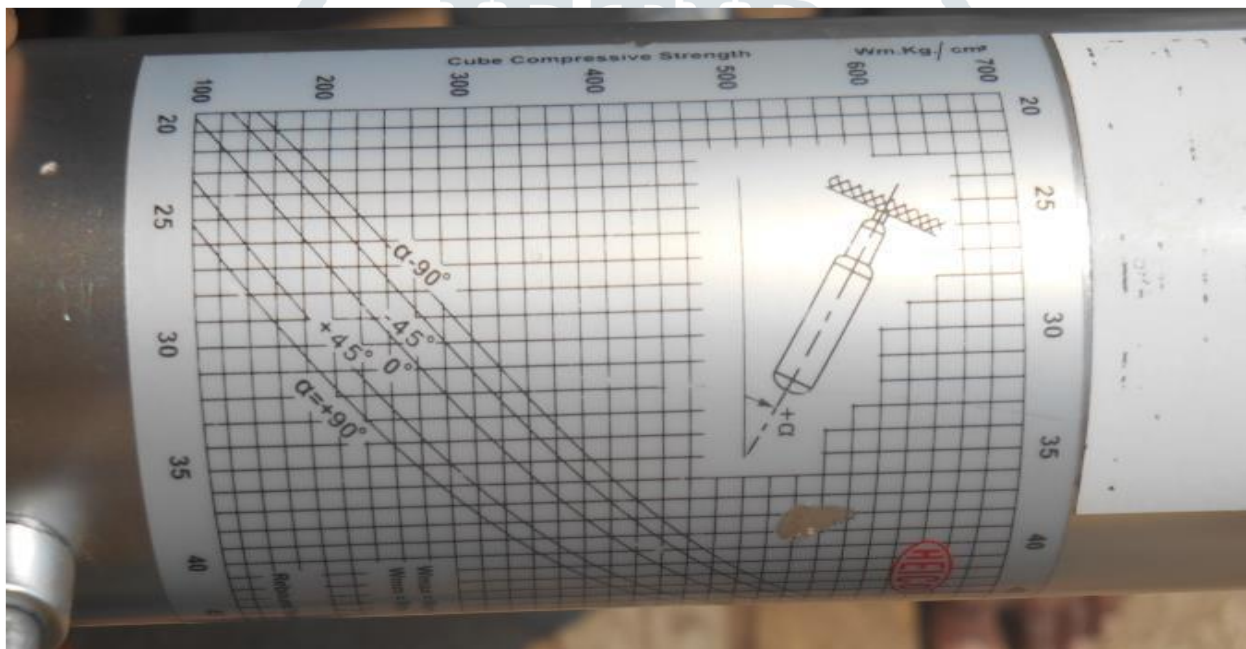
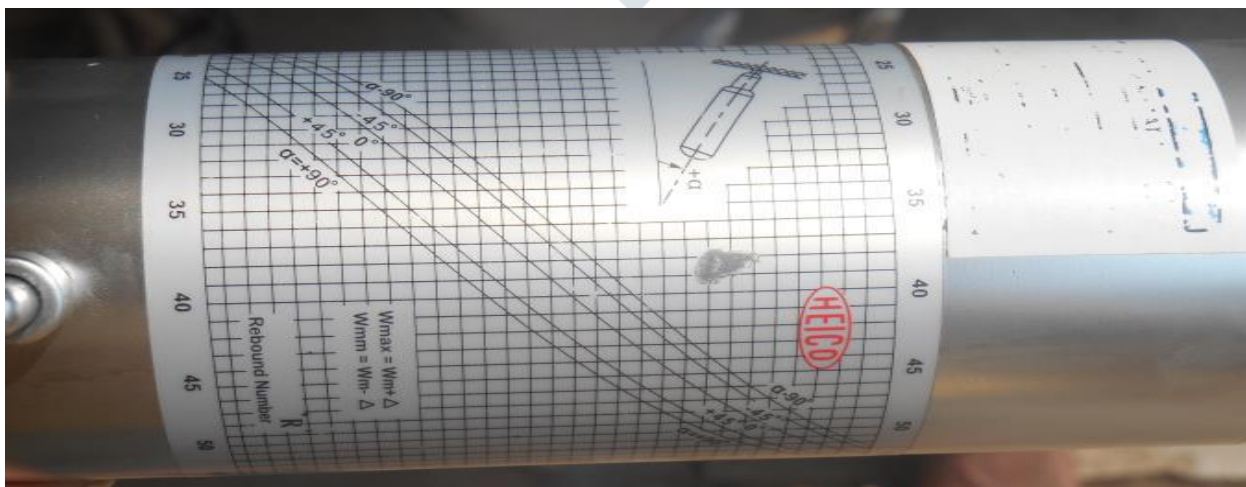
Fig.6- Rebound Hammer graph

Fig.7- Rebound Hammer graph

Rebound Value	Average	Compressive Strength Kg/cm ²
For Columns		
25		
20	22	120
21		
42		
36	36.7	340
32		
20		
24	20.7	110
18		
20		
25	23	140
22		
20		
23	23	140
26		
30		
28	28	220
26		
35		
28	31	260
30

Rebound Value	Average	Compressive Strength Kg/cm ²
For Slab		
36		
42	39.5	330
40		
35		
36	34.5	210
32		
For Beam		
27		
29	28	220
28		
27		
29	29	230
31

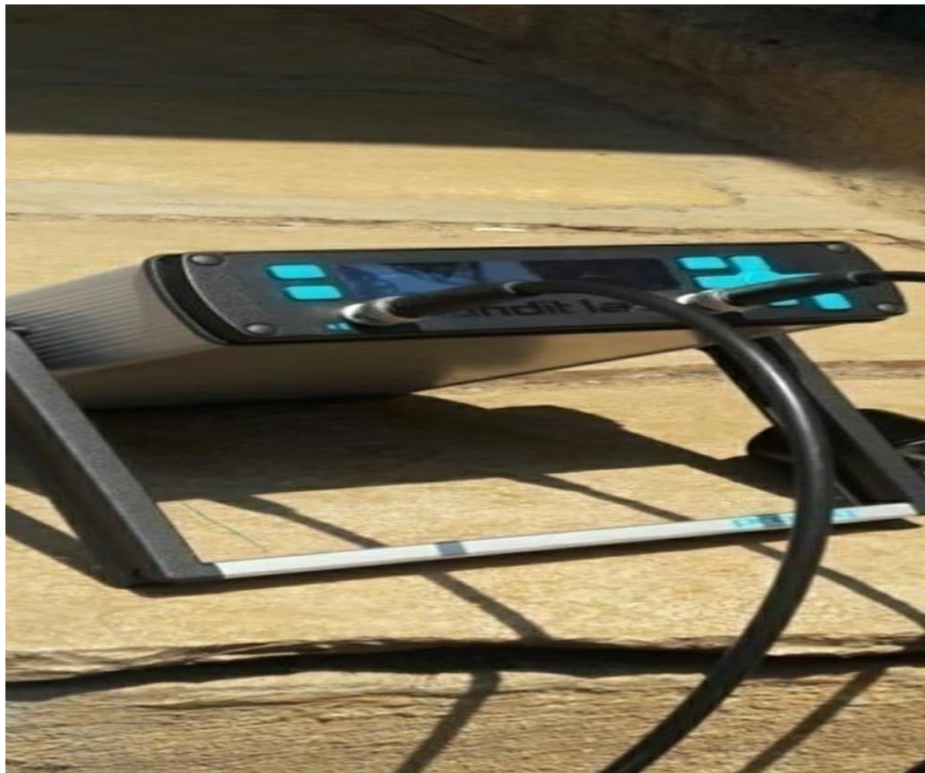
The method consists of measuring the time of travel of an ultrasonic pulse passing through the structural members. Comparatively higher velocity is obtained when concrete quality is excellent in terms of density, uniformity, homogeneity etc. Here are the results of ultrasonic pulse velocity meter test on structural members

Fig.8- Ultrasonic pulse velocity meter

Sr No.	Velocity (m/s) For Columns	Concrete quality grading
	For Columns	
1	409	Doubtful
2	1533	Doubtful
3	1439	Doubtful
4	642	Doubtful
5	1075	Doubtful
6	1996	Doubtful
	For Slab	
1	589	Doubtful
2	1519	Doubtful
	For Beams	
1	4123	Good
2	1143	Doubtful
3	230	Doubtful

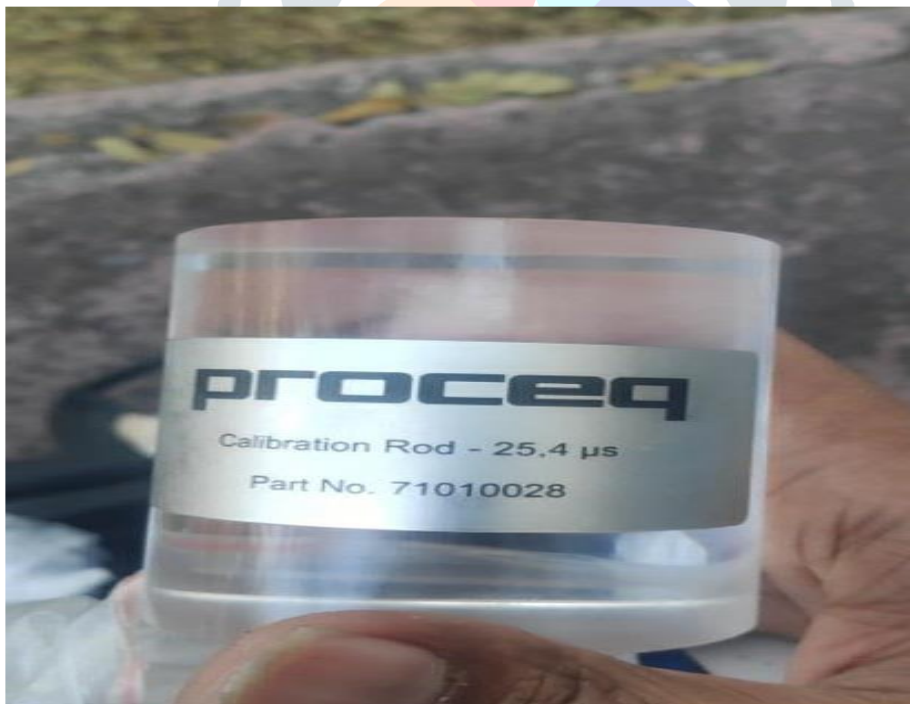
Fig.9- Ultrasonic pulse velocity meter calibration rod
