# APPLICATION OF GEOBAGS FOR CONTROL OF SOIL EROSION IN PANCHANGANGA RIVER BASIN AREA: AN ECO FRIENDLY DEFENSE

**Abstract :** River bank erosion is worldwide problem and is increasing in the course of civilization due to increased human activities leading to change in channel. Prevention of bank erosion is possible through restoration with erosion control structure. Textile industry has developed products with such applications giving rise to geotextiles. One such application of geotextile is geobag. Attempt is made in present work to cater erosion of river bank in local region with geobags. Pre monsoon post monsoon assessment of erosion status was carried out with slope calculations and physical observations such as retention of vegetation. Paper discusses in detail type of geobag used with method of installation and soil retention observations of the study area.

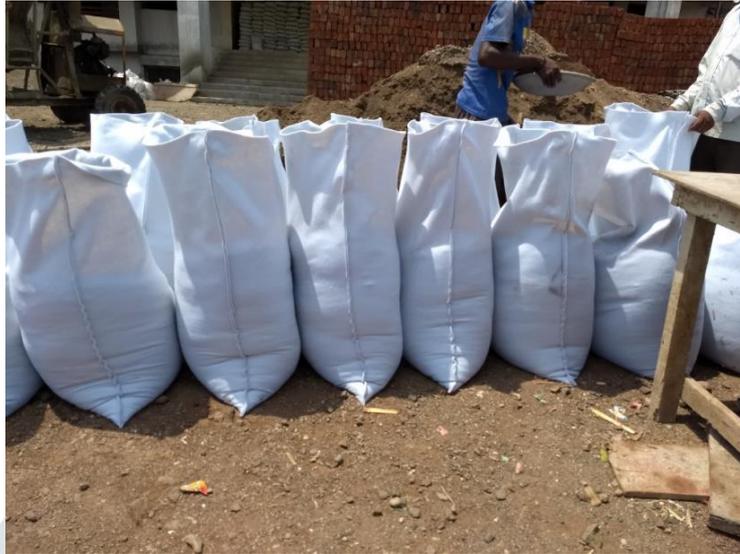
**Geobags filled with sand ready for sewing**

**Preparation of geobags :** Geobags of 60cm x 90cm size were prepared with nonwoven fabric because over woven geobag it has good filtration property, pore size, high air permeability, good abrasive resistance, fabric stability is more than woven fabric, higher thickness which ensures good puncture resistance, implemented easily. Bags were filled with sand and sewed with handy sewing machine to avoid gushing out due to pressure. Also care was taken not to fill the bags with sharp or pointed rocks to avoid tearing out of threads leading to false retention.

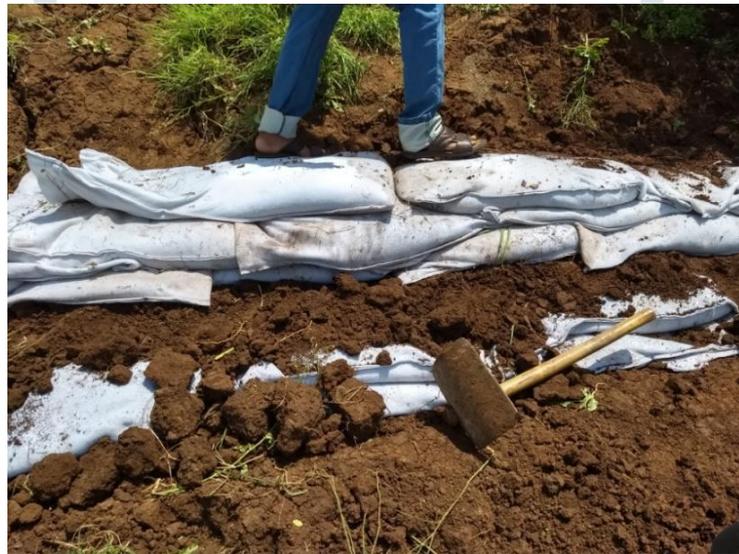
**Laying of geobags on river bank site**

*a Deploying the Bags:* The geobag were deployed, positioned and secured in proper position without causing any damage to it.

*b Completion and backfilling:* Upon completion of the geobag installation, the area was backfilled and compacted to the required specification

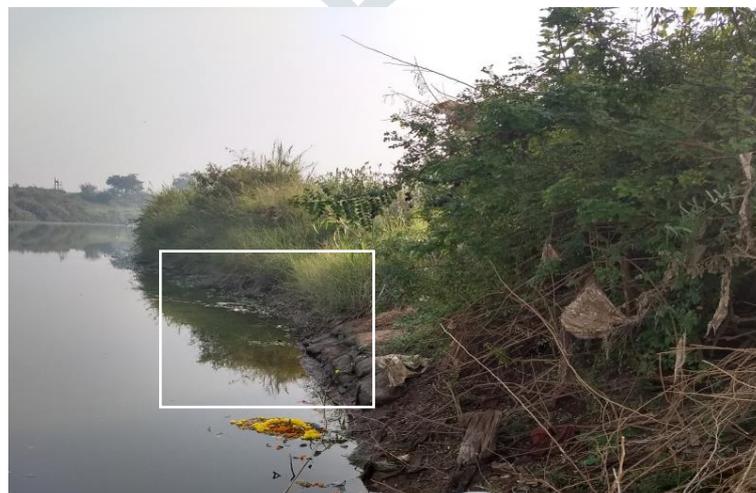
**Retention of river bank due to installed geobags (post monsoon) preventing dislodging**

Research work in this field made it possible to arrive at certain norms regard selection of geotextile as a filter layers for effective erosion control. The use of needle punched non-woven geotextile fabric for erosion control of river basin. Slope retention prevented dislodging of river bank protecting cross sectional area during historical flood of 2019. Effectiveness of geobag in erosion control is found to be good. 350 GSM needle punched non-woven fabric is found effective for river bank retention as per floodplain conditions of the study area. Non woven geobag is found to be good because of filtration property and air permeability over woven material used in previous studies. The geotextile produced exhibited required properties for river bank retention with good performance. This work provides further scope for wide application and resistance analysis of geobag material. Vegetation restoration on area is found to be indicator of erosion control which promotes natural restoration of the area .

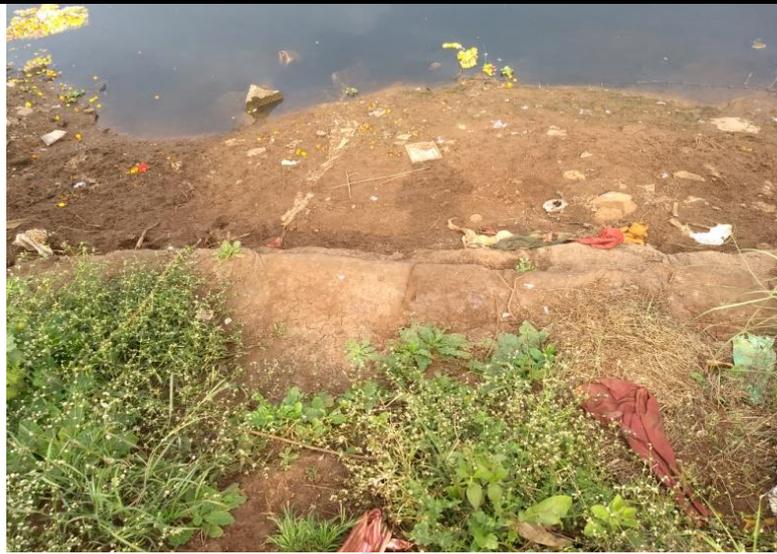
Vegetation growth on geobag installed sites indicating natural restoration of the bank to relative stability

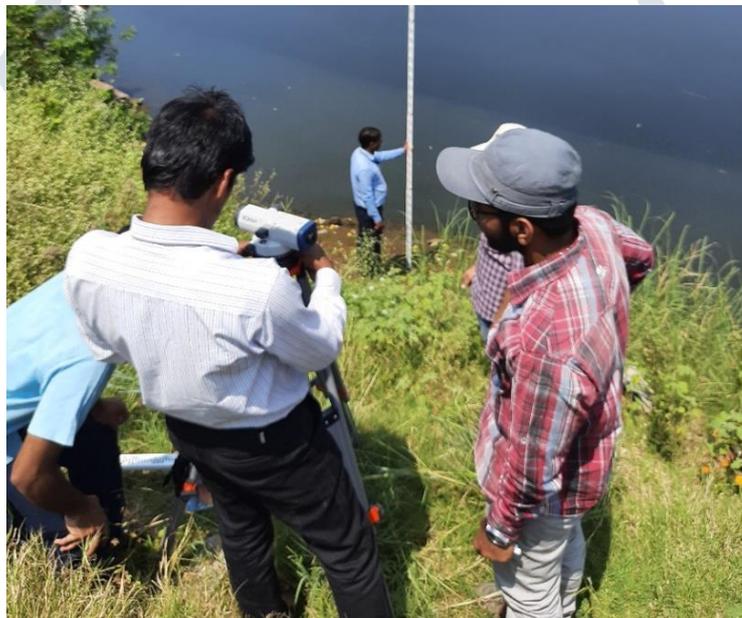
Reading bottom level of river (post monsoon)
