# CHANGING FACE OF PRAKASAM POND IN RELATION TO WATER RESOURCES' DEVELOPMENT IN AND AROUND SRI VENKATESWARA UNIVERSITY, CHITTOOR DISTRICT, ANDHRA PRADESH, INDIA

**Abstract:** This paper describes how Prakasam pond in Sri Venkateswara University (SVU), Tirupati in Chittoor District, Andhra Pradesh, India which the SVU Geology Department converted from a cattle pond to percolation pond in 1973, got changed into aquaculture pond, dry pond, sewage pond and back to dry pond due to anthropogenic causes. It also describes how the Tirumala-Tirupati-Devasthanam's (TTD) Haritha Project has led to sustainable development of deep groundwater of high quantity and quality all along a 12-km stretch of the Seshachala Hills between Srivarimettu on the west and Prakasam Pond on the east.

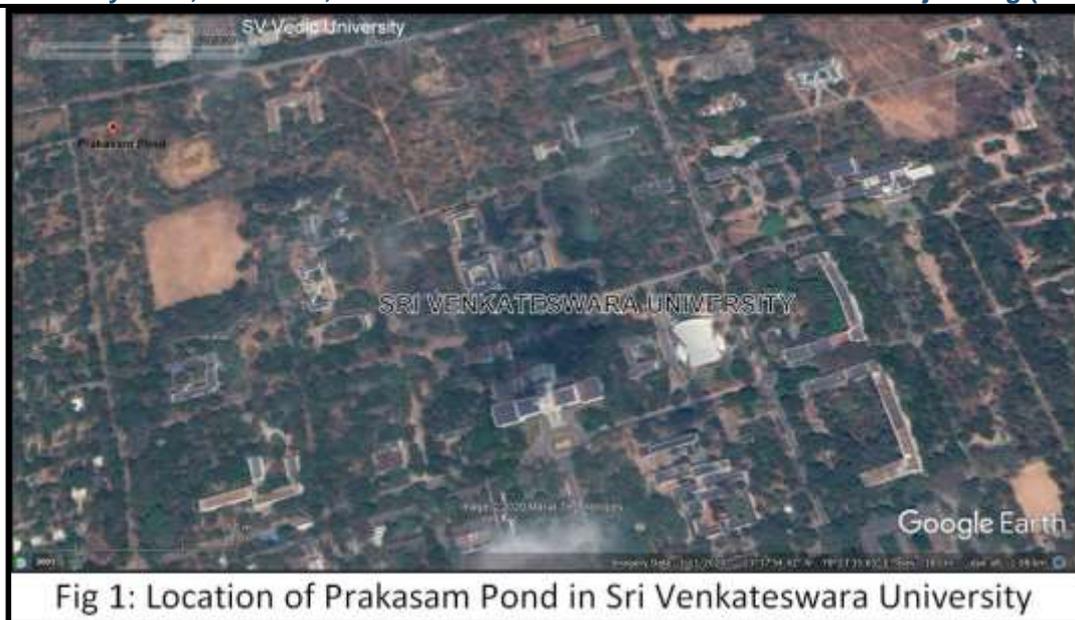
Prakasam pond (Latitude N 13° 37'54" & Longitude E 79° 23'36") is located in the northwest corner of Sri Venkateswara University (SVU) established in 1954 in a 1000 acre-land in Tirupati, Chittoor District, Andhra Pradesh, India. Fig 1 shows a portion of Sri Venkateswara University including Prakasam Pond.

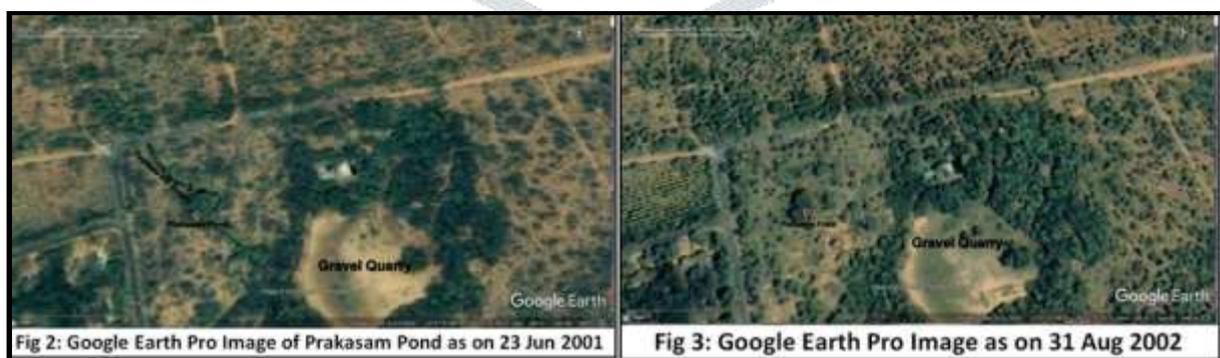
One unusual thing that happened to Prakasam Pond in 2001 was its becoming suddenly a dry pond. This could be seen from the Google Earth Pro image captured on 23 Jun 2001 (Fig 2) as per which the flow in the hill stream was too meagre to fill the pond; while even the hill stream couldn't be seen in the image captured on 31 Aug 2002 (Fig 3). Such a phenomenon is normally explained by the environmentalists as a consequence of the worldwide climate change which brought drastic reduction in rainfall in the catchment feeding Prakasam pond. But, we traced the real reason for this happening to the TTD's Haritha Project.

The little-known negative side of the Haritha Project is that a number of hill streams from the Tirumala Hills flowing in a southerly direction between Srivarimettu on the west and Prakasam pond on the east for a stretch of about 12 km along the second Tirupati-Tirumala ghat road including the one adjoining the Prakasam pond became completely dry (Figs 2 and 3).

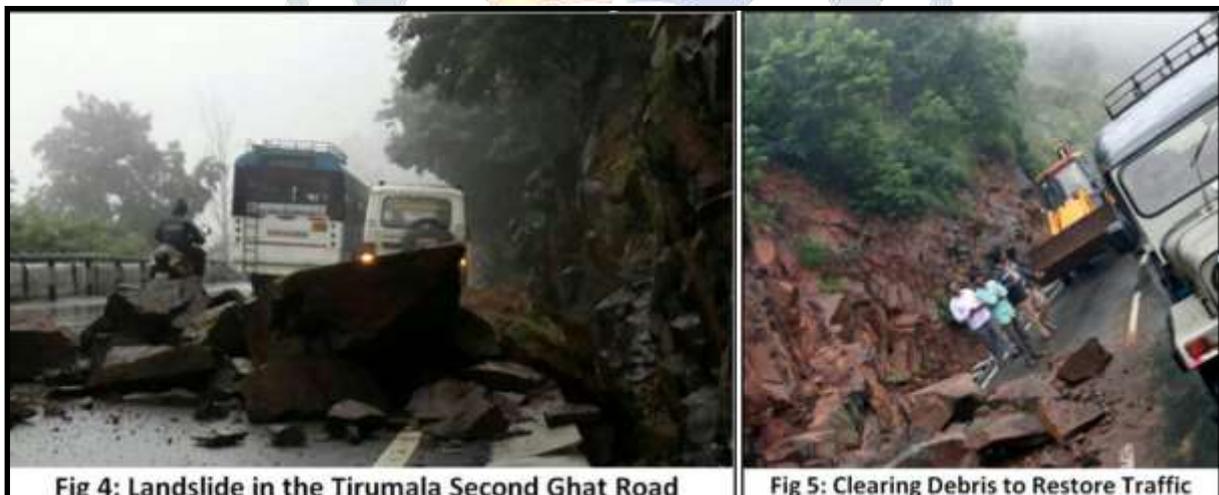
Another havoc created by the Haritha project along the same stretch is the frequent disruption of traffic along the 2<sup>nd</sup> ghat road to Tirumala during cloudburst rains, triggering landslides and rock-falls caused because of obstruction to free flow of rainwater by the Haritha project. This problem is experienced almost every year at one place or other of the ghat road during almost every year.

Fig 4 shows how the vehicles proceeding along the Tirupati-Tirumala 2<sup>nd</sup> ghat road providentially escaped disaster because of sudden landslides and rock falls under the influence of a cloudburst rain.

Fig 5 shows the timely action taken by the TTD Task Force to clear the debris and restore the traffic in record time.

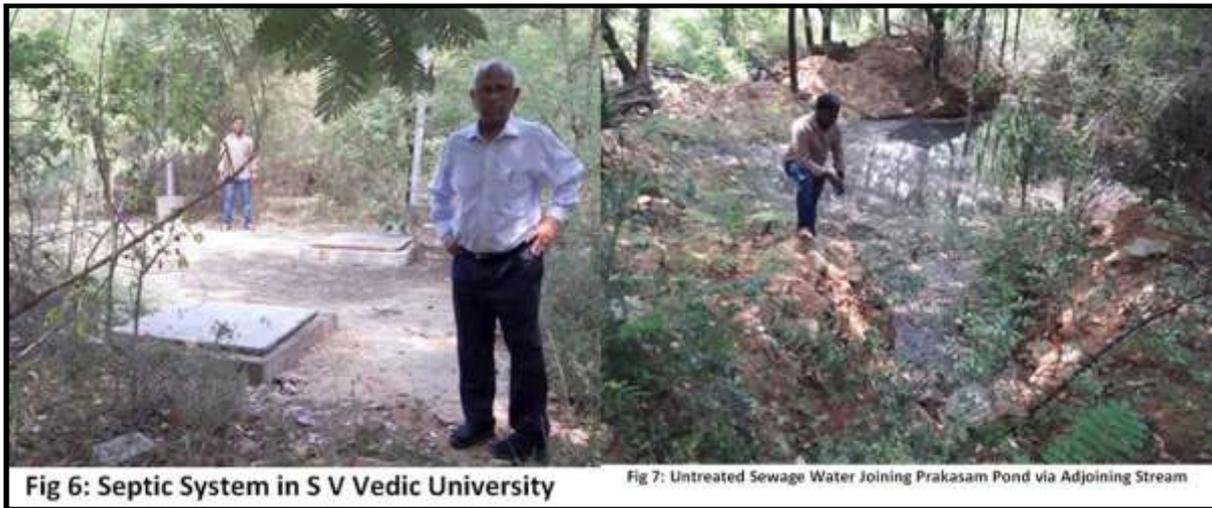
Fig 6: Septic System in S V Vedic University

Fig 7: Untreated Sewage Water Joining Prakasam Pond via Adjoining Stream

Fig 6 is the septic system installed in the western extremity of S V Vedic University with untreated sewage let into a stream abutting it towards west (Fig 7).

With the establishment of Sri Venkateswara Vedic University as an integral part of the TTD in 2006, the Engineering Wing of the TTD has been looking after all construction activities in the campus. One such work undertaken relates to creation of On-Site Sewage Facility (OSSF) to treat and dispose the entire effluent generated in the campus. Construction of such systems is a standard practice all over the world where large drain fields are available and where it is not practicable to connect the drain water to the main sewage pipe lines of the standard sewage treatment plants. Such plants of adequate size when constructed properly with good design and maintained properly would lead to minimal groundwater contamination and no release of drain water at surface. Despite availability of large space available in the campus, the work was not designed and executed properly. As a result, the entire drain water was let into a stream adjoining

the septic system in the campus to flow freely for around 76 m (250') towards south to join the SVU's Prakasam pond.

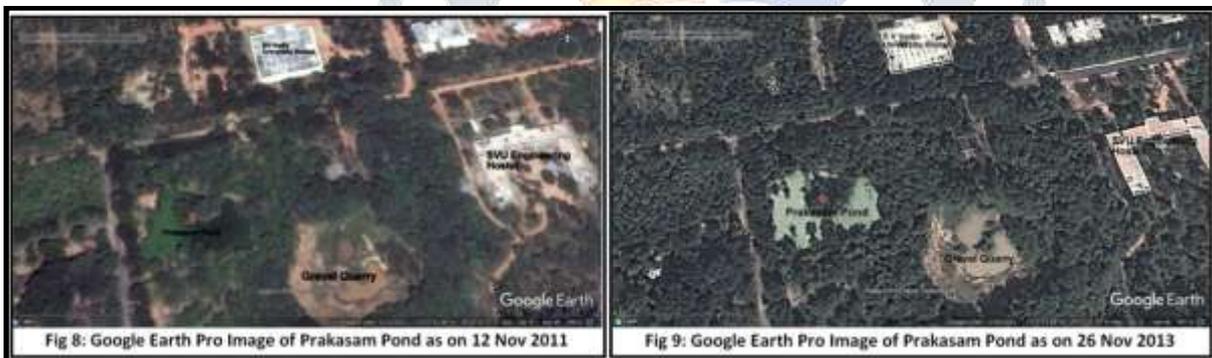
Figs 8, 9 and 10 are the Google Earth Pro images captured on 12 Nov 2011, 26 Nov 2013 and 21 Apr 2016 showing Prakasam pond as a sewage pond. The differences shown by the three images reflect the influence of rainfall on the vegetation growth of the region. The one shown in Fig 8 reflects conditions after moderate rains; Fig 9 conditions after heavy rains; and Fig 10 under extreme aridity in summer. Fig 9 particularly highlights the greenbelt development with teakwood plantations grown under the Haritha project. Fig 11 is a photo of Prakasam pond taken almost around the same time of capturing the image shown in Fig 10, showing the blue-green algal scums floating on the pond water.

Fig 8: Google Earth Pro Image of Prakasam Pond as on 12 Nov 2011

Fig 9: Google Earth Pro Image of Prakasam Pond as on 26 Nov 2013

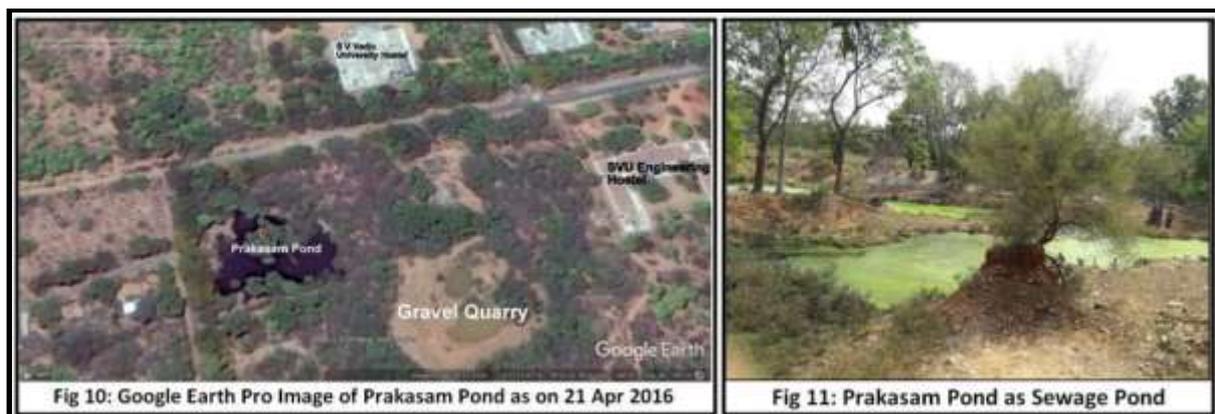
Fig 10: Google Earth Pro Image of Prakasam Pond as on 21 Apr 2016

Fig 11: Prakasam Pond as Sewage Pond

Apart from the pond serving as a breeding ground for mosquitoes, surplus drain water from the pond flows downstream by gravity flow causing further environmental pollution and groundwater contamination.

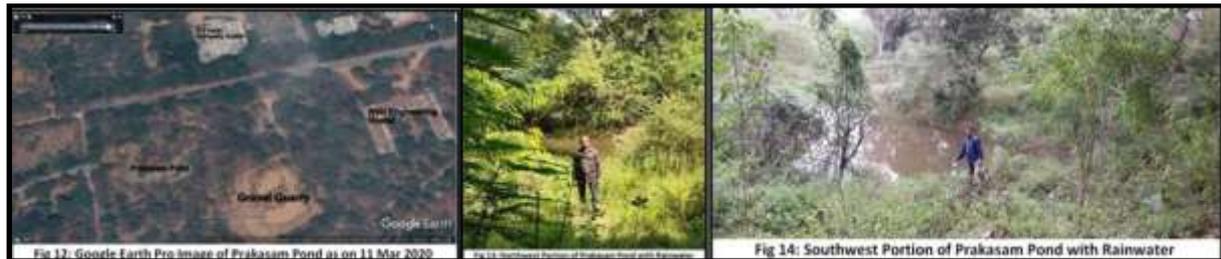
As a result of this work, the Prakasam pond became once again a dry pond as shown in the image captured on 11 Mar 2020 (Fig 12). Although the pond looks dry in summer, it gets filled up with rainwater in the rainy season as per Figs 13 and 14. The environmental damage already caused in and around Prakasam pond by way of letting untreated sewage into it since 1996 remains still unanswered.

The appeal made by Jagadiswara Rao (2016) through print media (Rangarajan, 2016) led the Engineering wing of the TTD to promptly suspend conveyance of untreated sewage water into the Prakasam pond. Instead a pipeline carrying untreated sewage water was laid by the side of the pond to convey the sewage water outside the SVU into a stream flowing to the Tirupati Sewage Treatment Plant (STP) located close to the Tirupati International Airport (Venkateswarlu et al, 2020).

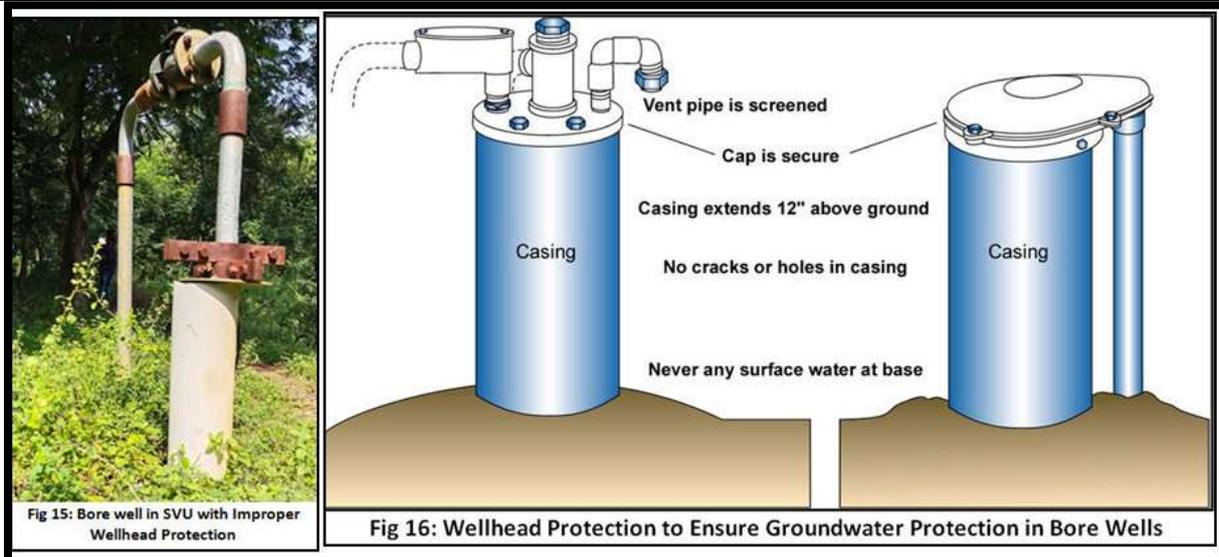
The conventional methods of drilling in vogue in the area are such that both contaminated surface water and shallow groundwater enter into the bore wells in large amounts. Fig 15 shows one such bore well constructed in the vicinity of Prakasam pond. The only way the deep bore wells could provide good-quality water is to use a drilling technology using blank casing for sufficient length together with properly sealed annulus that prevents entry of any surface water and shallow groundwater. Fig 16 shows the various precautions to be taken in maintaining a good wellhead protection, which include (a) no surface water at base any time, (b) no cracks or holes in casing, (c) extending casing at least 12 inches above ground, (d) keeping cap secure, and (e) effective screening of vent pipe.
