# IMPACT OF HIGH TEMPERATURE ON PROPERTIES OF MARBLE WASTE CONCRETE WITH POST- HEATED WATER CURING

**Ramkisan Nana Ahire, Sandip karale, Ubaid Ansari**  
**PG STUDENT, Senior Lecturer, Head of department**  
**JES'S S.N.D COE & R.C BABHULGAON**

**Keywords:** Marble waste, High Temperature, pulse velocity, Post heated Curing, Fire damage, Compressive

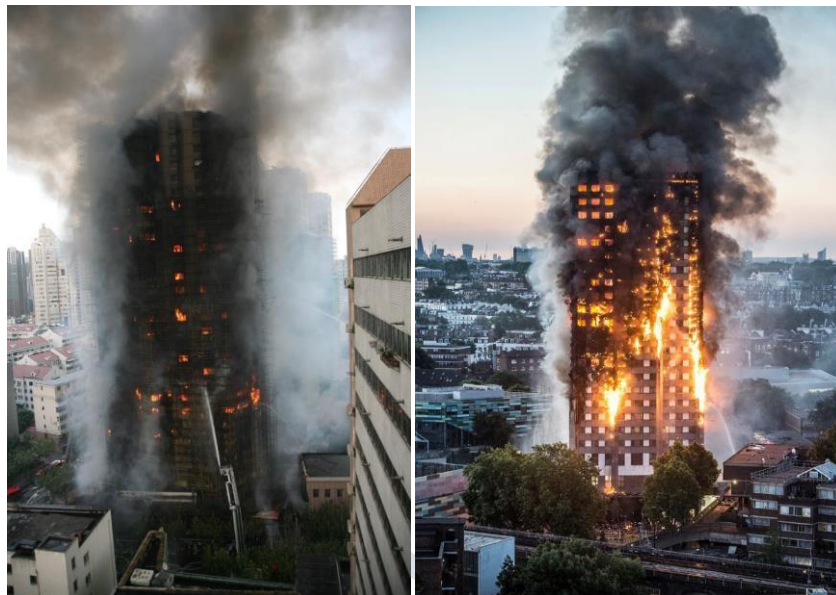
Figure 1.1 Major fire disasters Table 1.2 Major fire disaster

a)	b)
<b>Date</b>	15th November 2010	14th June 2017
<b>Location</b>	Shanghai, China.	Grenfell Tower, London, England.
<b>Cause</b>	Scaffolding erected for the renovation caught fire due to the sparks of welding work.	Freezer in the refrigerator caught fire due to an electrical fault. Cladding and insulation gave rise for the rapid spread of fire.
<b>Decision after damage assessment</b>	Renovation	Demolition
<b>Source</b>	Photo: Peijin Chen	Photo: Jeremy Selwyn

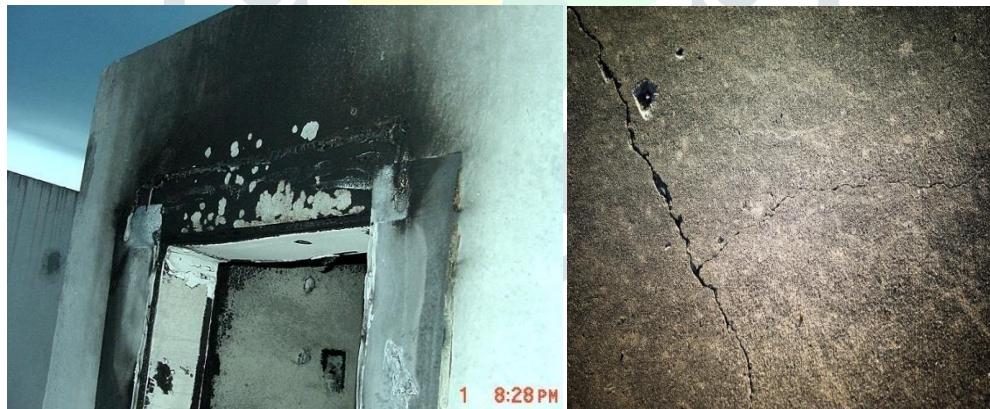
**Figure 1.2 Surface of the concrete surface after exposure to elevated temperature**

Heating above 300°C, changes the color of the concrete to pink (300-600°C) and then to whitish grey between the temperature range 600 to 900°C. Free moisture present in the concrete evaporates between the temperature range of 100°C and 200°C; this evaporation builds the vapour pressure and encourages the spalling. At 250°C temperature, concrete dehydrates. At 300°C, 15-40% strength reduces because of dehydration of calcium hydroxide and at 550°C, 55-70% strength reduces due to aggregate deterioration. Siliceous aggregate Quartz shows volumetric expansion and thereby damage to the concrete with temperature. At 800-900°C CaCO<sub>3</sub> present in limestone aggregate concrete turns into CaO and further expands with temperature.

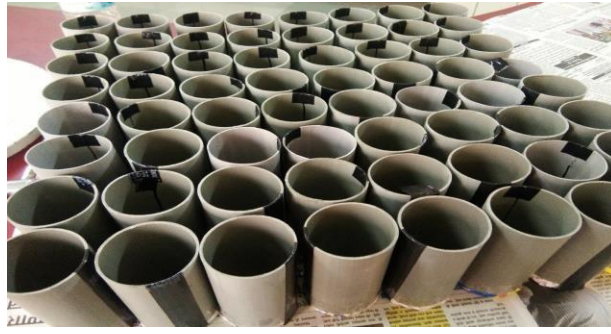
**Figure 3.2 PVC cylindrical concrete moulds Cube:** Concrete cube specimen of size 150mm x 150mm x150mm receptively.

It is observed that a specimen obtained from a PVC tube by applying the second condition is good as compared to the other two conditions. Cutting the tube along the length for easy removal of a specimen. Later on, all the tubes were cut along the length before pouring concrete into them. Figure

3.2 shows the PVC cylindrical moulds. In the trial specimens escaping of the cement slurry from the vertical slit was observed. To avoid cement slurry to flow out from the vertical cut during compaction, the cut was sealed with adhesive tape as shown in figure 3.2.

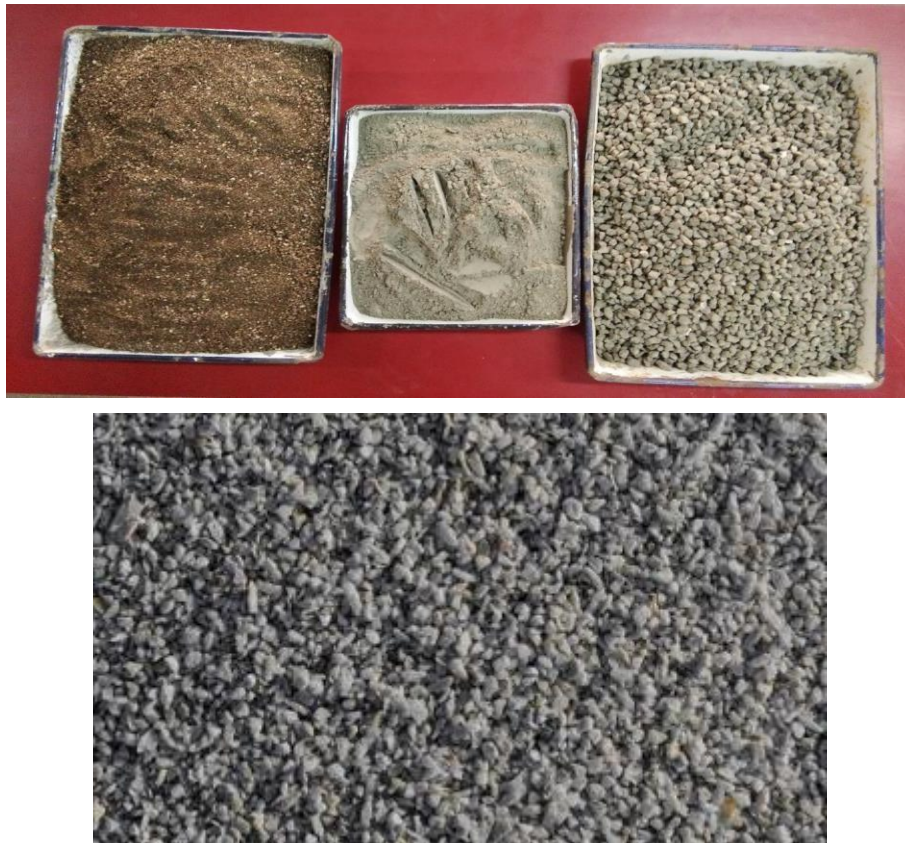
Figure 3.2 measured cement, sand, and aggregate marble chips aggregate

**3.6 Concrete mixing and moulding:** For mixing concrete, pan type concrete mixer and hand mixing were used. A measured amount of cement, sand, and coarse aggregate are shown in Figure 3.3 below. The concrete mixer was washed with clean water for avoiding the mixing of any foreign matter. Dry mixing of fine and coarse aggregate for 3 minutes was done before adding cement and Marble chips, thereafter cement, Marble chips and water were added at the same interval (Husem 2006) and a homogeneous mix of concrete was obtained. Concrete was poured in the mould in three layers by tamping each layer 25 times with a steel rod and allowed it to set for the next 24 hours at room temperature. Figure 3.4 shows the moulds filled with fresh concrete. After demoulding the diameter of the demoulded concrete specimens were checked with the help of venire caliper at 3 different sections along the length of the specimen, and a uniform diameter was recorded. No indication of flowing out of the cement slurry was observed from the vertical slit due to the presence of the adhesive tape. Subsequently, all de molded specimens after 24 hours were kept in water for 56 days curing at the 27°C temperature as shown in Figure 3.3. In this study total, 438 samples were cast for both the water-cement ratios.

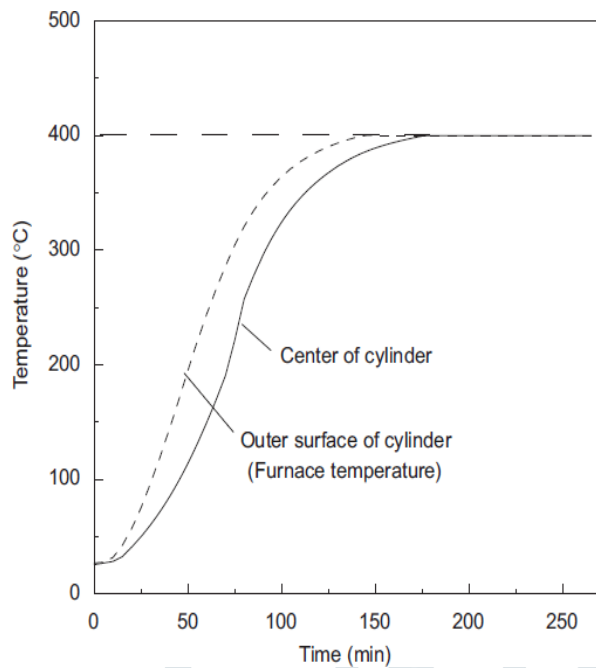
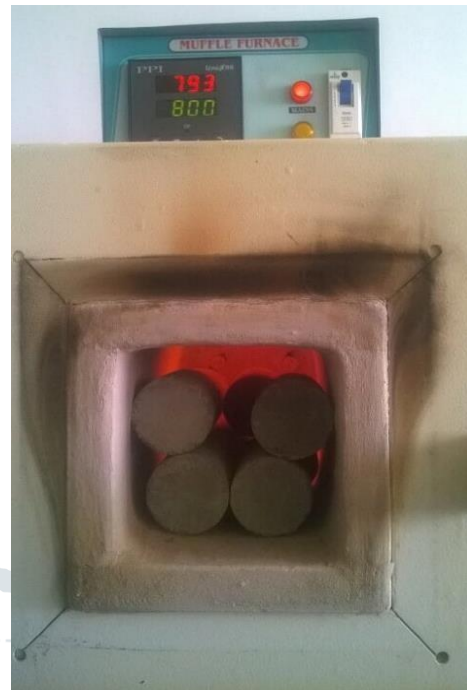
i.e. from  $\alpha$  crystal phase to the temperature above 573°C which brings  $\beta$  crystal phase in quartz. After heating to 600°C concrete does not remain structurally useful. Within 600-800°C temperature, if the calcareous aggregate is used, that imparts significant contraction in concrete by releasing carbon-dioxide which brings severe micro-cracking in the matrix of cement. Heating of the concrete up to 1200°C imparts whitish grey coloration caused due to dissociation and extreme thermal stress, caused due to the disintegration of calcareous constituents of aggregate and cement matrix (Ingham 2009). In addition to the above parameters, the shape of the specimen with the available surface area for uniform heating and relatively small size of the specimen, it was decided to heat the early age concrete up to the peak temperature 400°C, 600°C and 800°C to study the strength changes in concrete. After curing of the concrete specimens for 56 days they were kept in the electric muffle furnace with the electronic controller in the SSD condition. Before heating, a damp cloth was used to wipe off the surface water. According to the study carried out by (Nassif et al. 1999; Yang et al. 2009), it was stated that, once the furnace achieves the peak temperature, the temperature difference between the core and the outer fibers disappears. Further, this relationship was verified by the Lin et al. (2011) (as shown in Figure 3.4(a)) and found to be consistent with the previous relationship. In this experimentation Concrete specimens were kept in the electric muffle furnace for one hour once furnace achieves the peak temperature. One

hour exposure time allows achieving uniform heating of the concrete throughout the section, Figure 3.5

**Figure 3.5 (a) Time-temperature curve for the center of the specimen and outer surface of the specimen (Lin et al. 2011); (b) Heating of the specimens at elevated temperature in electric muffle furnace.**

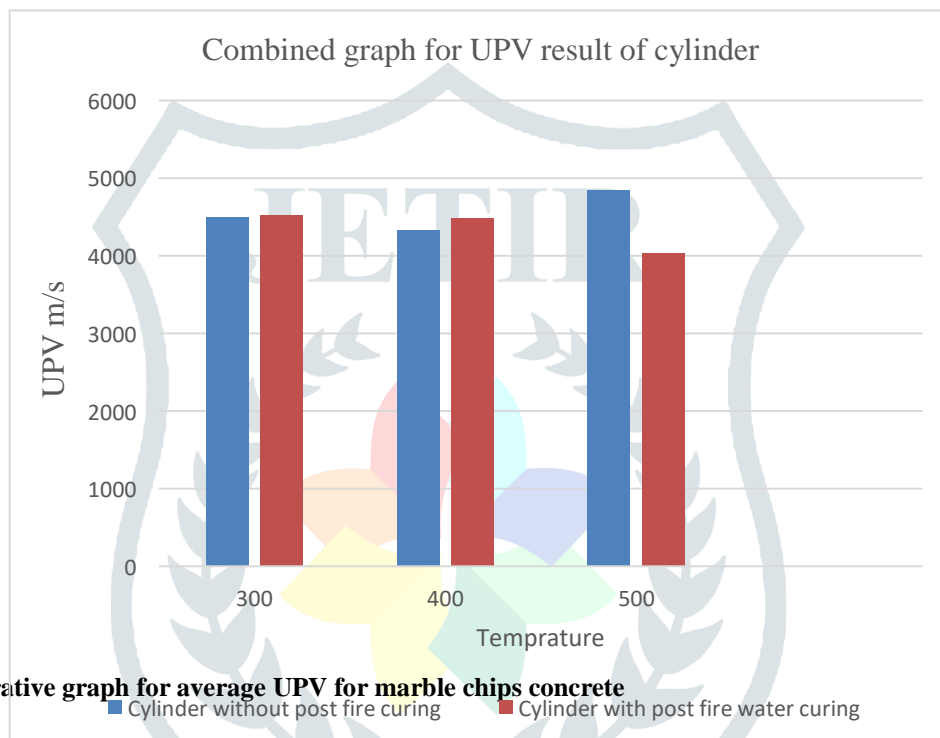
**Graph No. 4.5 Comparative graph for average UPV for marble chips concrete**

■ Cylinder without post fire curing ■ Cylinder with post fire water curing

It had been observed that is no decrease of strength more than 10% for strength obtained for cubes exposed to 600°C and Room temperature. i.e. for M30 grade concrete- 15% marble concrete , at 300°C-34.24, 400°C-31.86, 500°C-30.67, There is increase in strength of heated concretecube and cylinder due post fire water curing for 3 days as result shows there more strength increment in the 300°C-32.43, 400°C-31.81, 500°C-31.37 as compare to cube not subjected post fire water curing. Also for UPV result for cylinder shows improvement in the velocity for different temperature as 300°C-4452.33, 400°C- 4384.3, 500°C-3927.66.
