Study and problem identification for failure analysis of suspension springs of Indian railway engine WAG-9,Locoshed Ajni,Nagpur,India

In this paper we have discussed about the approach that we are going to adopt for the problem identification of the suspension spring of railway engine WAG-9 and how we are going to provide the alternative solution to the Indian Railways Regarding the material used for suspension spring.The investigation is focused around the failure of secondary suspensuion spring and primary suspension spring.first of all.The design of spring is prepared by using design data provided by railway officials .The Design of the springs is shown in following figures.

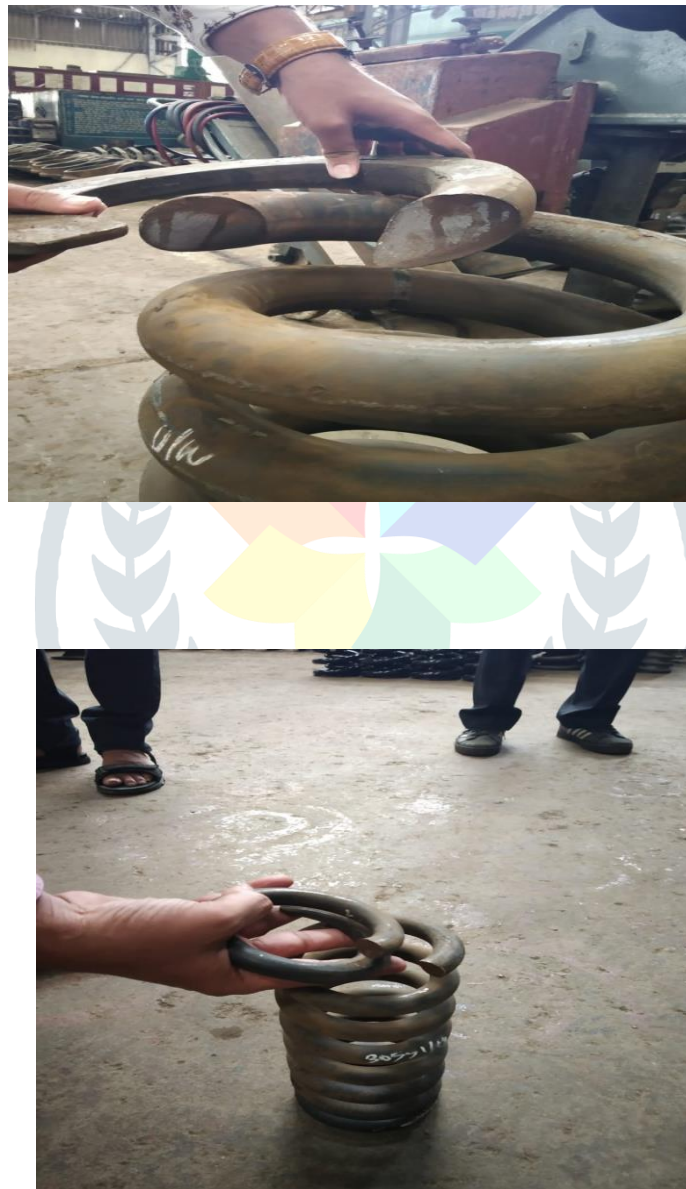
- **Following are the observations on failed spring:**
- The spring usually breaks between first to third coils.
- Failure initiates at the inner radii of spring which progresses and shears the spring into two pieces. (Refer figure 4).
- The scratches on the damper confirm the deformation of assembly by about 25mm more than the stationary condition indicating higher loads while running. (Refer figure 5).

Fig.Broken Primary Spring

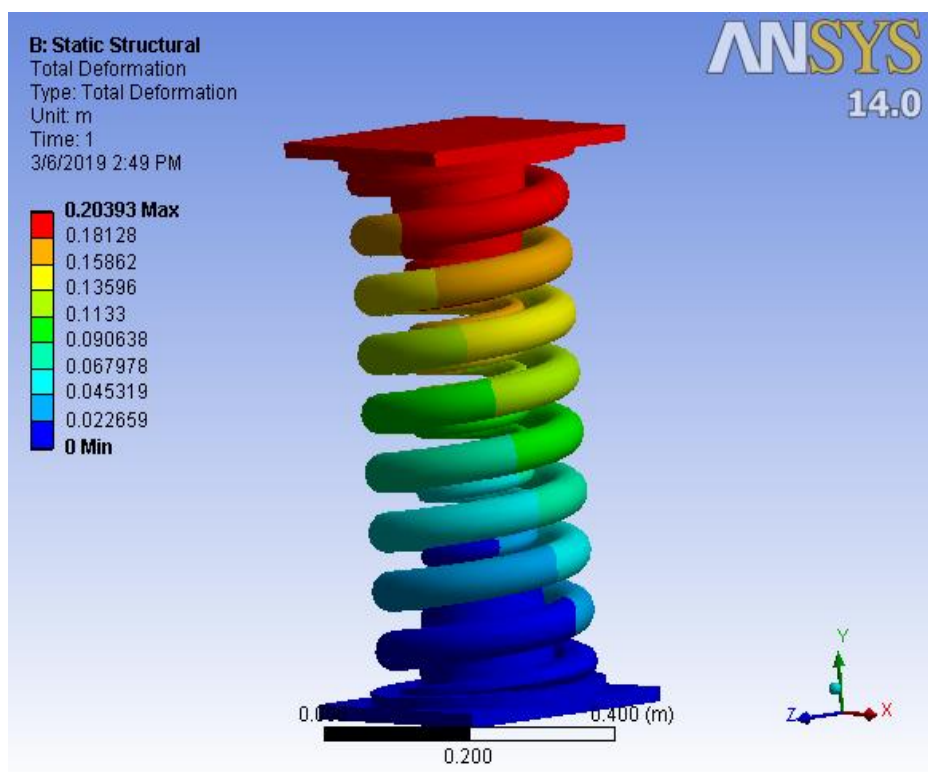
MAXIMUM DEFORMATION AT FIRST TWO COILS

Fig.Secondary Spring

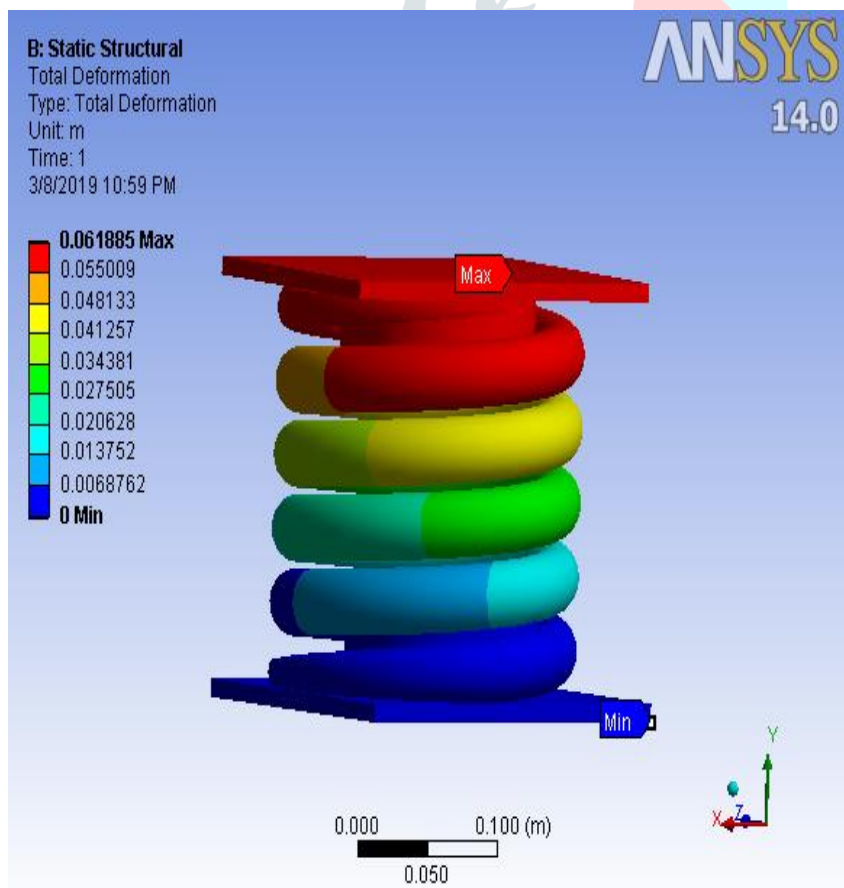
DEFORMATION MAXIMUM BETWEEN FIRST TWO COILS

Fig.Primary spring
