EXTINCTION OF LAKES: THE FUTURE OF BANGALORE

Abstract

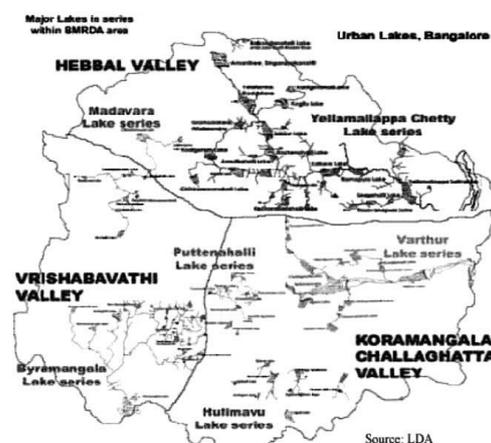
Fig.1: The Lakes and the Valley System of Bangalore.
Source: Lake Development Authority

Bengaluru, which is 3000 feet above mean sea level, has no perennial rivers and so lakes became the main source of water supply for its survival. The average rainfall in Bengaluru is 800 to 900 mm per annum regularly. Due the terrain of Bangalore, the rainwater moves from the higher terrain to the lower areas (~20% of the rainfall, ~70% being evapotranspiration, the balance being percolation to ground-water). The rain water first flows into the lakes/ tanks which is at the higher levels, its excess then flows into the next level of lakes through *Rajakaluwes* (which were not less than 30 feet in width) which became inlets to the lakes and when the second level lakes filled up, the water overflows to the third level of lakes and so on till the excess water from the last level of lakes flows into the four natural drainage valleys of Hebbal Koramangala, Vrishabhavati, and Challaghatta.

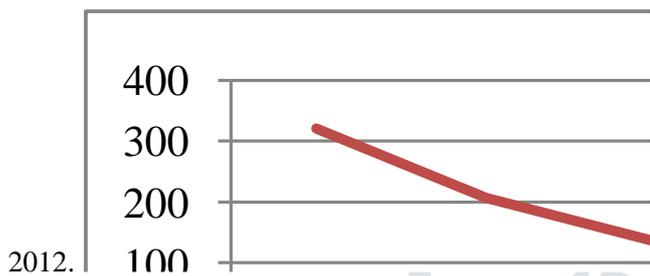
Graph 1: Decline of wetlands in Bangalore region

disposal. All the lakes or tanks in Bangalore were constructed in the 16th C by constructing bunds or dams across the natural valley systems. These lakes met the basic requirements of drinking water, irrigation and fishing needs of the society and were a positive influence on the ecology and microclimate of the city. This helps in recharging the ground water in the region, but also averted flooding, treated small amounts of effluents, restricted sediment loads and functioned as a productive ecosystem. There were 262 lakes and tanks in the city around the year 1961. But due to rapid urbanisation, increased demand for real estate and infrastructure needs the open spaces and water bodies were hugely affected. There was a sharp decline of 78% of water bodies and an increase of 466% of built up area from 1993 to

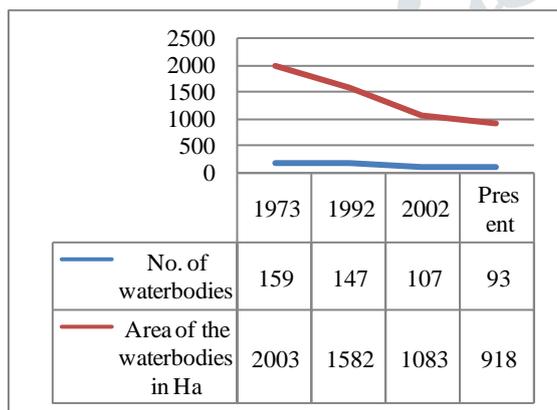
Graph 2: The Decline in the number of water bodies from the year 1973 to present in Greater Bangalore region.

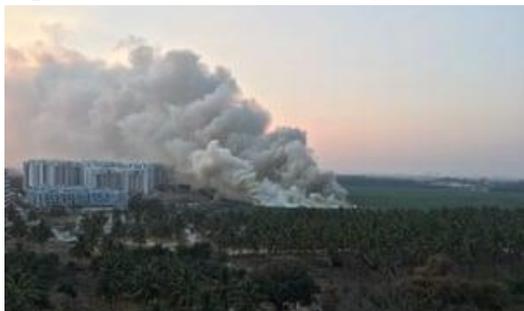
Pic 1: Bellandur lake, covered in a thick layer of vegetation, burned for hours on the evening of 16 February 2017 Source: Photograph by Aaditya Sood

Illegal dumping of garbage along the banks of lake is another reason of concern. Garbage weed and dry grass in the area is regularly burnt without the supervision of garbage collectors. Even an accidental fire can flare the lake as the water contains flammable chemicals.

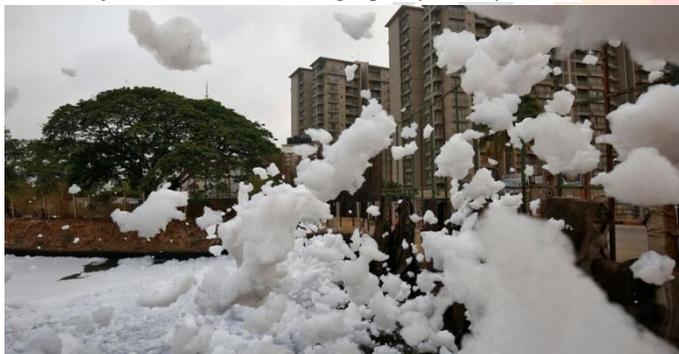
Pic 2: Bellandur lake covered with froth and foam

The phenomenon of froth and fire is killing Bellandur Lake. Detergents and unchecked sewage from households in the neighbourhood is responsible for water contamination in the lake. Industries located along the upstream of the lake are conveniently disposing toxic chemicals into the lake. The contamination of the lake by untreated sewage and effluents has surpassed the lakes assimilative capacity. Nitrogen, phosphorous and carbon enters the lake through pollutants. Nitrogen is taken up by aquatic plants and algae. Phosphorous and carbon gets trapped in sediments. Wind along with excess rain causes the sediments to swell. Swollen sediments along with running water from higher altitudes causes froth formation due to phosphorous, as explained in studies by Indian Institute of Sciences, Bangalore. The stench

of the foam is very strong. The lake froths easily overflow's on to the roads.
