STUDY OF EDAPHIC CHARACTERS OF SELECTED RIVER BANK SITES IN CENTRAL KERALA

Abstract : Rivers are probably one of the most dynamic waterscapes on the planet which accounts for the creation of history, culture, lives and livelihood by its running arteries across the land. The complexion of a river is determined by the nature of plains it surges through, their slopes, altitude, latitude, and of course the soil texture. The soil sediments fetched by the rivers accounts for the creation of a different culture and history. Even the flora and fauna in and around the river sites depends upon the nature of soil it carry. Kerala is rich in river diversity which holds unique characters, but during the last few years these rivers are in the verge of being vanished due to over pollution. So in this context it is important to study the edaphic characters associated with different rivers, for getting the actual status of the river. The present study is such an effort to study the edaphic characters of selected river sites in central Kerala.

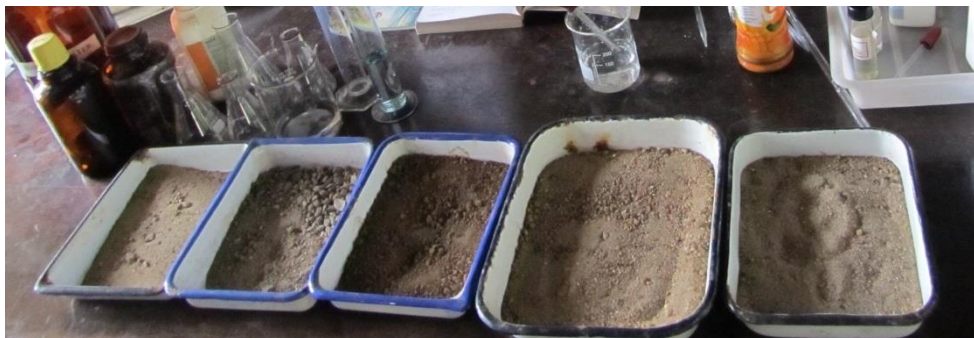
The colour, smell and texture of the soil samples(Fig.8) were analysed for future reference.

Fig.8- Soil Samples kept for analysis

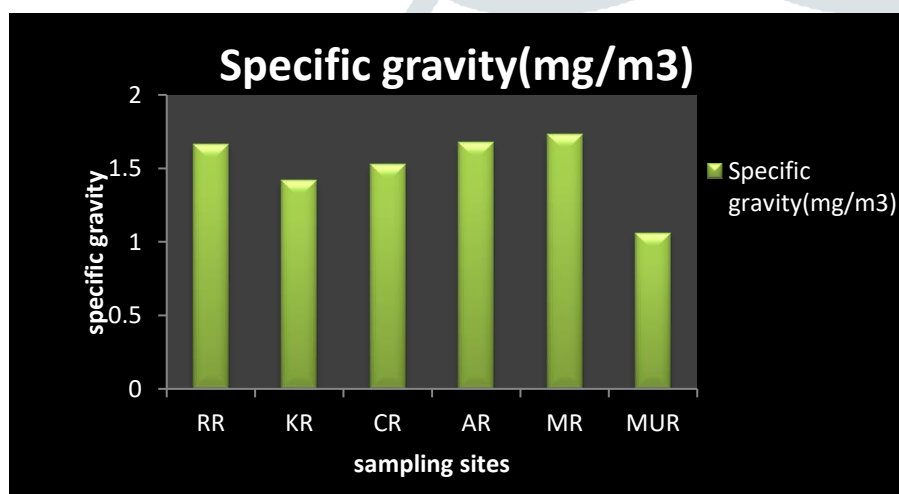
Fig. 10 comparison of Specific Gravity in six different sampling sites

By analysing the figure 9 the Sample collected from MR shows high bulk density were as the sample collected from MUR shows low bulk density when compared to the other. Increase in bulk density restricts infiltration and make soil impermeable. Figure 10 shows the comparison of Specific Gravity of six sampling sites.MR shows high specific gravity followed by AR and RR and low specific gravity was observed for MUR. In contrast with the above two result MUR was found to be having high water holding capacity (96%) and there by high moisture content (graph.4) where as MR (59%) shows low water holding capacity (figure 11) and low moisture content.
