IMPROVEMENT OF SEISMIC PERFORMANCE OF STONE MASONRY STRUCTURE: A REVIEW

¹Kapil Gandhi, ²Bhawani Singh Bhati, ³Dr. S.S. Sankhla

Index Terms— Earthquake-Resistant, Seismic Retrofitting, Stone Masonry Structure, Seismic Deficiencies.

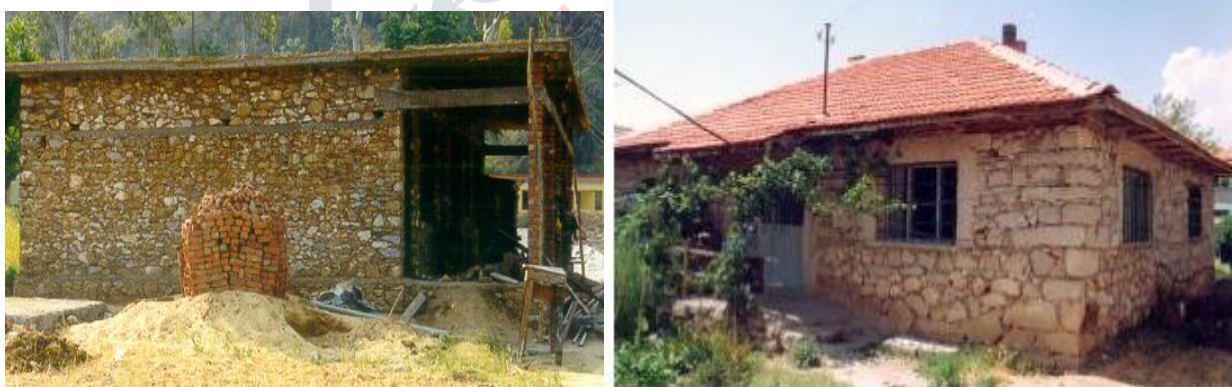
Figure 1 Stone masonry construction in India

Stone masonry is a traditional form of construction that has been practiced for centuries in regions where stone is locally available. Stone masonry has been used for the construction of some of the most important monuments and structures around the world. Buildings of this type range from cultural and historical landmarks, often built by highly skilled stonemasons, to simple dwellings built by their owners in developing countries where stone is an affordable and cost-effective building material for housing construction. Houses of this construction type are found in urban and rural areas around the world. There are broad variations in construction materials and technology, shape, and the number of stories. Houses in rural areas are generally smaller in size and have smaller- sized openings since they are typically used by a single family. Multi-family residential buildings in urban areas are often of mixed use - with a commercial ground floor and a residential area above. Houses in rural areas and suburbs of urban centers are built as detached structures, while housing units in urban centers often share a common wall. Stone masonry walls are usually constructed using low-strength mortars, such as mud or lime:sand mortar. A higher - strength cement:sand mortar has been used in the last few decades, however its use does not necessarily imply an increase in the wall strength. In areas where flat stones are available, walls are often built without any mortar (that is referred to as dry masonry).

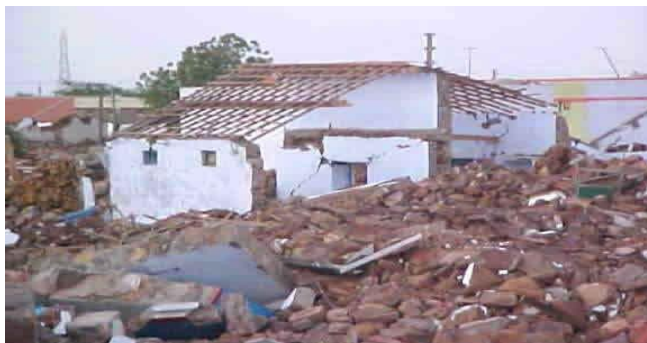
Figure 2 Damage to Stone Masonry Building in Bhuj, Gujrat Earthquake 2001

Stone masonry buildings have shown poor performance in earthquakes, leading to significant human and economic losses. This includes performance in earthquakes in Italy, Greece, Turkey, Montenegro, Slovenia, Algeria, Iran, Pakistan, India, Nepal, and many other countries. In the 2005 Kashmir earthquake (M 7.6), over 74,000 people died in Pakistan, most of them buried under the rubble of traditional stone masonry dwellings. In India, most of the 13,800 deaths during the 2001 Bhuj earthquake (M 7.7), and more than 8,000 deaths in the 1993 Maharashtra earthquake (M 6.4), were attributed to collapses of this type of construction. Examples of devastation caused by heavy damage or the collapse of stone masonry buildings in past earthquakes are shown in Figures 2 to 4.

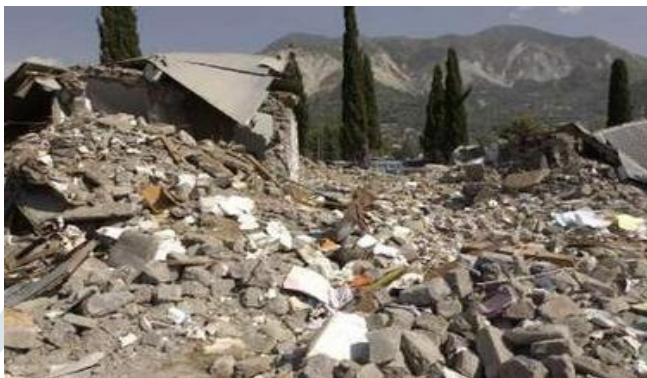
Figure 3 Damage to Stone Masonry Building in Kashmir Earthquake 2005

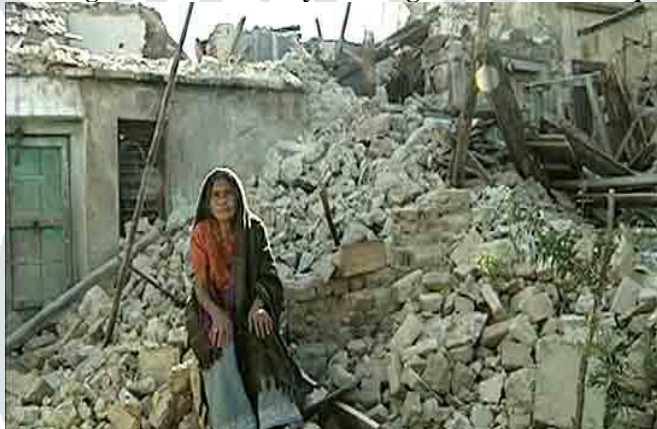
Figure 4 Damage to Stone Masonry Building in Maharastra

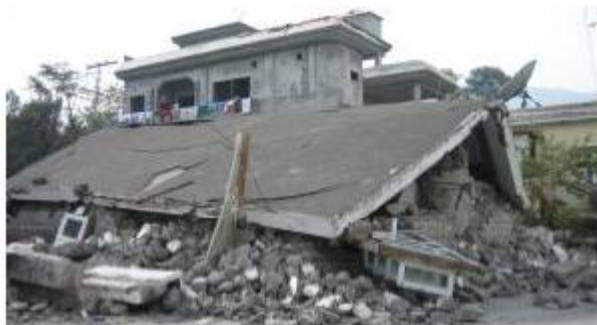
Figure 5 Roof collapse due to a loss of the gravity load-bearing capacity of stone walls in the 2005 Kashmir

Roof collapse is one of the major causes of fatalities in masonry buildings during earthquakes. It can take place when either the walls lose the ability to resist gravity loads and collapse, or when the roof structure collapses. Roof collapse is often caused by inadequate wall-to-roof anchorage. The roof structure can simply "walk away" from the walls and cave into the building. Roof collapse can also be caused by the collapse of supporting walls, as shown in Figure 5. Some stone masonry buildings have heavy roofs that contribute to their seismic vulnerability. Heavy RC roof slabs contributed to the collapse of buildings in the 2005 Kashmir earthquake, as shown in the figure 5.

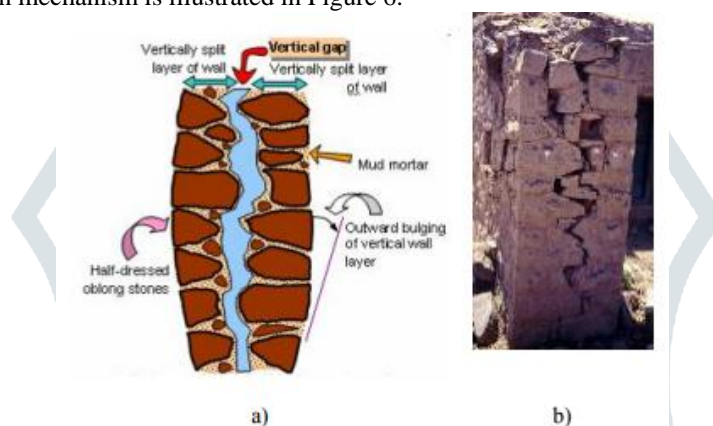
Figure 6 Delamination of stone masonry walls: a) delamination mechanism; b) delamination of wall wythes in the 1993 Maharashtra, India, earthquake

Delamination of Wall Wythes is a common failure mechanism in stone masonry buildings. As discussed earlier, stone masonry walls comprise two exterior wythes, and the space between the wythes is usually filled with small stones and pieces of rubble bonded together with mud mortar. These wythes are usually constructed using large stone boulders (either round stones or partially dressed stones) which are not tied together. Once the shaking starts, unstable stone blocks start to move sideways, and the internal core move downwards leading to delamination of wythes. Delamination mechanism is illustrated in Figure 6.

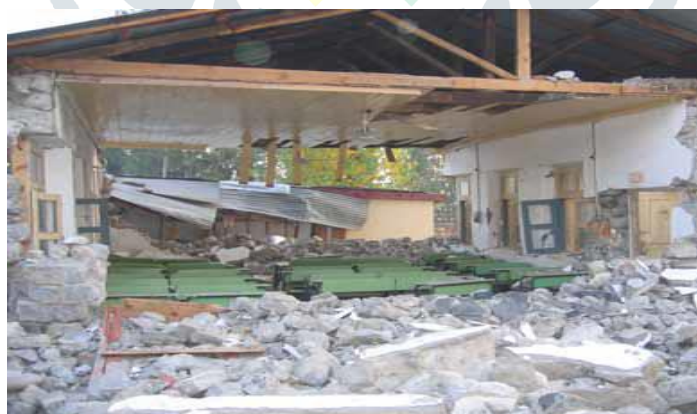
Figure 7 Out-of-Plan Collapses of Two Parallel Walls

Out-of-plane wall collapse is one of the major causes of destruction in stone masonry buildings. This is particularly pronounced in buildings with flexible floors and roofs, large distance between transverse (cross) walls, and weak connections between the structural components. As a result, each wall vibrates on its own when subjected to earthquake ground shaking, and ultimately collapses (topples), as shown in Figure 7. Out-of-plane toppling of gable walls in stone masonry buildings with pitched roofs is common, because these walls are taller than other walls and tend to vibrate as free-standing cantilevers show in figure 7.

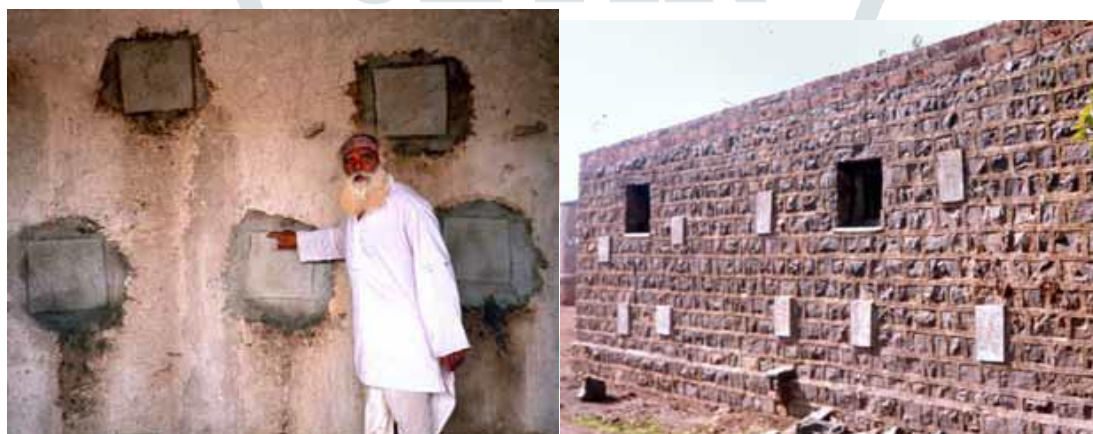
Figure 10 Examples of completed through-stone retrofit projects in Maharashtra, India

The installation of through-stones is labor-intensive, but it may be a feasible retrofit option for stone masonry walls provided that the wall thickness is not excessively large. The procedure is illustrated in Figure 9. First, a hole needs to be created in the wall by removing stones. To create a hole, stones need to be loosened by means of gentle pushes sideways, upward and downward using a small crowbar, so that the other stones in the wall are not disturbed. The hole should be dumbbell-shaped, that is, it will be larger on the wall surfaces than in the interior. A hooked steel bar needs to be installed and the hole should be filled with concrete. Finally, the exposed surface should be covered with a rich cement and sand plaster coating and cured for at least 14 days. Through-stones should be installed very carefully; otherwise surrounding portions of the wall may be damaged. Examples of throughstone applications are shown in Figures 10.
