ROLE OF CONSTRUCTION PRACTICES FOR STONE MASONRY STRUCTURE WITH RESPECT TO SEISMIC PERFORMANCE

Abstract— Stone masonry is a traditional form of construction that has been practiced for centuries in regions where stone is locally available. Unfortunately, these buildings show poor performance even under minor earthquake shaking. Research on the seismic behavior of masonry structures is nowadays almost entirely dedicated to existing buildings and to the issues related to assessment and reduction of their seismic vulnerability. For countries with a long story of civilization, the seismic protection of masonry buildings involves also the issue of protecting the cultural heritage of the country. There is also a rather generalized negative attitude towards the use of structural masonry for new buildings in seismic areas, since most collapses and deaths in recent earthquakes are due to inadequate performance of unreinforced masonry buildings (usually non-engineered, low-quality, old dwellings). This explains why the large majority of the current scientific and technical literature on seismic behavior of masonry is dedicated to the study of existing structures and very seldom is masonry b

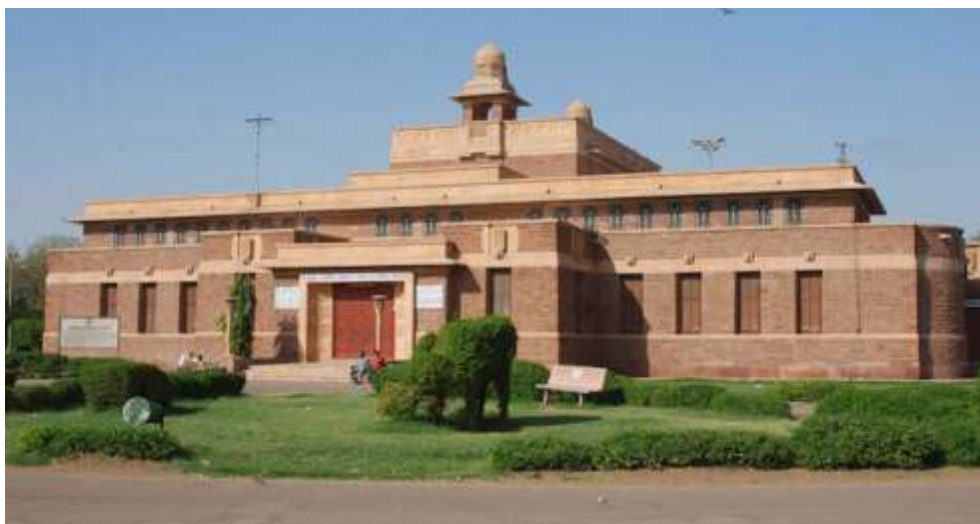
Figure 1: Traditional stone masonry building in Jodhpur, Rajasthan

The main lateral and gravity load-resisting system consists of stone masonry structural walls. The walls are generally uniformly distributed in both orthogonal directions with a wall thickness ranging from 300 mm to 700 mm. The wall density (area of walls in one direction versus total plan area) ranges from 5% to 25%. Stone masonry apartment buildings in Algeria have an extremely low level of wall density (5% to 6%) despite having up to five stories with a story height of 3.5 m.

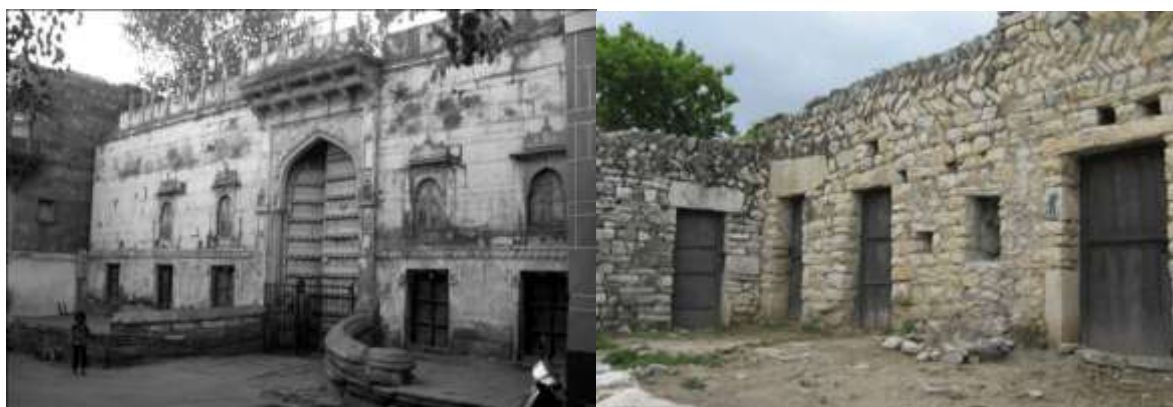
Figure 2: Stone masonry construction in Rajasthan: a) a typical stone masonry house in Jodhpur, and b) a typical rural house in a village of Jodhpur

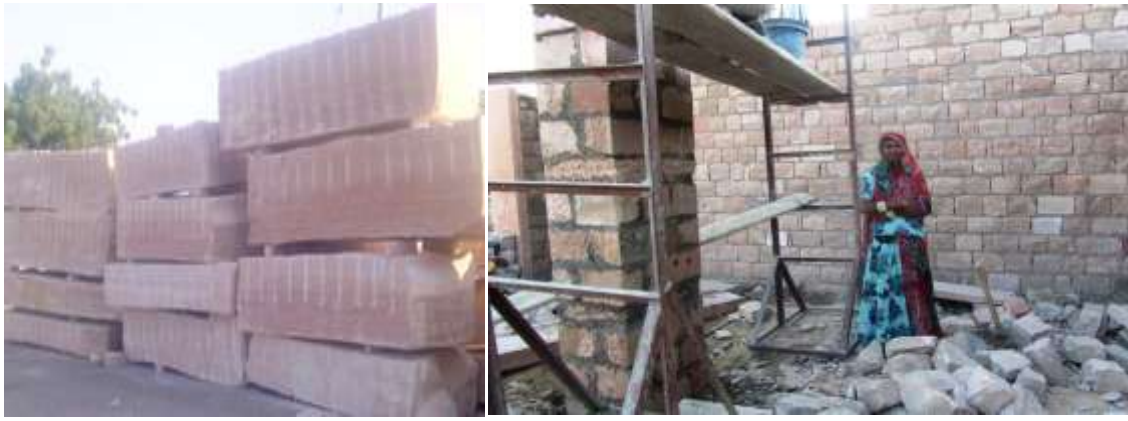
Figure 3: Stone masonry construction: a) Un-dressed stones for construction, and b) Stone masonry construction in Jodhpur, Rajasthan, India

The key components of a typical stone masonry building include floor/roof systems, walls, and foundations. Stones from different sources are used for wall construction, including river stones, field stones, and quarried stones. These stones are often used without additional shaping, especially when the tools, expertise, or labour required to shape these stones are either not available or not affordable. Stone masonry walls usually consist of two wythes, and the space between the wythes is filled with mud, small stones and pieces of rubble. Through-stones (long stones that extend through all wythes), which are essential for bonding the wythes and ensuring wall integrity, are usually absent. Wall thickness is usually on the order of 500 mm, but it could be excessively large, in some cases up to 2 m. This type of stone masonry construction is called random rubble stone masonry. In some cases, stones can be partially or fully shaped (dressed) to better suit construction, as shown in Figure 2a). Construction of a random rubble stone masonry wall is shown in Figure 3b). Stone masonry walls are usually constructed using low-strength mortars, such as mud or lime sand mortar. A higher - strength cement sand mortar has been used in the last few decades; however its use does not necessarily imply an increase in the wall strength. In areas where flat stones are available, walls are often built without any mortar (that is referred to as dry masonry).

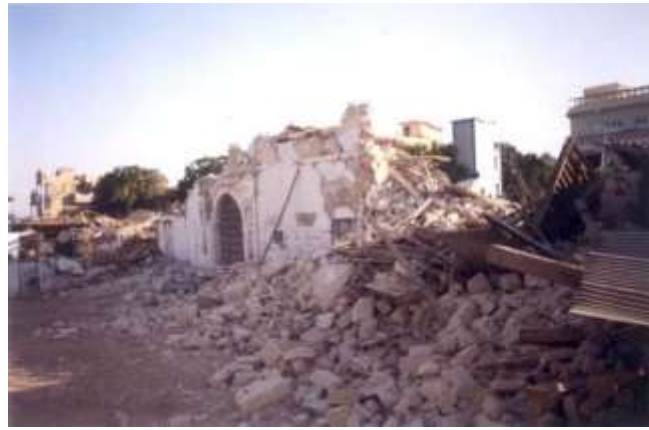
Figure 4: Roof collapse due to a loss of the gravity load-bearing capacity of stone walls in the Rajasthan

Roof collapse is one of the major causes of fatalities in masonry buildings during earthquakes. It can take place when either the walls lose the ability to resist gravity loads and collapse, or when the roof structure collapses. Roof collapse is often caused by inadequate wall-to-roof anchorage. The roof structure can simply "walk away" from the walls and cave into the building. Roof collapse can also be caused by the collapse of supporting walls, as shown in Figure 4. Some stone masonry buildings have heavy roofs that contribute to their seismic vulnerability. Heavy RC roof slabs contributed to the collapse of buildings in the Rajasthan earthquake, as shown in the figure 4.

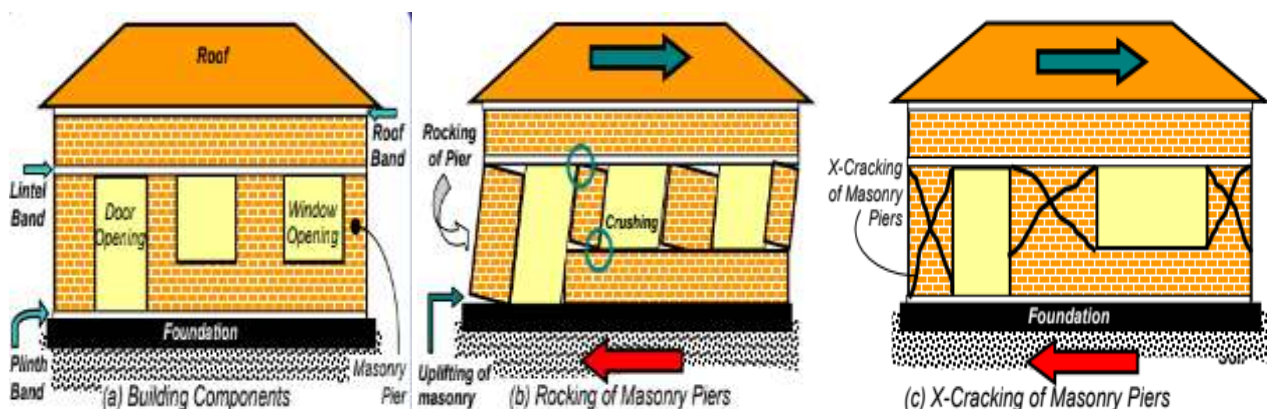
Figure 6: Earthquake response of a hipped roof masonry building – no vertical reinforcement is provided in walls.

Consider a hipped roof building with two window openings and one door opening in a wall (Figure 6a). It has lintel and plinth bands. Since the roof is a hipped one, a roof band is also provided. When the ground shakes, the inertia force causes the small-sized masonry wall piers to disconnect from the masonry above and below. These masonry sub-units rock back and forth, developing contact only at the opposite diagonals (Figure 6b). The rocking of a masonry pier can crush the masonry at the corners. Rocking is possible when masonry piers are slender, and when weight of the structure above is small. Otherwise, the piers are more likely to develop diagonal (X-type) shear cracking (Figure 6c); this is the most common failure type in masonry buildings.

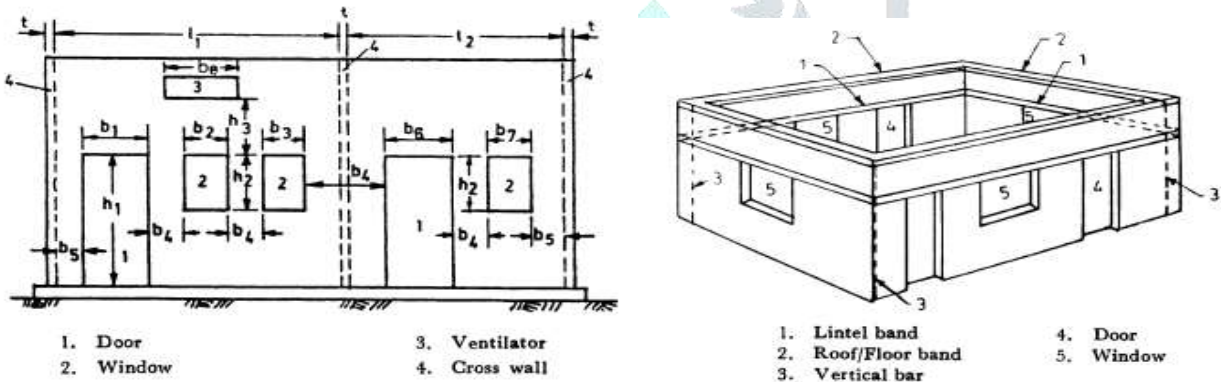
Figure 8: Dimensions of openings overall arrangement of reinforcing low strength masonry buildings

Door and window openings in walls reduce their lateral load resistance and hence should preferably be small and more centrally located and overall arrangement of reinforcing low strength masonry buildings as shown in figure 8.

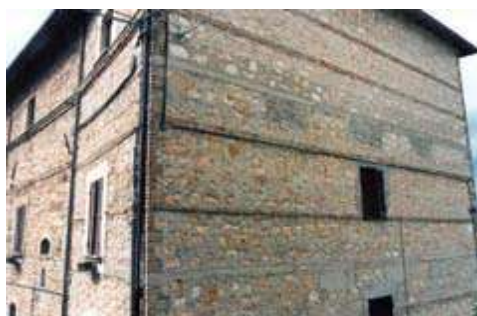
Figure 9: Seismic-strengthening techniques in Italy: installation of new steel wall ties

The actual shear resistance of structural walls can be enhanced if they are properly tied and connected to floor and roof structures. In the case of existing buildings, this is achieved by means of steel, timber, or reinforced concrete ties at floor levels. Vertical ties of the same material are inserted at the corners and between openings to prevent instability. The timber joists of floor structures are connected to the walls by means of steel anchors and plates. Ties are placed symmetrically on both wall sides; alternatively, RC are placed at the exterior and steel ties are placed at the interior wall surface.

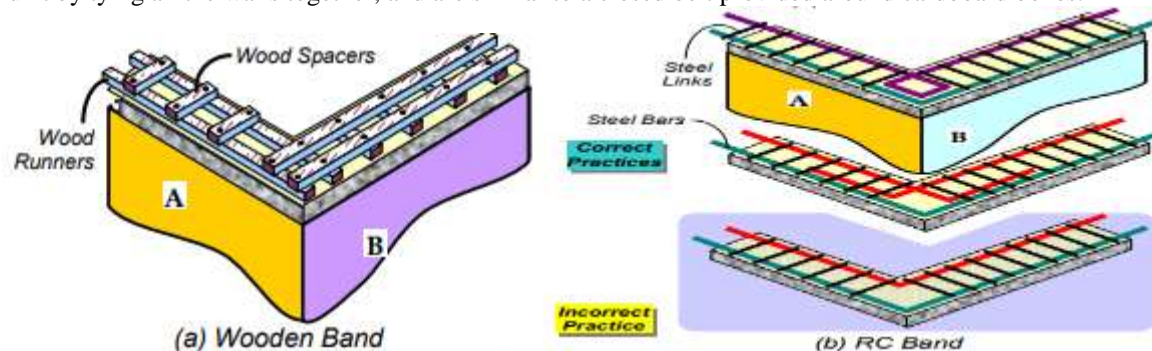
Figure 10: Horizontal Bands in masonry buildings

Horizontal bands are also the most important earthquake-resistant feature in masonry buildings. The bands are provided to hold a masonry building as a single unit by tying all the walls together, and are similar to a closed belt provided around cardboard boxes.

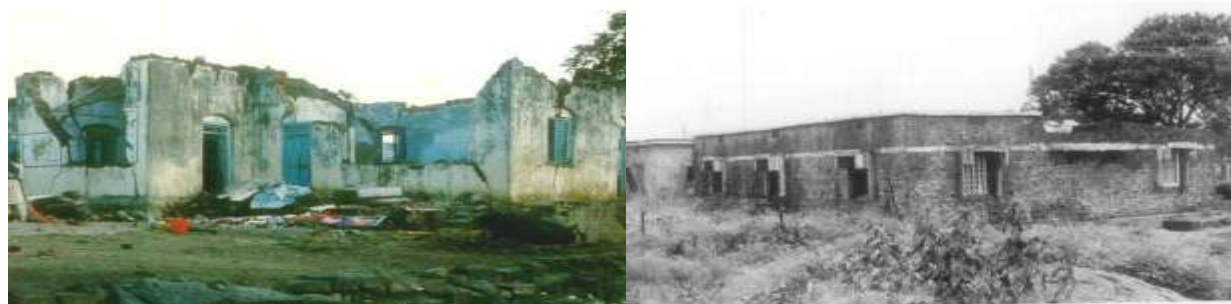
(a) Building with no horizontal lintel band: collapse of roof and walls

(b) A building with horizontal lintel band in Killari village: no damage

Figure 11: The 1993 Latur Earthquake (Central India) - one masonry house in Killari village had horizontal lintel band and sustained the shaking without damage.
