ANALYSIS AND DESIGN OF PEDESTRIAN LEVEL OF SERVICE ON NH-146 IN FRONT OF SATI VIDISHA (M.P.)

¹Akanksha Mishra, ²Dr. Pradeep Purohit

¹Samrat Ashok Technological Institute, Vidisha, India

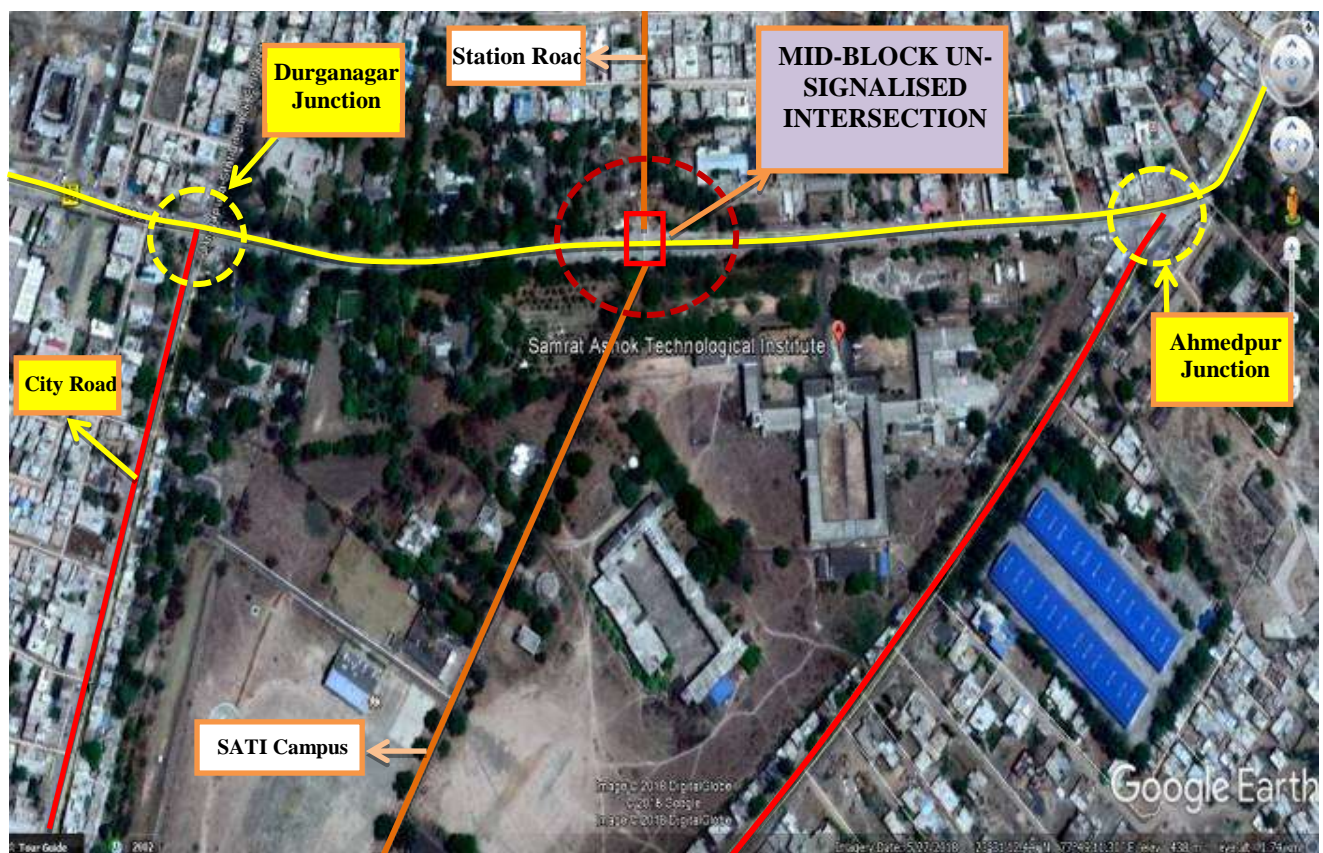
Figure : Selected area for study (Google map)

Here, the location of the study is Mid-Block Un-signalised Intersection in front of SATI College on NH-146, Vidisha District. This study has been carried out for determining the Pedestrian Level of Service on Mid-Block Un-signalised Intersection. The Pedestrian count data of both directions have been collected. The various patterns of pedestrian crossings on the

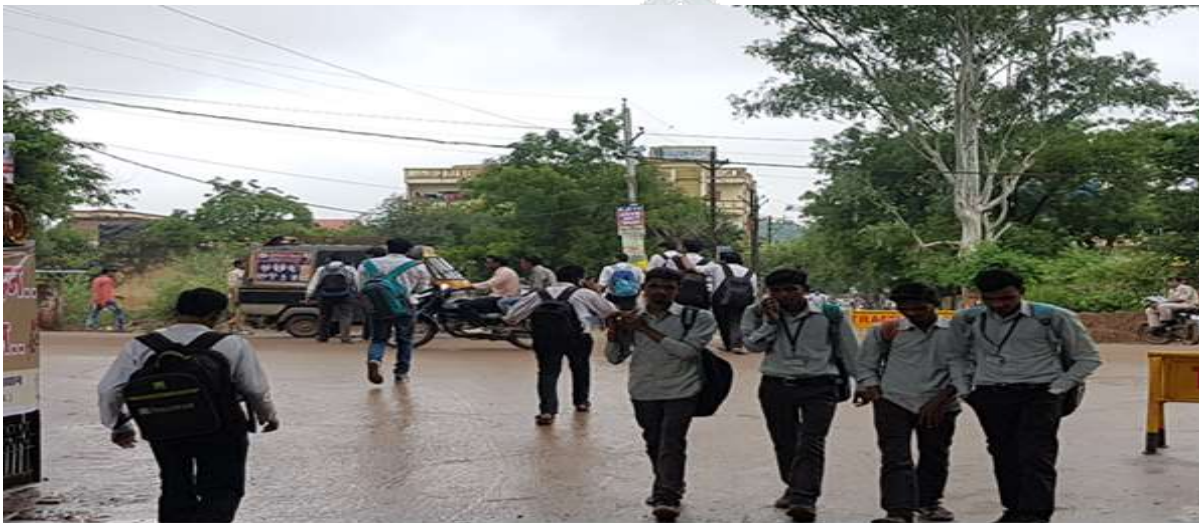
The characteristics for such study truly shows the requirement of side & cross walk, presence of road markings, signage requirement and safety assurance on intersection are measured during the field survey.

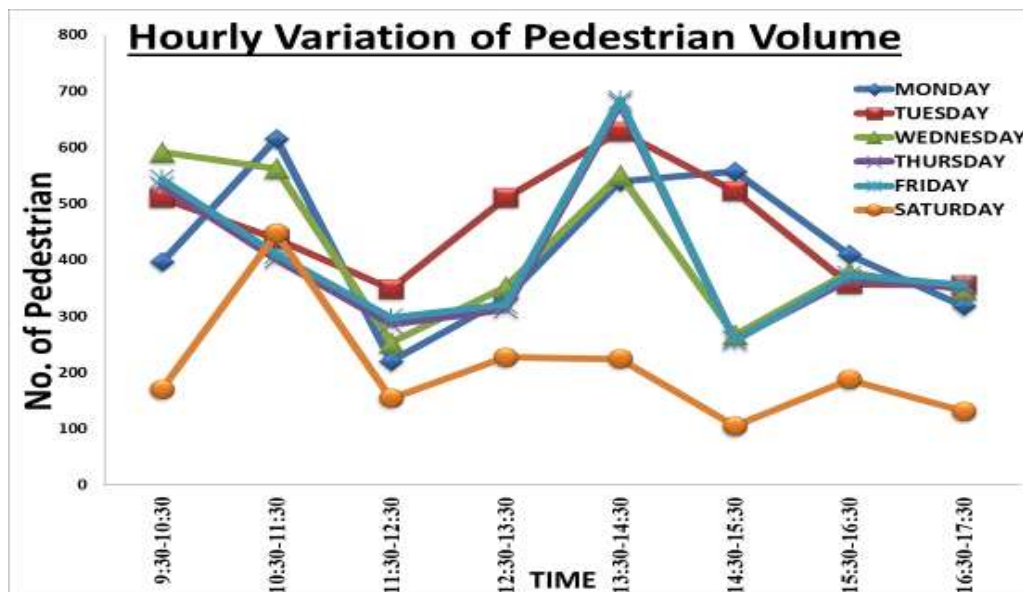
Graph 4.7: Daily Distribution Graph

During volume count, it is observed that **3667 and 1645 number of** pedestrians crosses the study area on Tuesday and Saturday respectively. It is evident that large number of pedestrian crosses the road on Tuesday compared to other days.
