# Analysis of Pedestrian Safety In Relation To Urban Road Situations

**Abstract::** Most pedestrian accidents in built-up areas occur at intersections. Even after signalized intersection, the number of accidents involving pedestrians often remains high. The area selected for this survey, is from Mehdiapatnam to Uppal of Hyderabad city, Telangana State. It is a straight long road with 30 km stretch with a heavy traffic. We followed the guidelines for pedestrian safety facilities of IRC: 103-2012. In a survey we have done with obstructions between footpaths, position of zebra crossings, pedestrian signals, condition of footpaths, kerbs, Pedestrian message signs, based on the requirements. Finding from these studies was that a crosswalk should be located less than two meters from the intersection to optimize pedestrian safety. The conclusions drawn from this study can use to improve the state of pedestrian safety in urban areas.

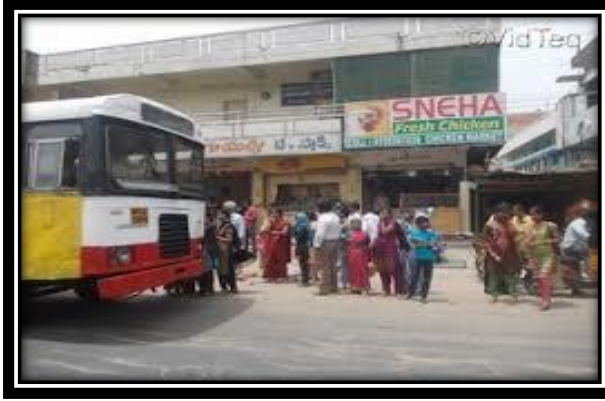
**Fig 3.2:** Pedestrians waiting for the bus on road

The above figures are from sight areas of Mehdiapatnam and Uppal. We found that there is no proper busstop for pedestrians, so they are waiting for the buses on the road and that is causing disturbance to the other vehicles.

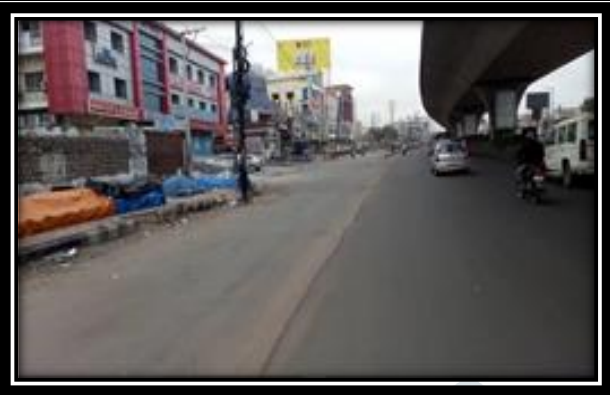
Footpaths are encroached by Fruits shops etc...	All types of shops should keep far away from the footpaths.
2

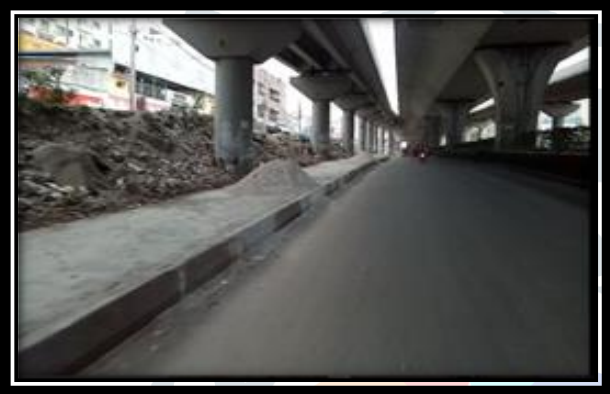
Dust and other construction materials were poured on the Footpaths, causing inconvenience to the pedestrians.	Footpath need to be clear without any obstacles.
3

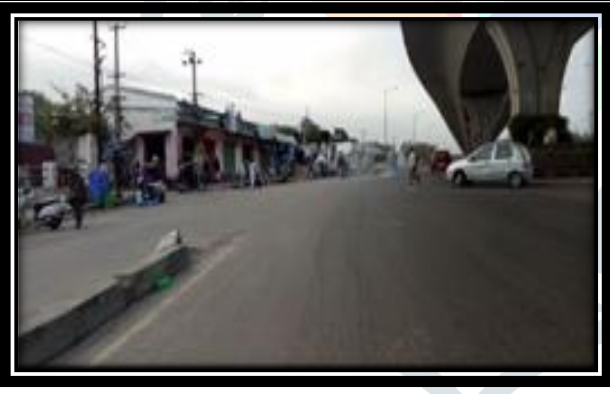
Along with Zebra crossing, signboards should also be present.	The cautions boards need to place their indicating pedestrian crossing.
4

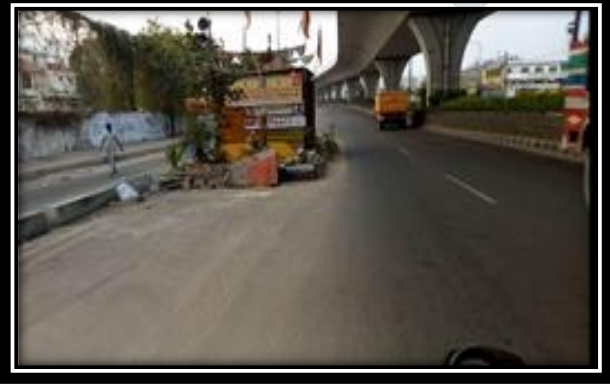
Religious construction in the middle of the road. This creates a blind spot to the vehicular and may cause the accidents to the pedestrians.	Speed reduction signboards need to place indicating the pedestrians flow.

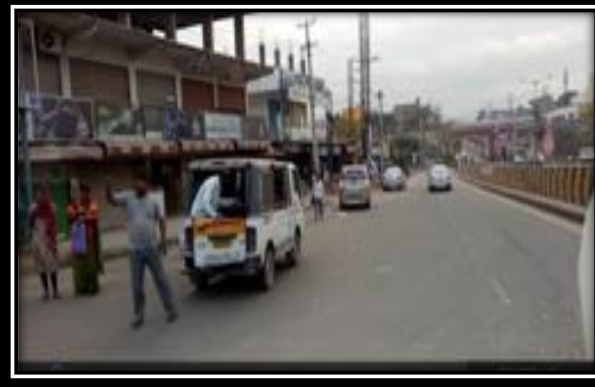
<p>However, there is a bus stop, but people are waiting on road for boarding the buses.</p>	<p>The awareness camps need to do to give clear idea about the purpose of bus stops.</p>
<p>6</p>

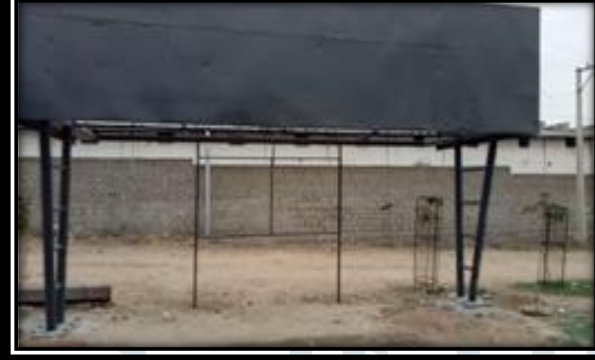
<p>There is no seating facility in bus stops. This makes people stand on the road causing obstruction to the road traffic.</p>	<p>Seating facility need to provide and well maintenance of the bus stop need to do.</p>
<p>7</p>

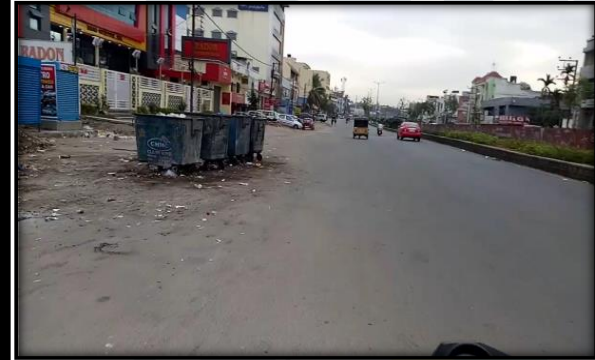
<p>GHMC dustbins are in between the pedestrian's walkways and on parking areas.</p>	<p>This causes a great hazard to the vehicular traffic and the pedestrians too.</p>
<p>8</p>

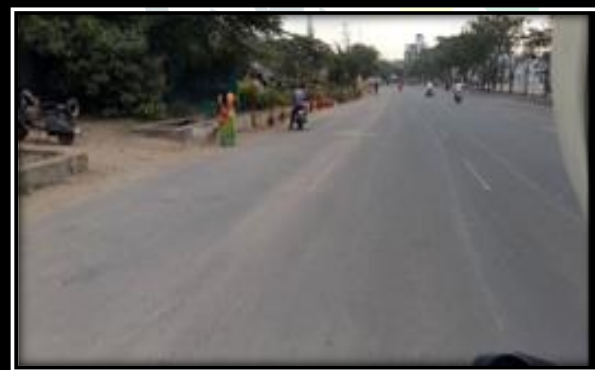
<p>Footpath is not clean and is occupied by nurseries.</p>	<p>All types of shops need to keep far away from the footpaths.</p>
<p>9</p>

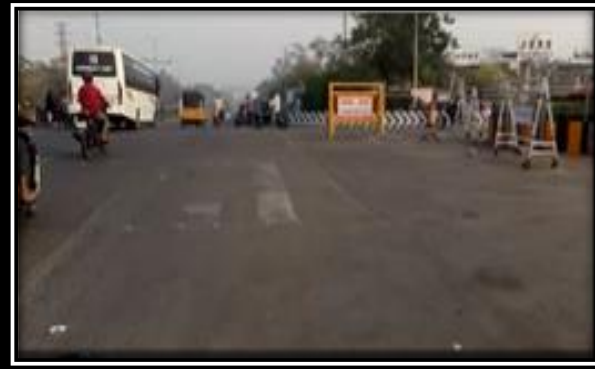
<p>Zebra crossing were faded.</p>	<p>The zebra crossings have to be definitely marked to give the pedestrians safety.</p>
