The Impact of Hazards on Traffic Safety

ABSTRACT: A Road Safety Audit (RSA) is a procedure for assessing accident potential and safety performance for a provision of new schemes and schemes for the improvement and maintenance of existing roads. The selected area is inner ring road of Hyderabad city, the road length is 33.6 Kilometres. The investigation done in the areas of Mehdiptnam, Uppal, Nagole, LB Nagar, Santhosh Nagar, Chandrangutta, Ahramghar, Attapur, Rethibowli places of Telangana State. Audit had conducted following the guidelines of as per IS codes IRC: SP: 88-2010, IRC: 67-2012, IRC: 35-1997. This paper explore the defects in the design and other safety features. Finally, we concluded with some changes in the geometric designs to reduce the accidents.

The stretch from Mehdiptnam to Uppal x road of inner ring road had been selected for the investigation.

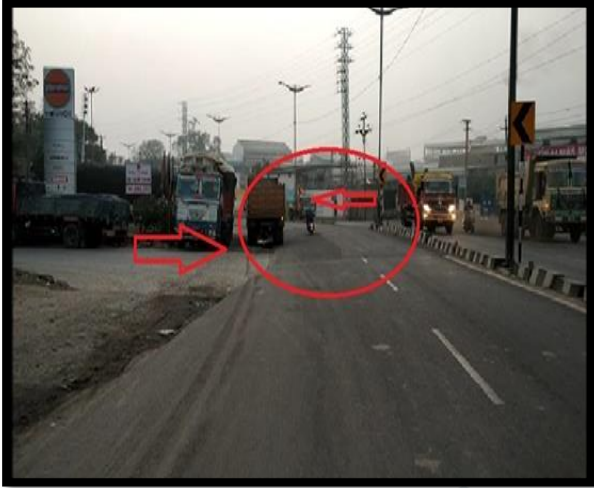
Element	Image	Problem	Recommendation
Horizontal and Vertical Curve details

<p>Design of horizontal curves were checked to ensure whether adequate super elevation, transition lengths have been provided for chosen radius of curve and for design speed.</p>	<p>At this Horizontal curve, the minimum sight distance is not there, drivers will face difficulty to control the speed of vehicle and accidents will occur at this U-turn.</p>
Crash Barrier locations.

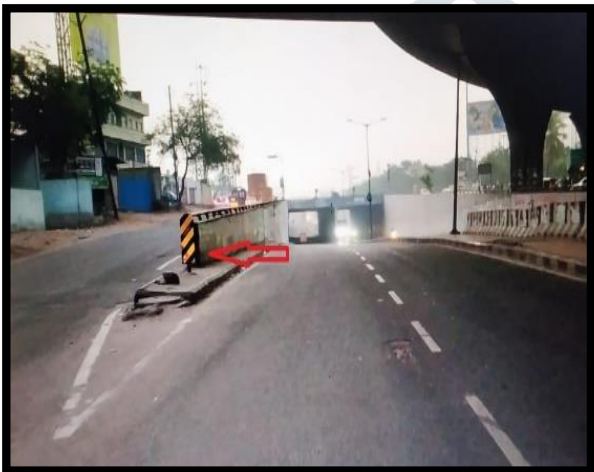
<p>Crash barrier is not properly connected with bridge concrete. In the approaches of structures, it should be extended up to the end of approach.</p>	<p>At this place crash barrier is good but maintenance is required.</p>
Major Junction Locations

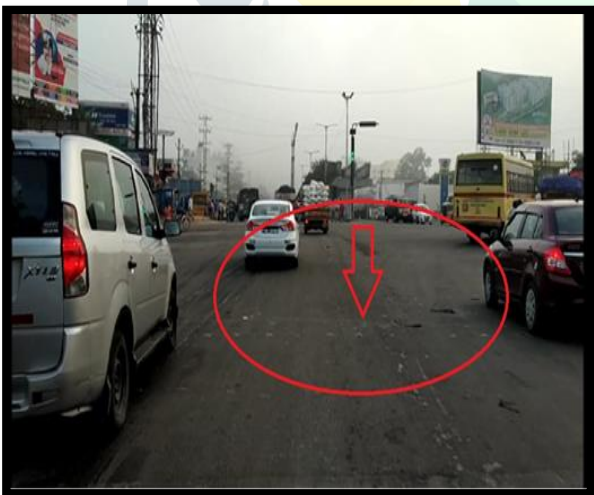
<p>At this Major junction carriageway markings as well as warning markings are not provided.</p>	<p>Installation of road studs has to be done in all junctions. Object / hazard markers are to be provided within the channelizing and divisional island facing traffic to warn the drivers in advance.</p>

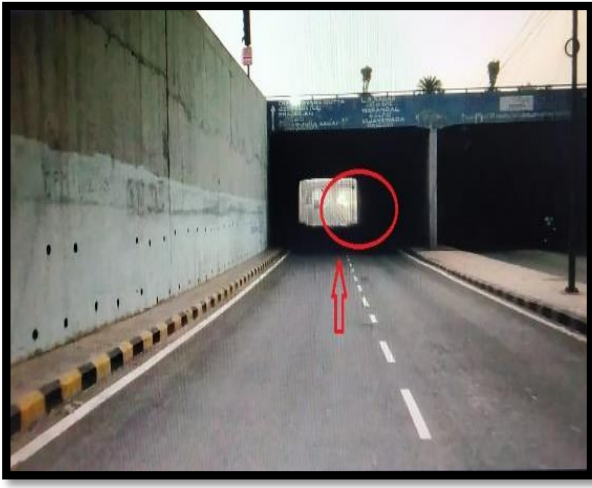
<p>Grade separator and Vehicular underpass Locations</p>

<p>At this place under pass crossing is 20 meters, but lightings is not provided.</p>	<p>Adequate vertical clearances have been provided. Geometrical improvement of at-grade road needs to be taken-up with proper channelizing islands for uninterrupted traffic movements.</p>
<p>Sign posts, Hazard markers and Road Studs</p>

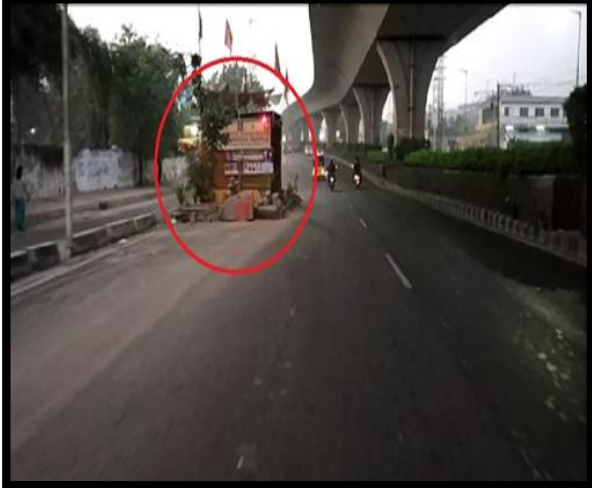
<p>Hazard sign board is not placed and reduce road width is also not mentioned.</p>	<p>Speed limit signboards and Hazard markers shall be provided for channelizing and divisional islands at all major junctions, median openings, before parapet of CD structures/bridges, before crash barrier, before vertical posts/columns of overhead gantry signboards resting on shoulders.</p>
<p>Lighting arrangement</p>

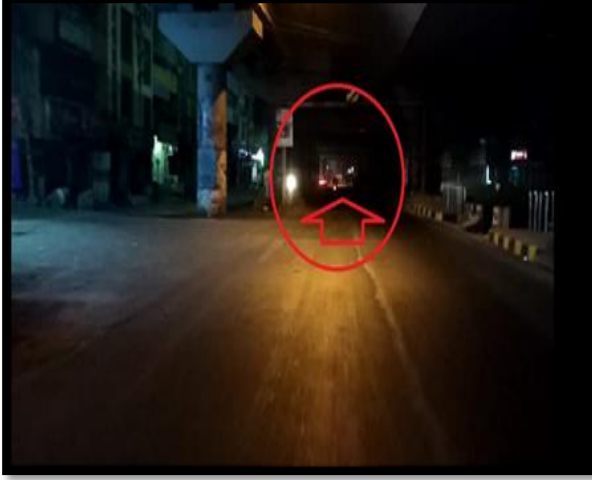
<p>Adequate lighting arrangement is in progress on flyovers and on at grade roads in town limits. High mast lighting has to be provided at some locations.</p>	<p>Illumination is required at this carriageway</p>

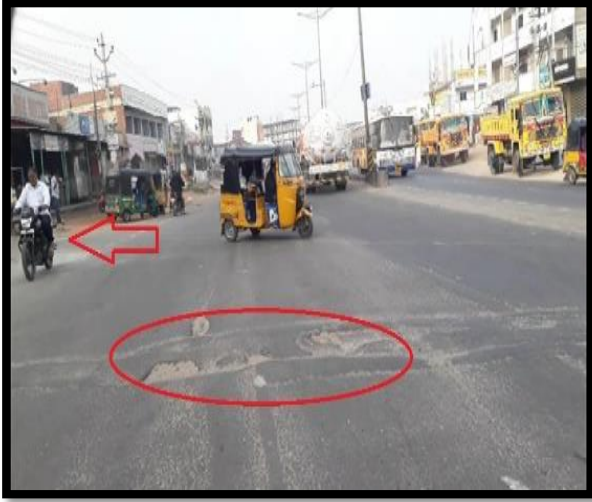
<p>Pedestrian Markings</p>

<p>No proper pedestrian markings and carriage way damage at this spot. This causes inconvenience to pedestrians and vehicular.</p>	<p>Conflicts exits between vehicular and pedestrians at the junctions. Proper Lane markings and pedestrian's markings need to be maintained.</p>

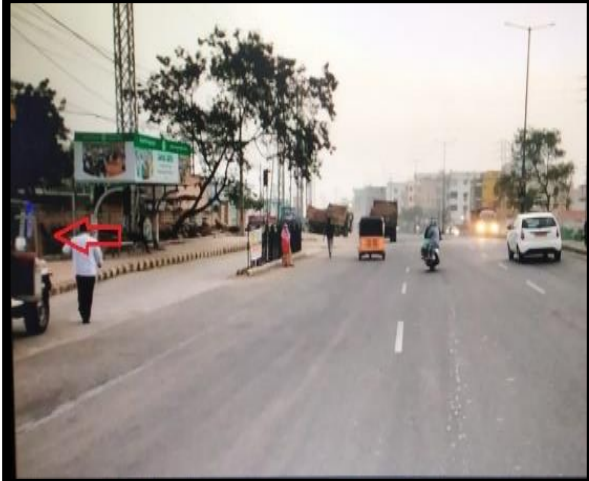
<p>Bus bay</p>

<p>Bus bay sign board in not provided, this creates confusion to the vehicular and users.</p>	<p>Informatory sign boards shall be installed ahead of the bus bay. Pavement marking needs to be carried out. Raised pedestrian footpath needs to be constructed for safety of passengers.</p>
<p>U-TURN</p>

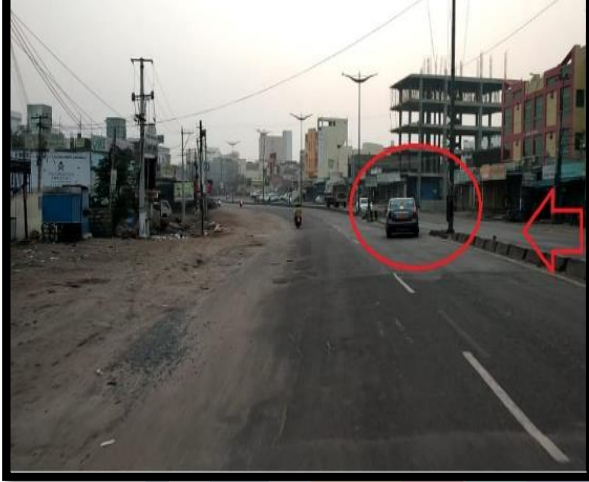
<p>At the place U-turn signboard is not provide, so vehicular cannot identify the U-Turn. Sometimes this causes the accidents if the fron vehicle takes a turn suddenly.</p>	<p>U- Turn sign board need to place</p>

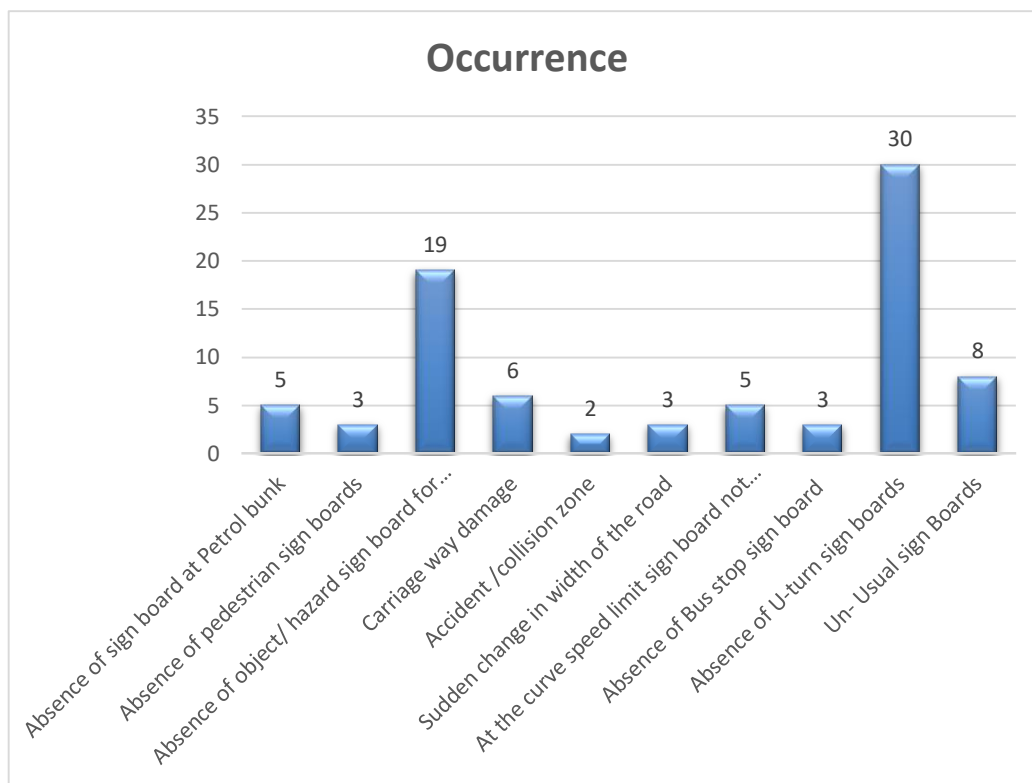
Graph 3.1: The variations of the Hazard types on the Carriageway.

Table 3.2: Hazard on the carriageway and its occurrence.

S.No	Issue	Occurrence
1	Absence of sign board at Petrol bunk	5
2	Absence of pedestrian sign boards	3
3	Absence of object/ hazard sign board for bridge	19
4	Carriage way damage	6
5	Accident /collision zone	2
6	Sudden change in width of the road	3
7	At the curve speed limit sign board not provided	5
8	Absence of Bus stop sign board	3
9	Absence of U-turn sign boards	30
10	Un- Usual sign Boards	8

From above study, work and analysis of collected data, expert reviews, Questionnaire survey, following conclusion can be made. U-turn signboard absence at the major junctions, improper Object sign boards, creates a confusion in the driver and leads to the accidents. Irregular longitudinal markings effects the driving behaviour and Vehicles moves in a Zig – Zag position. It found that Road Markings, Condition of Shoulder, Traffic Volume, Spot Speed, improper drainage arrangement were main parameters for causing accidents. Absence of road informatory signs, regulatory signs boards, and road markings adds into seriousness of the problem.
