RECONDITIONING OF ROLL NECK SLEEVES & BUSHES IN WIRE ROD MILL

The main objective of this project is to reduce the inventory cost by reconditioning of bushes in wire rod mill. In this research work, the damaged bushes are reconditioned by using metal coating (Two wire electric arc spraying) method.

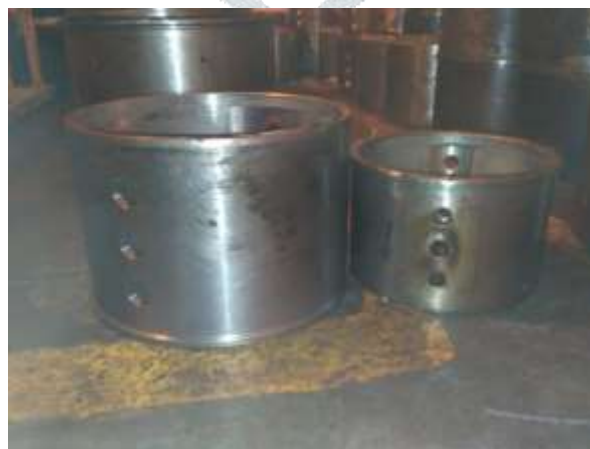
Figure 1.1 : Bush

The bush is a stationary element in the bearing assembly. It is designed in the form of a babbitt-metal lined steel shell. The babbitt metal is a one type of soft metal used in bush is to perform operations with most effective. Reasonably long eye bolts are screwed into the tapped holes provided in the flange faces of the bushing. Bending and deformation of the eye bolts are counteracted by means of a "spreader" or "separator" type element provided with V-notches on either side being located between the two bolts. After the bushing has been properly cleaned and provided with an oil film, it is slowly lowered into the roll chock bore without any under forces being applied. The structure of the bush is same at both drive side and operation side.

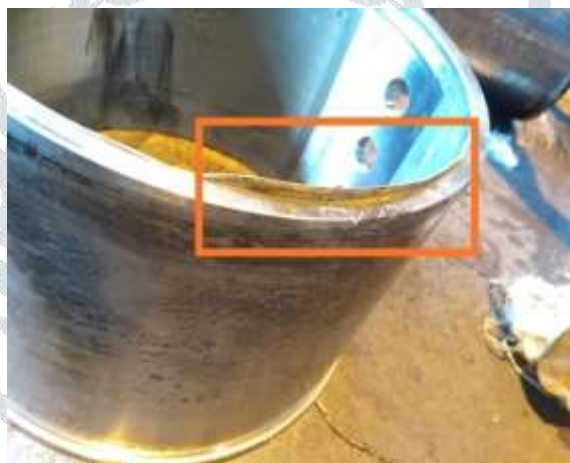
Figure 3.1 : wear out of the babbitt material

- Babbit metal wear out is a major problem of bearing assembly in wire rod mill. While performing the operations the sleeve is continuously rotating in the bush through motor shaft in the mill. The lubricant is supplied in between the sleeve and bush in the bearing assembly while rotating.
- If there is any problem occurs in the supply of lubrication in between the sleeve and bush while rotating, it causes more friction in between the sleeve and bush. Later on the babbitt layer which is coated on inside of the bush is wear out because the babbitt metal is a soften metal. Sometimes the load conditions are also effects the failures of the bush in the mill.

- First clean the bush and degrease the area which is to be coated.
- Check the dimensions of the bush which is to be repaired.
- Undercut the damaged the area by blasting with angular steel grit to a maximum depth (0.2 to 0.5), after masking the sides which are not to be coated.
- The blasting ensures that roughen the surface and provides good bonding for the coating.
- Preheat the part about 600C by using blower.

- Arrange the bush on lathe and apply a bond coat of nickel aluminide as a base metal while bush is rotating on lathe.

- The babbitt wires are arranged at a hole in the center of the tip on torch.
- The molten babbitt material is blown with compressed air force, which causes the interlocking with surface irregularities.
- During spraying, the temperature would not exceed 900C. If necessary, interrupt the spraying and keep the part to cool down up to 600C and repeat the process until we get the required thickness.
- Measure the dimensions of the bush while performing the operations and we maintain over thickness of 0.5 to 1 mm for machining operations on it.
- By spraying metal on the parent metal there is an increase in porosity, compressive strength and hardness.
- After completion of the process, remove the bush from lathe and measure the dimensions.

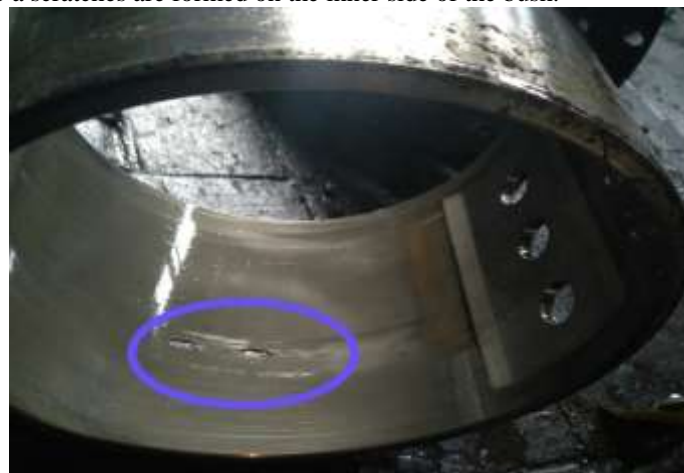
Figure 3.2: Scratches on inner side of the bush

The scratches are formed on inner side of the bush while performing the operations. The sleeve neck is wear out while friction takes place in between the sleeve and lock nut. The sleeve neck metal is wear out in the form of small discontinuous chips. These chips are entered into the inner side of the bush through the lubricants. If the chips are enter into the inside of the bush, the inner side of the bush is a soft metal so a scratches are formed on the inner side of the bush.

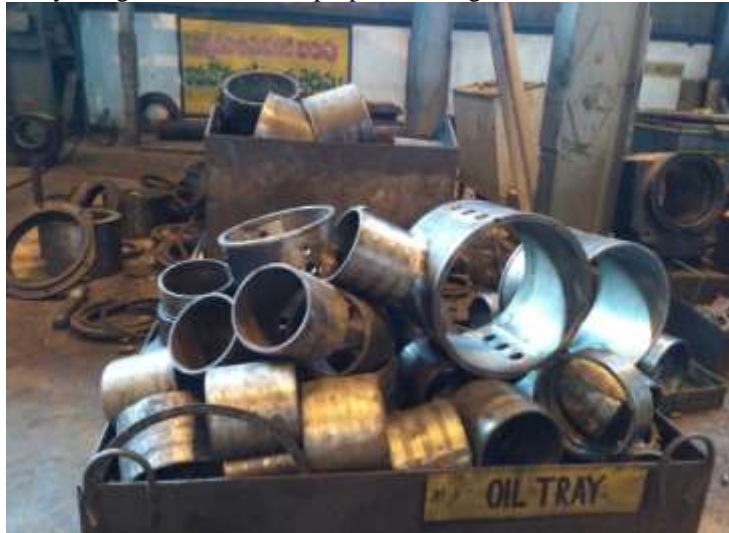
Figure 3.3 : Bushes at scrap area

While assembly, the bush is inserted in a chock bore by worker. If the bush is not positioned exactly in the chock bore ,the worker is hammering on it. This causes the damage of the babbit layer. Do not rotate the bush inside the chock bore. Before assembly the parts should cleaned by using oil and maintain proper handling to reduce the failures of the parts.

In my observation nearly 35 to 40 damaged bushes are kept aside for send to the scrap area. So I’m concentrating on reconditioning of damaged bushes to reduce the inventory cost for the mill.

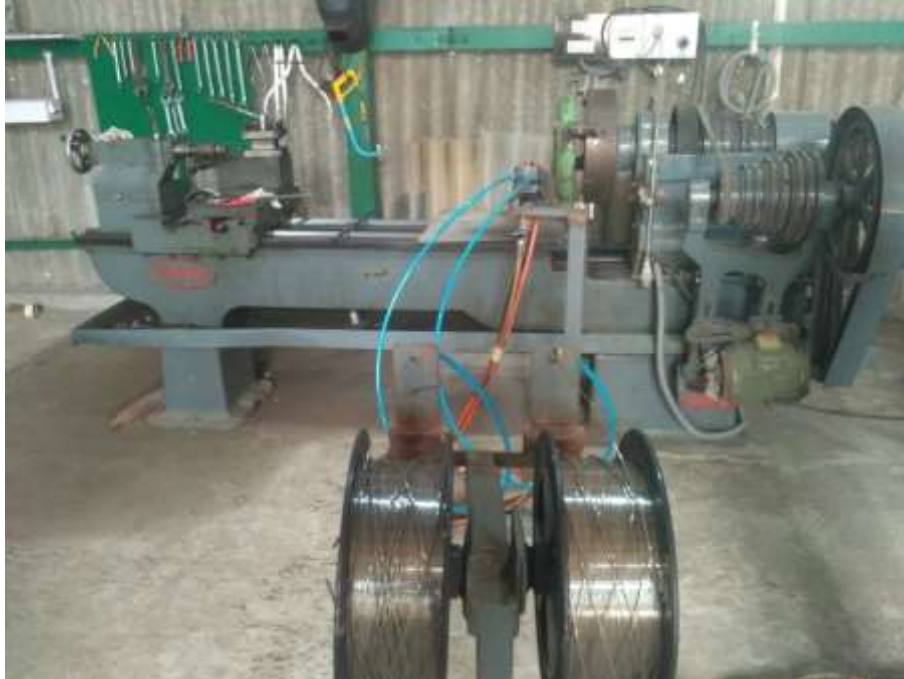
Figure 6.1 : Layout of Two wire electric arc spraying

The Two-wire electric arc spraying method utilizes an arc point which is created between two wires which are electrically conductive. Melting will occur at the point where the wire are connect. The arc allows for heating the wires and creates deposition on the parent metal by the use of torch. A compressed air is used for spraying the coatings. This method is popular due to its cost effectiveness. The base material used for this process is either zinc or aluminum.
