## RECONDITIONING OF BUSHES IN WIRE ROD MILL

The main objective of this project is to reduce the inventory cost by reconditioning of bushes in wire rod mill. In this research work, the damaged bushes are reconditioned by using metal coating (Two wire electric arc spraying )method.

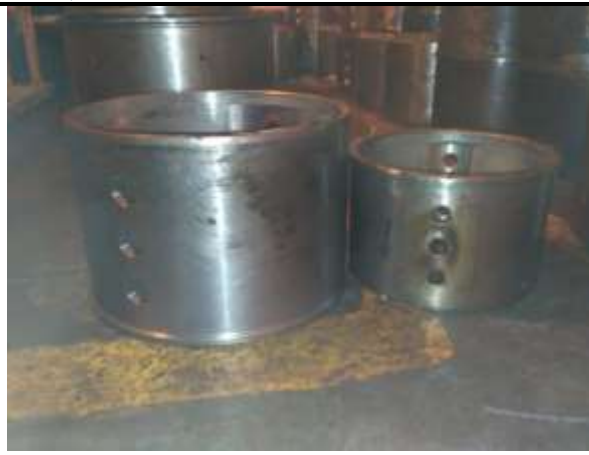
Figure 1.1 : Bush

The bush is a stationary element in the bearing assembly. It is designed in the form of a babbitt–metal lined steel shell. The babbitt metal is a one type of soft metal used in bush is to perform operations with most effective. Reasonably long eye bolts are screwed into the tapped holes provided in the flange faces of the bushing. Bending and deformation of the eye bolts are counteracted by means of a “spreader” or “separator “ type element provided with V-notches on either side being located between the two bolts. After the bushing has been properly cleaned and provided with an oil film, it is slowly lowered into the roll chock bore without any under forces being applied. The structure of the bush is same at both drive side and operation side.

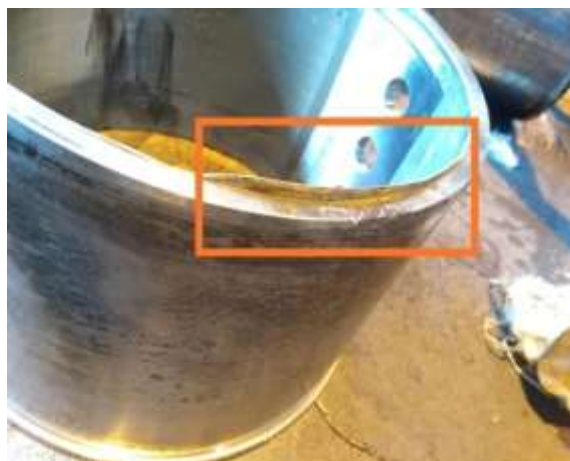
- Babbit metal wear out is a major problem of bearing assembly in wire rod mill. While performing the operations the sleeve is continuously rotating in the bush through motor shaft in the mill. The lubricant is supplied in between the sleeve and bush in the bearing assembly while rotating.
- If there is any problem occurs in the supply of lubrication in between the sleeve and bush while rotating, it causes more friction in between the sleeve and bush. Later on the babbitt layer which is coated on inside of the bush is wear out because the babbitt metal is a soften metal. Sometimes the load conditions are also effects the failures of the bush in the mill.

Figure 3.1 : wear out of the babbitt material

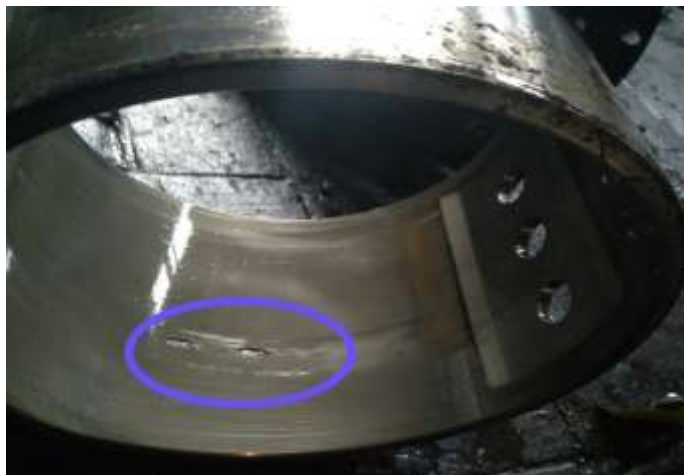
The scratches are formed on inner side of the bush while performing the operations. The sleeve neck is wear out while friction takes place in between the sleeve and lock nut. The sleeve neck metal is wear out in the form of small discontinuous chips. These chips are entered into the inner side of the bush through the lubricants. If the chips are enter into the inside of the bush, the inner side of the bush is a soft metal so a scratches are formed on the inner side of the bush.

**Figure 3.2:** Scratches on inner side of the bush

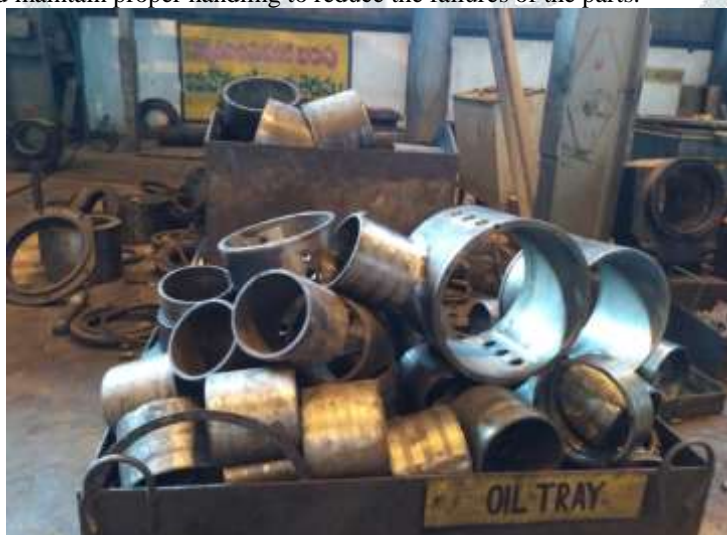
While assembly, the bush is inserted in a chock bore by worker. If the bush is not positioned exactly in the chock bore ,the worker is hammering on it. This causes the damage of the babbitt layer. Do not rotate the bush inside the chock bore. Before assembly the parts should cleaned by using oil and maintain proper handling to reduce the failures of the parts.

**Figure 3.3 :** Bushes at scrap area

In my observation nearly 35 to 40 damaged bushes are kept aside for send to the scrap area. So I’ m concentrating on reconditioning of damaged bushes to reduce the inventory cost for the mill.

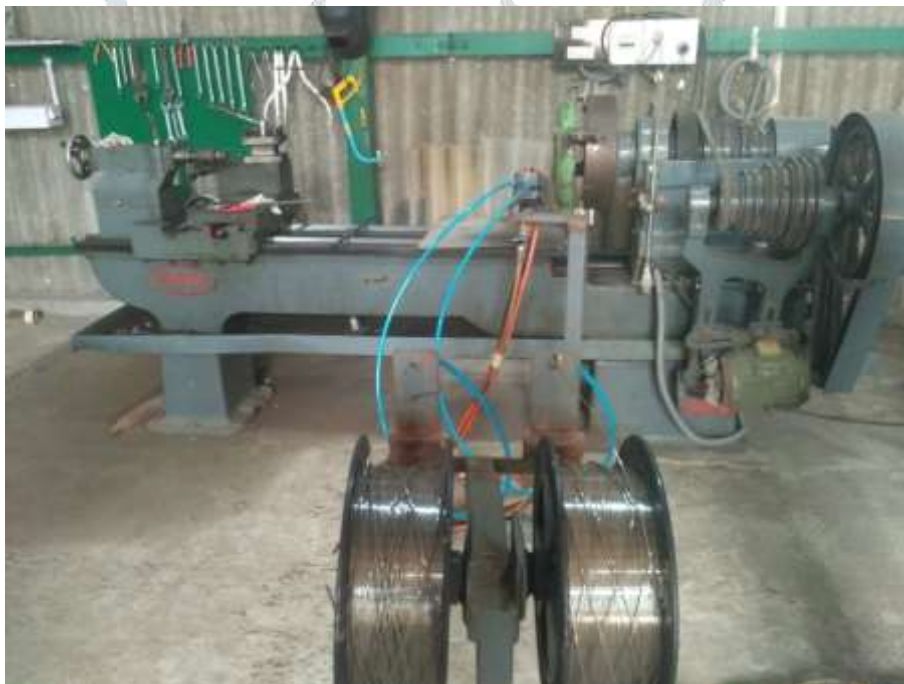
The Two-wire electric arc spraying method utilizes an arc point which is created between two wires which are electrically conductive. Melting will occur at the point where the wire are connect. The arc allows for heating the wires and creates deposition on the parent metal by the use of torch. A compressed air is used for spraying the coatings. This method is popular due to its cost effectiveness. The base material used for this process is either zinc or aluminum.

**Figure 6.1 :** Layout of Two wire electric arc spraying

- First clean the bush and degrease the area which is to be coated.
- Check the dimensions of the bush which is to be repaired.
- Undercut the damaged the area by blasting with angular steel grit to a maximum depth (0.2 to 0.5), after masking the sides which are not to be coated.
- The blasting ensures that roughen the surface and provides good bonding for the coating.
- Preheat the part about 600C by using blower.
- Arrange the bush on lathe and apply a bond coat of nickel aluminide as a base metal while bush is rotating on lathe.

- The babbitt wires are arranged at a hole in the center of the tip on torch.
- The molten babbitt material is blown with compressed air force , which causes the interlocking with surface irregularities.
- During spraying, the temperature would not exceed 900C. If necessary, interrupt the spraying and keep the part to cool down up to 600C and repeat the process until we get the required thickness.
- Measure the dimensions of the bush while performing the operations and we maintain over thickness of 0.5 to 1 mm for machining operations on it.
- By spraying metal on the parent metal there is an increase in porosity, compressive strength and hardness.
- After completion of the process, remove the bush from lathe and measure the dimensions.

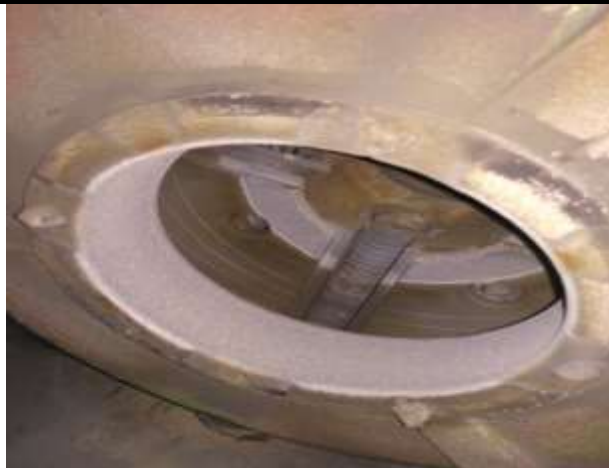
**Figure 6.2 :** Material coated bush on lathe

- The excessive thickness of the bush is removed by using grinding operation on it, until we get the required size and good surface finish.
