A CASE STUDY ON EFFECTS OF UNMAINTAINED IRRIGATION CANAL LOCATED NEAR MAURAIYA VILLAGE, AHMEDABAD

Keywords - Canal Water Pollution, Irrigation Water, Village Sewage systems.

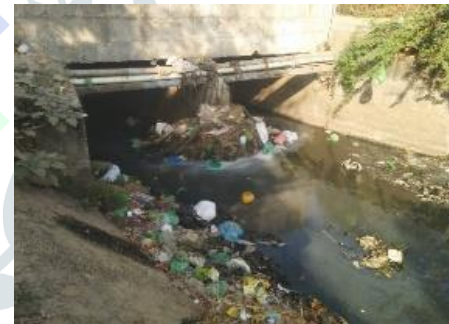
Figure 3 R.C.C Culvert condition from

6. The bridge centre pier is blocked a consolidated garbage received from running water and over the bridge people activities, of volume 2 M3 approximately

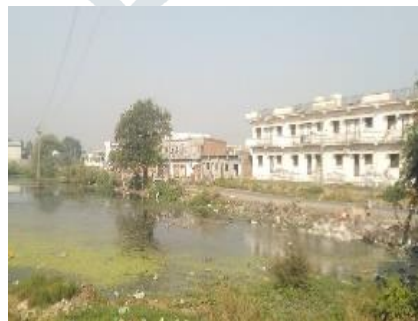
Figure 4 Colonies situated near sides of canal

9. Other side of canal have thick unbalance tree plantation to obstruct the view of canal, where in some area it is covered by PCC for the household movement and to utilize the space for the colony settled near bank of canal.
