“A Comprehensive Investigation of Cracks on the Ground Floor of Kendriya Vihar 2”

4.2 CAUSES OF CRACKS IN KENDRIYA VIHAR - 2

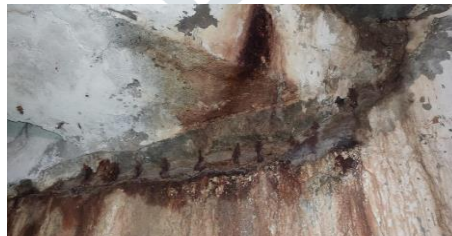
“Figure 3 Cracking due to Moisture”

4.2.3 Moisture Changes: Moisture-related issues are a common cause of cracks. When materials absorb water, they can undergo expansion, and when they dry out, they may contract. These repeated cycles of expansion and contraction can result in cracking, particularly in materials like clay, soil, or concrete.

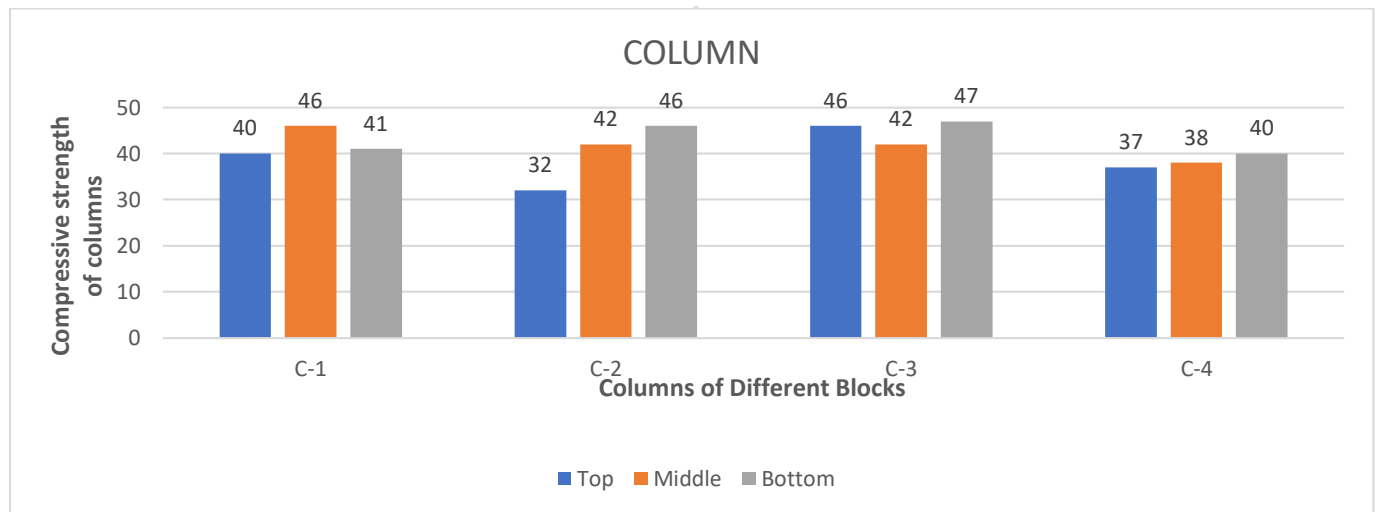
Graph 1: Point of Test on Columns v/s Compressive Strength of Columns

The investigation discovered differences in rebound values between cracked and non-cracked sections. Lower rebound values were reported in cracked locations, indicating that the concrete compressive strength was lowered.

S. No.	Rebound No.			Comp. Strength			Description
	Top	Mid.	Bott.	Top	Mid.	Bott.	
C-1	42	45	40	40	46	41	Lower column section's strength is weaker, but still in good shape.
C-2	35	43	45	32	42	46	Column's upper part is in good condition, slightly weaker than rest.
C-3	45	43	46	46	42	47	Columns in this block are in good condition.
C-4	38	39	42	37	38	40	Columns in this block are in good condition.

The Rebound Hammer and UPV tests reveal cracks and potential structural deficiencies in high-rise buildings. Lower rebound values indicate reduced concrete hardness, while increased travel time and reduced wave velocity indicate changes in density and homogeneity. These findings emphasize the need for identifying and addressing cracks to ensure structural integrity and long-term performance. Further investigation, such as visual inspections and additional testing methods, may be necessary to accurately assess the extent and implications of identified cracks.

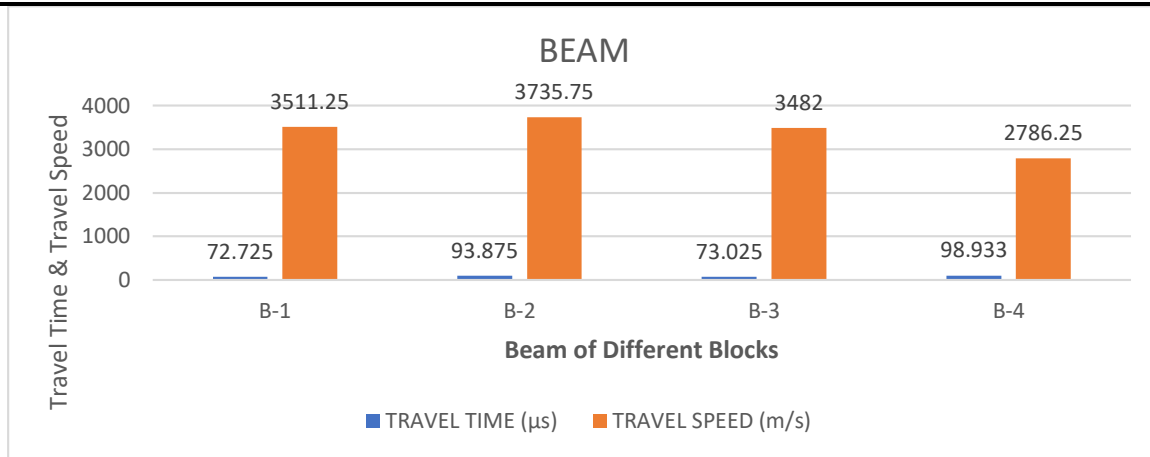
Graph 2: Point of test on Beam v/s Travel Time or Travel Speed of Ultrasonic Pulse for Beam.

UPV test results reveal cracks in cracked areas, causing increased travel time and reduced wave velocity, indicating disruption of ultrasonic wave transmission and changes in concrete density and homogeneity.

S. NO.	TRAVEL TIME (μ s)	TRAVEL SPEED (m/s)	DESCRIPTION
B-1	72.725	3511.25	The velocity is below 3750 m/s so the concrete quality is doubtful.
B-2	93.875	3735.75	The velocity is below 3750 m/s so the concrete quality is doubtful.
B-3	73.025	3482	The velocity is below 3750 m/s so the concrete quality is doubtful.
B-4	98.93333	2786.25	The velocity is below 3000 m/s so the concrete quality is poor.
