# ENHANCING THE STRUCTURAL PERFORMANCE OF RC CONTINUOUS BEAMS USING GLASS FIBRE REINFORCED POLYMER (GFRP) STRENGTHENING TECHNIQUES

Nagesh Singh Baghel<sup>1</sup>, Mr. Akhand Pratap Singh<sup>2</sup>,  
M.Tech Scholar<sup>1</sup>, Assistant Professor<sup>2</sup>,

Shri Rawatpura Sarkar University Raipur Chhattisgarh

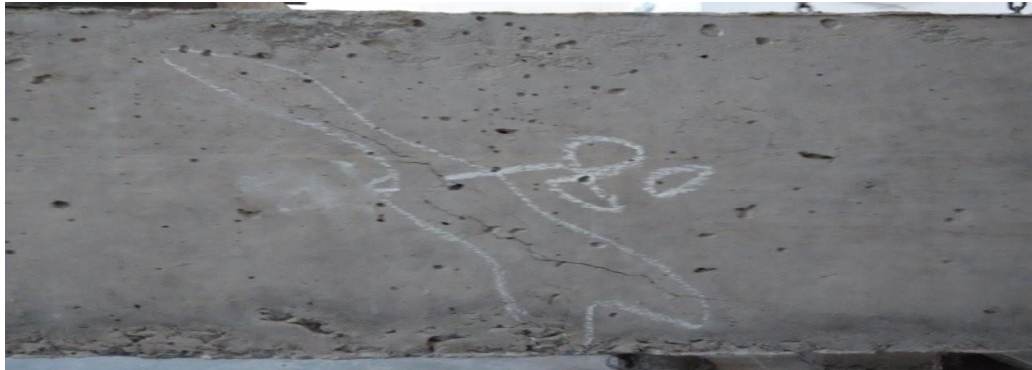
*Fig 3.3 First Crack On the Beam*

The control beam, CB1, failed in the RC shear failure mode. The wide diagonal shear cracks were observed. The cracks were well extended from mid support to the left centre span. The first crack of CB1 was obtained at 80KN load and the ultimate failure of the beam occurred at 240KN load.
