# STABILITY ANALYSIS OF ROCK SLOPE AT ADOSHI AND KHANDALA

**ABSTRACT** -The Mumbai-Pune Expressway (Maharashtra), officially known as the 'Yashwantrao Chavan Mumbai Pune Expressway' is India's first six-lane concrete, high-speed, access controlled tolled expressway. It spans a distance of 94.5 km. The expressway starts at Kalamboli (near Panvel), and ends at Dehu Rd. (near Pune). It cleaves through the scenic Sahyadri mountain ranges through passes and tunnels. The expressway handles about 43,000 (passenger carrying units) PCUs daily and is designed to handle up to 1,000,000 PCUs. The expressway experienced problems with rock fall. The present study aims to carry out Stability analysis of rock slope at Adoshi and Khandala including suggesting the remedial measures required if any. A reconnaissance inventory carried out by the Central Road Research Institute, New Delhi, India revealed that about 90% of the slope failures. The Rock fall and debris flow are the predominant problems at Adoshi and Khandala location. The size of the rock blocks varies from a few centimeters to a meter and some time even larger in diameter. The hill slope geometry at this location is such that rock block

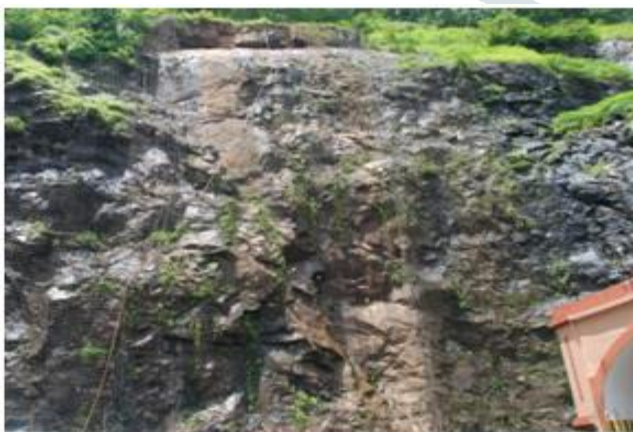
(a) View of Adoshi Hill after the distress

The slopes on left side of Adoshi and Khandala before entering into it are vertical rock. The first case of rock and debris fall at this location reportedly occurred in the year 2003-2004, during monsoon. Since the rock blocks are intermittently falling from the face, as well as from top of the slope. The size of the block varies from a few centimeters to a meter and sometimes even more in diameter. The incidences of the rock fall are frequent during rainy season. The impact of the falling as noticed is very high. There are reported instances of boulders not only damaging the side drains but also middle of the expressway. The hill slope condition at this location is such that the rock block falls directly on expressway because there is no space between the expressway and the cut slope, and therefore resulting in no reduction in the momentum of the detached rock before actually hitting the expressway. The sliding material itself blocks a part of the expressway, thereby causing inconvenience to the traffic. The direct fall makes the impact more dangerous and is most of the times fatal when rock block hit running vehicle resulting to the loss of life which cannot be valued.

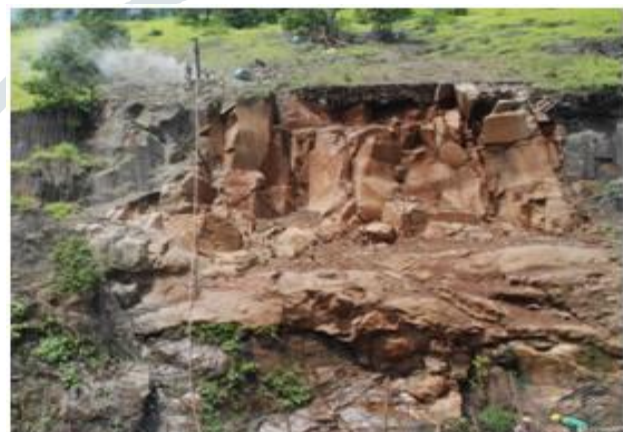
(b) View of Khandala Hill after the distress

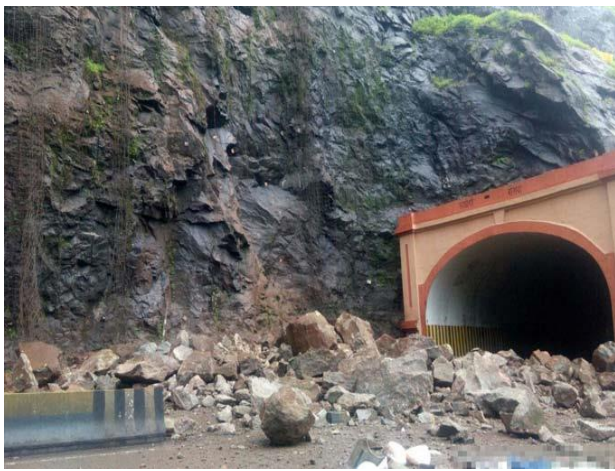
(c) Rock fall at Adoshi Tunnel

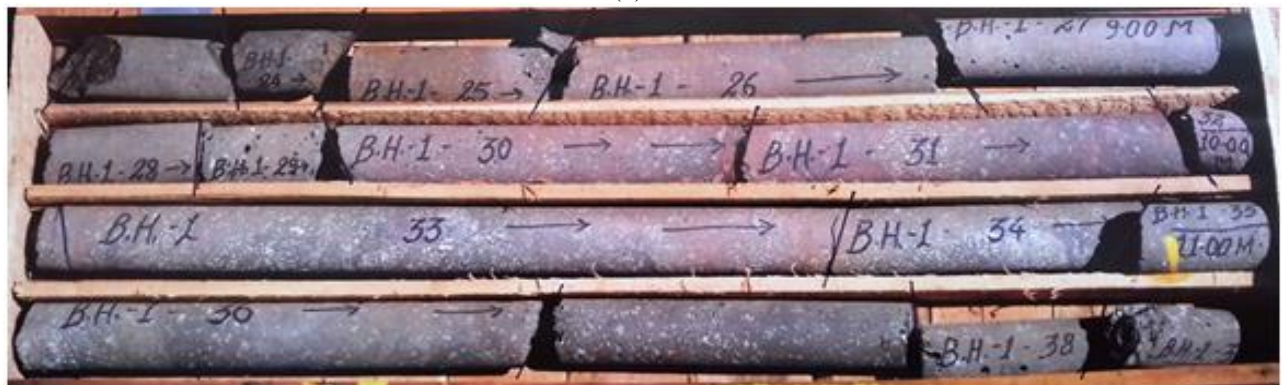
(b) Sample Bore Log for depth 8.0 to 12.0 m

Fig 2. Sample Bore logs BH1

Bore log data revealed that the topmost layer constituted of Murrum followed with highly weathered and highly fractured amygdaloidal basalt with recovery in form of rock fragments and nil RQD (core pieces length > 10cm). This layer ranged between ground and 4m to 7m depth. Middle layer showed moderate recovery in form of core pieces with moderate RQD of 35 % to 70 % .This layer ranged between 5m to 11m depth and constituted fairly jointed amygdaloidal basalt. Bottom layer post 10m to 11m depth was found to be the strongest with above 90 % recovery and similar percentage of RQD.

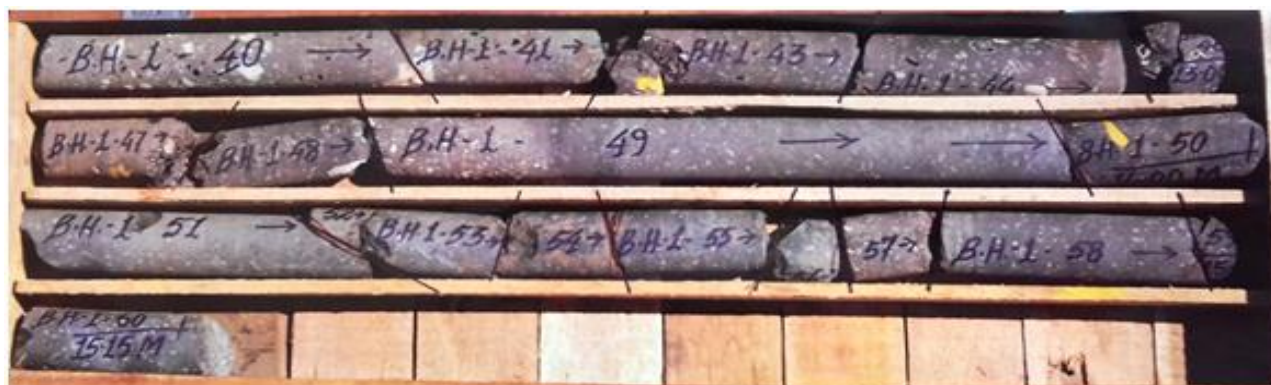
(C) Sample Bore Log for depth 12.0 to 15.15 m

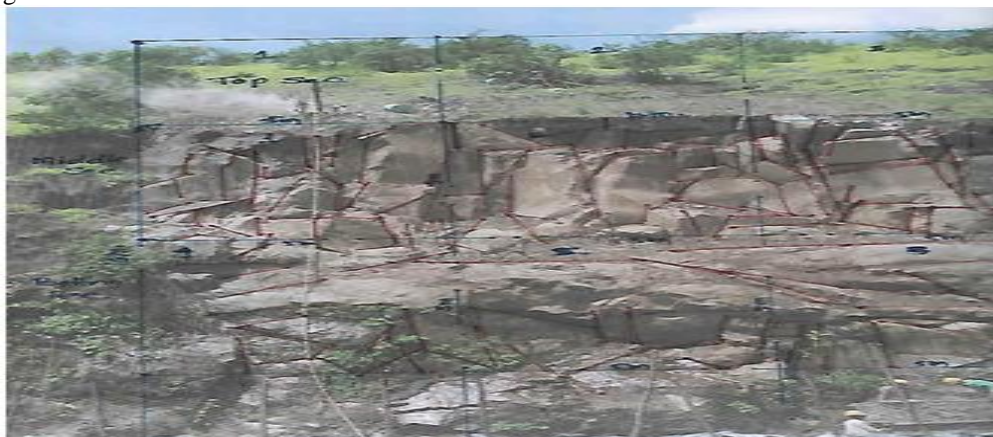
**Fig 3.** Khandala rock cut for mapping and for joint measurement

Photographs for Khandala and Adoshi section of vertical rock cut with previous history of rock slide were clicked for mapping & analysis. The length and height of rock cut was physically measured. The photos were mapped with 5m × 5m grid

- Length : 405m
- Height : 15m to 22m
- Number of Mapping sections (5m × 5m grid) : 243

For statistical analysis purpose 5m × 5m grid sections were further segregated in three layers top, middle and bottom.
