Condition Assessment of Old Residential Police Quarters

Abstract:-Now a days testing and quality checkup are important at several stages during life of a structure for property maintenance of the civil infrastructure. Existing structure is situated at Nagpur city which was constructed at 1978. It has multistory (G+3) RCC framed structure which is used for accommodation to the police constable of hereby area. As per detailed methodology Ultrasonic pulse velocity test was adopted for analyzing homogeneity of concrete, presence of cracks, voids and other imperfections. Rebound

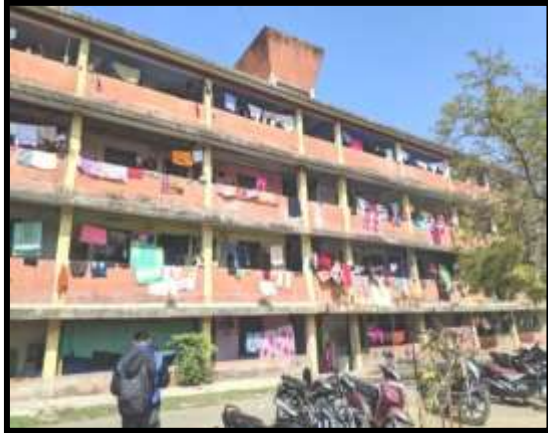
Fig.1 Existing Building

constructed at 1978. It has multistory (G+3) RCC framed structure which is used for accommodation to the police constable of hereby area [3]. As a part of maintenance they have done tenable repair of existing structure. The main objective of the paper to adopt Ultrasonic Pulse Velocity Test, Rebound Hammer Test, Cover Meter Test, Chemical Test, Analyzing depth of the carbonation, Half Cell potentiometer including Visual [1] observation to analyse the distress in building such as RCC structure damages, Cracks, Spalling, Seepage, Vegetation, Settlement, Atmospheric reactions.

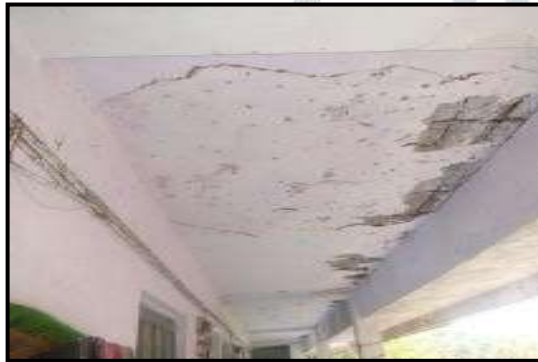
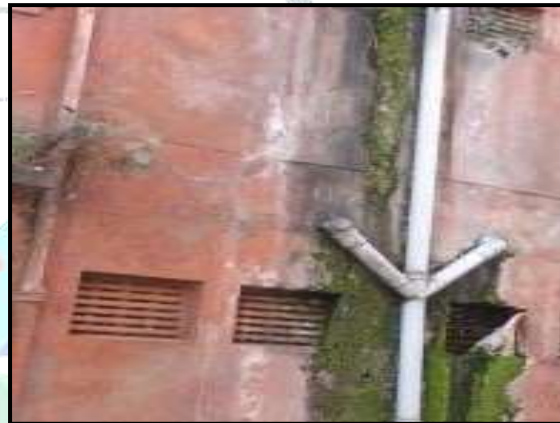
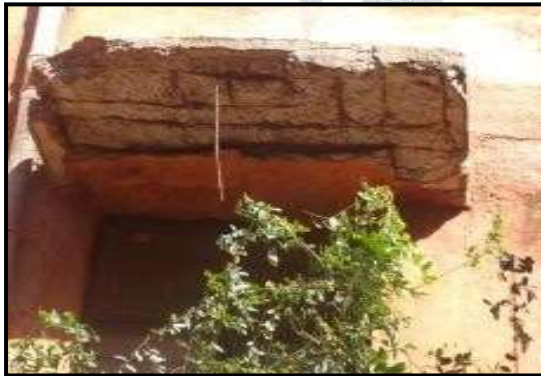
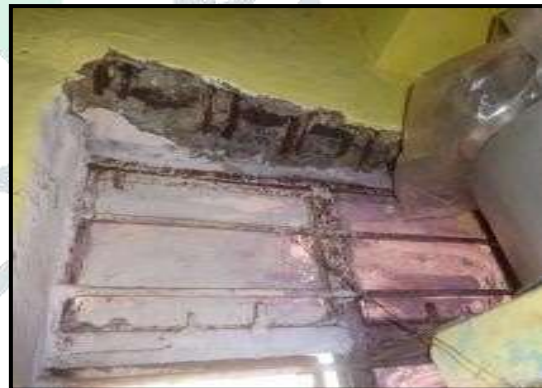
Fig.2 Visual Inspection

In Visual observation, we have check all the building thoroughly from inside and outside area to calculate the causes of the deterioration and distress of existing structure. Such as RCC structural damages, cracks, spalling, seepages, vegetation, settlement, atmospheric reactions etc. Describe in Fig. 3[5]

1. Improper material substandard used while construction.
2. Building has done tenable repairs without analyzing the behavior of structure.
3. High corrosion in column , beam and slab at maximum locations.

4. High seepage observed at kitchen , toilet and bathroom walls.
5. High vegetation at the back side of building.
6. The building has many construction deficiencies.
7. Slab leakage (Terrace).

- 1) Terrace-Acrylic polymer modified cement based waterproofing with fiber glass mesh.
- 2) External Plaster- a. Patches repair with modified cement plaster.
b. Provide rough cast cement plaster in two coats 12mm to 15mm thick with base coat
- 3) Structural Repairs-
a. Column -125mm thick M25 conventional and 60mm thick Mirco-Concrete to the column. After grouting both cement based and epoxy based.[5]
b. Beam-Anti corrosion treatment, epoxy based grouting , modified polymer plaster, repair.
c. Slab-Anti corrosive treatment , patch repair with modified polymer plaster.
d. Plumbing-New plumbing installation recommended.
e. Chajja -repair with micro-concrete or polymer modified plaster or recasted as per requirement.
f. Bathroom and Toilet-Brick bat coba waterproofing grouting, waterproof bedding 25mm thick

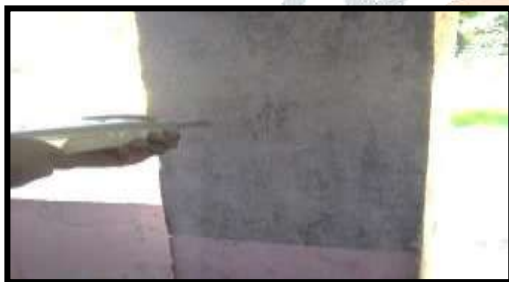
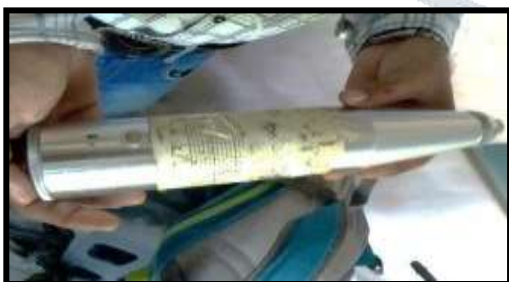
Fig. 3
Rebound Hammer

The rebound hammer In Fig.3 is one of the most popular non-destructive testing methods used to investigate concrete. It is conducted around all the points of observation on all accessible faces of structural element. Concrete surface are thoroughly cleans before taking any measurement. Around each point of observation, six reading of rebound indices are taken and average of these after deleting outliers as per IS 8900:19798 becomes the rebound index for the point of observation. The rebound numbers are influenced by a number of factors like type of cement and aggregate, surface condition and moisture content, age of concrete and extent of carbonation of concrete.

B. Rebound Hammer Test reading before strengthening at maximum location it is indicate that the Compressive Strength are found between M10 to M15 (Refer to IS 13311(Part II):1992). So it is observed that some columns are weak on the basis of obtained compressive strength with the help of Rebound Hammer Test

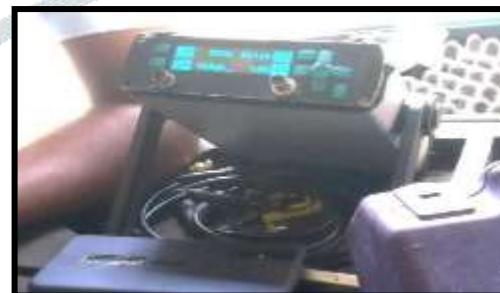
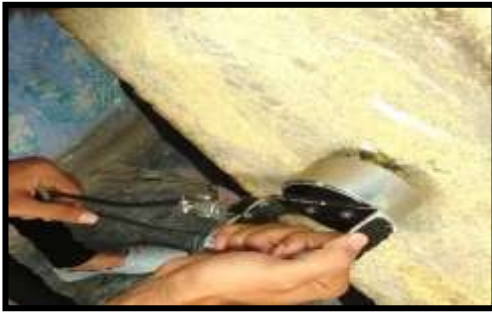
Fig. 4
Ultrasonic Pulse Velocity Test

The ultrasonic pulse velocity method is used for non-destructive testing of plain reinforced and pre-stressed concrete whether it is precast or cast in-situ. Object: The main object of ultrasonic pulse velocity method are to established

A. Ultrasonic Pulse Velocity Test reading before strengthening are founds in between 2.275 km/sec to 3.13 km/sec for Column, (Refer to IS 13311(Part I):1992). So it is observed that Micro Cracks and Major Honeycombing is found in some columns so it is necessary to do strengthening.

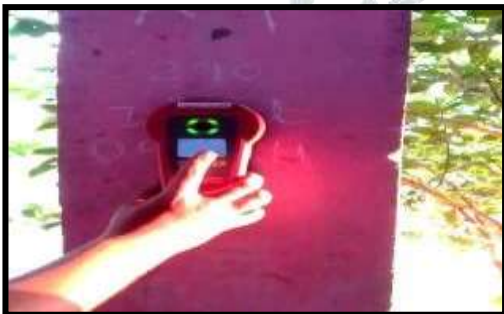
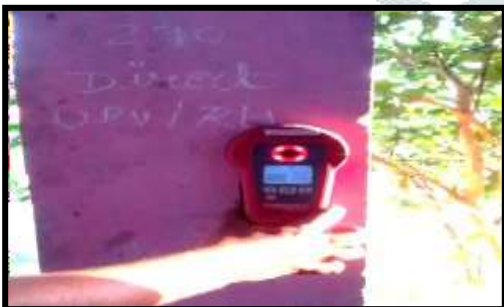
Fig. 5
Cover Meter

Rebar detector is one of the NDT, which are used to locate the steel bar embedded on concrete before drilling and before take core test. It will indicate rebar location and also will give an indication of the depth of concrete cover. It has the unique real time visualization mechanism, allowing the contractor to actually see the location of rebar's beneath the concrete surface. The features data storage for automatic collection of data to make rebar detection more efficient

C. The cover meter test readings are in acceptable limits (Reading in table 5)

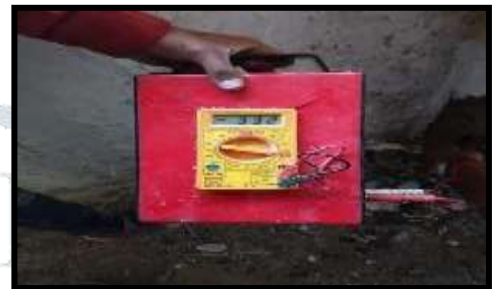
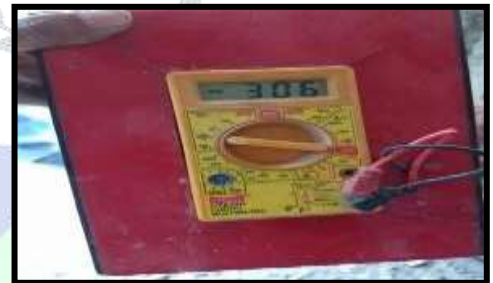
Fig. 6
Half-cell

Half-cell potential test is the corrosion monitoring technique to determine the probability of corrosion with the rebar in reinforced concrete structure. The instrument measures the potential and the electrical resistance between the reinforcement and the surface to evaluate the corrosion activity as well as the actual condition of the cover layer during testing.

E. As per Hall Cell potentiometer test on reinforcement it is observed that all the readings are range from -197 MV to -401MV.

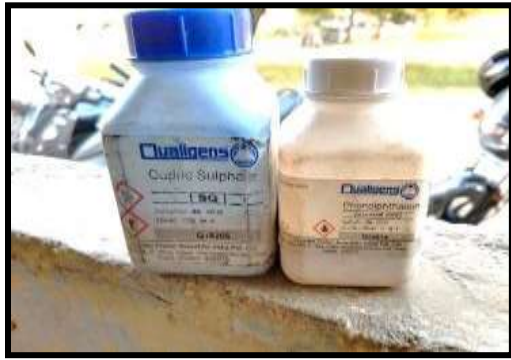
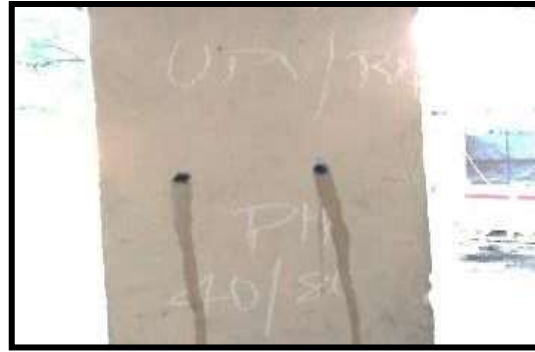
Fig. 7 phenolphthalein solution

This test allows the measurement of depth of carbonation through the surface of concrete. It will indicate the change of pH on freshly exposed concrete surface. The indicator is simply sprayed on the surface to be checked. The indicator will change to pink in uncarbonated concrete and remain colorless when sprayed on carbonated (low pH) concrete.

D. As per pH of concrete and carbonation of concrete, the pH of cover concrete is reduced and active corrosion of reinforcement observed at maximum locations.
