REVAMPING THE ROAD ACCIDENT BLACKSPOT

Abstract

Keywords: Road accidents, Blackspots, Gradient, Horizontal Curve.

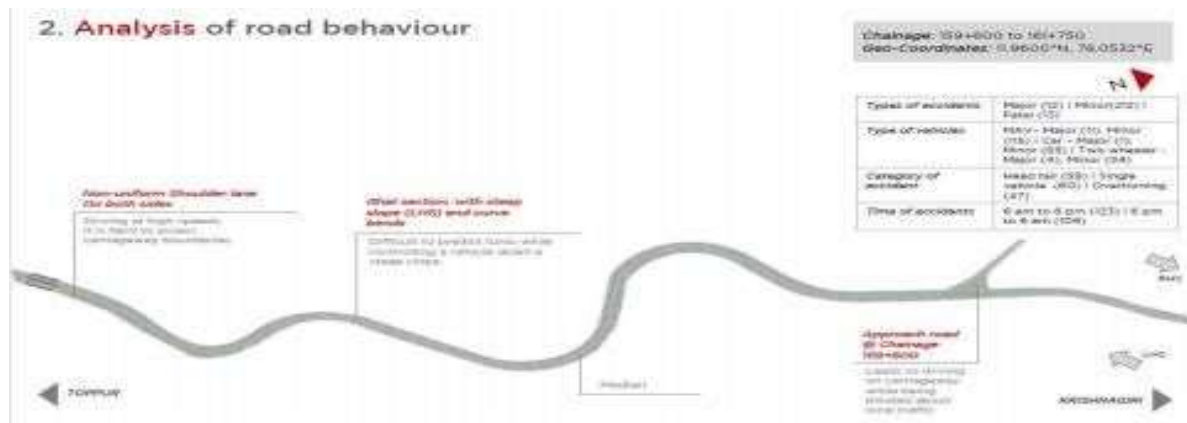
Fig 2: ANALYSIS OF ROAD BEHAVIOUR

The poor planning in the construction of the Thoppurhat road is the primary cause of the repeated accidents in the stretch of the national highway. The geometric calculations are wrong which is needed to be modified. As there are back to back descending curves, vehicles with even low payload find it difficult to make a turn.
