# A RESEARCH PAPER ON DEVELOPMENT AND IMPROVEMENT OF OVER HEAD CAMSHAFT BEARING IN GASOLINE ENGINE

**Abstract:** - This Study investigates methods of improving and enveloping cam shaft bearing of overhead camshaft of petrol engine three wheelers four stroke air cooled engine by analysis, field complaints with finding root cause of bearing failure. As the engine running up to certain km problem arises cam shaft bearing fails. After this due to disproportionate play occurs between parts ball bearing and outer race, which breaks outside the alignment at engine head with the tappet of engine head of petrol engine. Aiming at subterranean improvement describing influence with various method and process improvement to sustain ball bearing position w.r.t. cam shaft housing of engine head. Ball bearing pressing tool mandrill modified to maintain bearing position w.r.t. bore depth in main cam shaft on engine head assembly. While adding shield on bearing and pressing references are modified from outer race to inner race of this ball bearing. The impression of expansion imitates on routines and engine plane cam shaft successively.

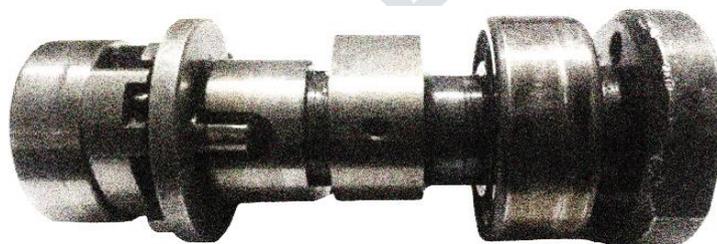
Overhead camshaft is a part of Engine Assembly which is mounted on top of engine main frame. The cycle of control spread in gasoline engine takes place as follow:

Fig 1. Overhead cam shaft mechanism

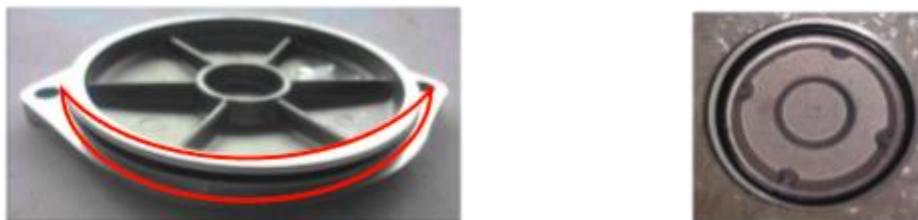
Fig. 1.2 O-ring improved

- 1) O-RING OF TAPPET COVER MODIFIED: - Engine head assembly, 1<sup>st</sup> ‘O ring’ located at Inlet valve on engine head with ‘O ring’ sitting slot in tappet cover & 2<sup>nd</sup> ‘O ring’ located in exhaust valve on engine head with ‘O ring’ sitting slot in tappet cover head. Before modifying ‘O ring’ oil leakage problem noted in Engine head assembly. Cam shaft bearing and engine head assembly mounting position will be consuming measurable permission, after adjusting bearing position always steady and mainstay wrt. to Housing.

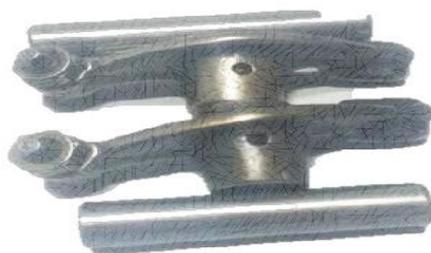
Fig 1.4 Tappet hardness increased

- 3) ROKER ARM HARNESS INCREASED: Failure analysis of cam shaft bearing includes the failure part of tappet. Due to uneven vibrations rocker arm splits/breaks in two parts causing major problem in cylinder head. Surface hardened from 58 HSc to 62 HSc as shown in figure.

Cam Shaft Analysis						
Surface Hardness	Core Hardness	Case Depth	Case Microstructure	Core Microstructure	%RA	Material
58 to 60 HRc	36 to 37 HRc	0.94 mm	Fine Tempered Martensite	Low Carbon Martensite	5.56	SAE 8620
59 to 61 HRc	37 to 39 HRc	1.01 mm	Fine Tempered Martensite	Low Carbon Martensite	4.48	SAE 8620
58 to 59 HRc	37 to 38 HRc	0.84 mm	Fine Tempered Martensite	Low Carbon Martensite	4.02	SAE 8620
