EXTENSION OF FLOORS IN RCC BUILDING

This research explains the basis of the structural design process, by way of familiarizing with the requirements of the project and understanding the architectural and services concepts. This research aims at formulating the main design parameters that we will adopt in developing the structural design and detailing of the structure which will be compatible with the architectural theme, satisfy the functional needs, adhering to other applicable building norms and Indian Standards provisions to achieve a safe & stable structure.

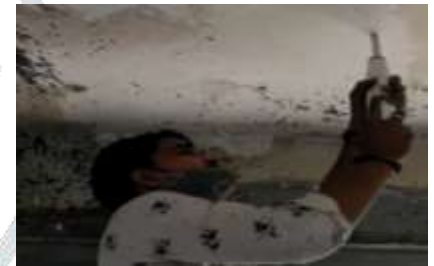
Fig- Rebound Hammer test report

It is a non-destructive testing apparatus, whereby the rebound of the spring driven mass is measured after its impact with the existing concrete surface.

Sr. No.	ID Mark of Member	Location	Grade of Concrete	Date of Casting	Age of Concrete (Days)	Avg. Rebound Index (After Mean Outliers)	Comp. Strength, (N/mm ²)	Direction of Rebound	Surface Condition
1	3rd Floor	C-1	NA	NA	NA	30.4	22.3	Horizontal	Dry
2	3rd Floor	C-2	NA	NA	NA	34.2	27.8	Horizontal	Dry
3	3rd Floor	S-1	NA	NA	NA	37.4	24.5	Vertical Up	Dry
4	1st Floor	C-3	NA	NA	NA	36.6	31.3	Horizontal	Dry
5	1st Floor	C-4	NA	NA	NA	32.6	25.5	Horizontal	Dry

Conclusion- As the rebound number is between 30-40 the quality of concrete is good.

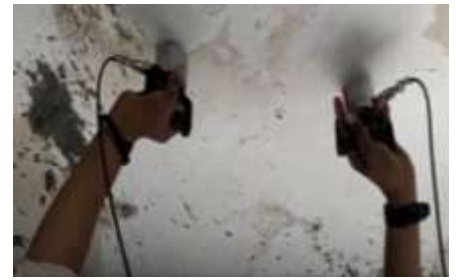
Fig- Ultra-sonic pulse velocity test

It is an in-situ, non-destructive test to check the quality of concrete, the strength and quality of concrete is assessed by measuring the velocity of an ultrasonic pulse passing through a concrete structure.

Sr. No.	ID Mark of Member	Location	Grade of Concrete	Date of Casting	Age of Concrete (Days)	Travel Path Length (mm)	Travel Time (μ sec)	Actual Velocity (Km/sec)	Corrected Velocity (Km/sec) !	Probing Method	Surface Condition
1	3rd Floor	C-1	NA	NA	NA	400	132.6	3.02	3.52	Surface Probing	Dry
2	3rd Floor	C-2	NA	NA	NA	300	94.3	3.18	3.18	Cross Probing	Dry
3	3rd Floor	S-1	NA	NA	NA	400	145.4	2.75	2.75	Surface Probing	Dry
4	1st Floor	C-3	NA	NA	NA	400	131.3	3.05	3.55	Surface Probing	Dry
5	1st Floor	C-4	NA	NA	NA	350	124.9	2.80	2.80	Cross Probing	Dry

Conclusion- Concrete quality is reasonable

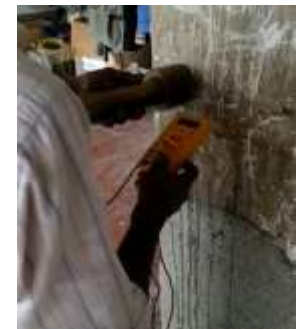
Fig- Half-cell potential meter test

It is the only corrosion monitoring technique for Corrosion Potentials of Uncoated Reinforcing Steel in Concrete. It is used to determine the probability of corrosion within the rebar in reinforced concrete structures

Sr. No.	ID Mark	Location	Half Cell Potential Value in (-mV)
1	1st Floor	C-3	269
2	1st Floor	C-4	171

Conclusion- Corrosion level is low

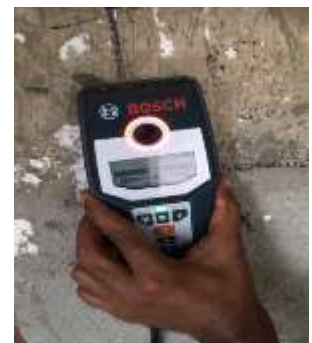
The test is used to determine effective concrete cover, detect reinforcement. It is also very useful to locate rebars before hacking of concrete or extracting concrete cores.

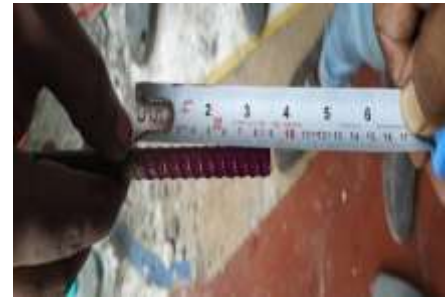
Carbonation testing provides a means which can determine the extent of carbon dioxide infiltration into the concrete.

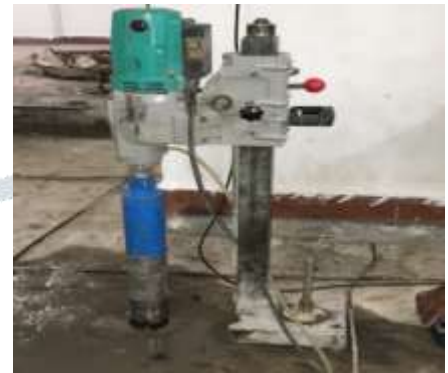
Fig- Core Test Results

The Core Cutting was done to check the depth of footing and also the grade of the concrete

Sr No.	Specimen ID Mark	Date of Casting	Age of Specimen (Days)	Core Height (h) (mm)	Core Dia (d) (mm)	Core Wt. (Kg)	Cross sectional Area, mm ²	Max. Load (KN)	Actual Comp. Strength (N/mm ²)	Correction Factor For Dia #	Correction Factor for (h/d) ratio \$	Corrected Comp. Strength (After Dia & h/d Ratio) (N/mm ²)	Equivalent Cube Comp. Strength (N/mm ²)
1	MID Foundation - 1	NA	NA	129.13	67.89	1.160	3620.4	66.90	18.48	1.06	0.985	19.38	24.1
2	MID Foundation - 2	NA	NA	128.49	67.43	1.125	3571.5	82.37	23.06	1.06	0.990	24.19	30.2
3	2nd Floor Slab - 1	NA	NA	112.18	67.83	1.022	3614.0	71.87	19.89	1.06	0.962	20.28	25.3
4	2nd Floor Slab - 1	NA	NA	129.43	67.68	1.180	3598.0	67.90	18.87	1.06	0.990	19.81	24.8
Average Value												20.91	26.1

Conclusion- Concrete grade can be considered as M25
