## **STRUCTURAL HEALTH MONITORING OF END PLATE STEEL BEAM-COLUMN CONNECTION USING EMI TECHNIQUE: NUMERICAL SIMULATION**

Dr. S. K. HIRDE<sup>1</sup>, AJAY S DHAMALE<sup>2</sup>

1. Professor & Head, Applied Mechanics Department, Government College of Engineering, Amravati, Maharashtra, India.
2. PG student, Structural Engineering, Government College of Engineering, Amravati, Maharashtra, India.

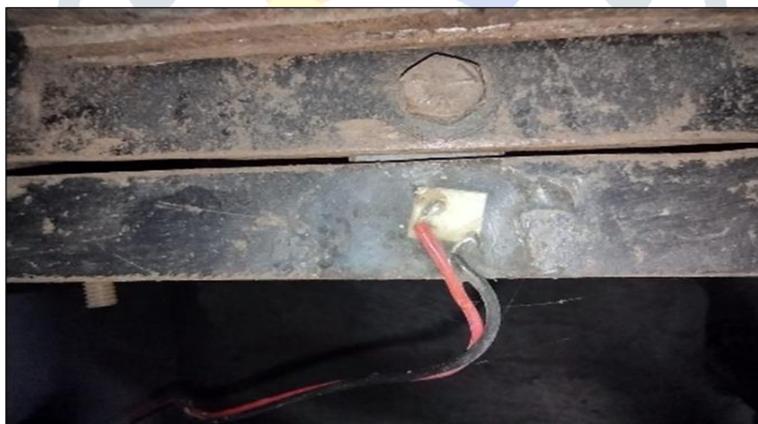
**Fig.1** Lead Zirconate Titanate (PZT) patch.

In the EMI technique, a PZT patch is typically bonded to the surface or embedded inside the structure (to be monitored) with a high-strength epoxy adhesive and electrically excited using an LCR meter or an impedance analyzer. In sweep mode, the LCR meter measures the electro-mechanical (EM) admittance of the PZT patch (consisting of the real part, conductance, and the imaginary part, susceptance) over a user-specified frequency range at specified intervals. When plotted as functions of frequency, these measurements form a unique signature of the structure, which can only be altered by physical changes to the structure. When the structure's condition is to be assessed in the future, the signatures are collected and compared to the baseline signature. The consistency of the signature indicates the health of the structure. Any change in the signature indicates the occurrence of damage. Essentially, the LCR meter sends a harmonic voltage signal across the PZT patch at a specific frequency. As a result, deformations occur in the patch as well as the surrounding area of the host structure. The response of this area to the imposed mechanical vibrations is transferred back to the PZT patch in the form of electrical response, as conductance and susceptance signatures. The structural characteristics are reflected in the signatures as a result of this interaction. Any damage to the structure alters the structural characteristics, and thus the signatures. [2] The PZT patch and LCR meter are shown in fig 1 and fig 2 respectively.

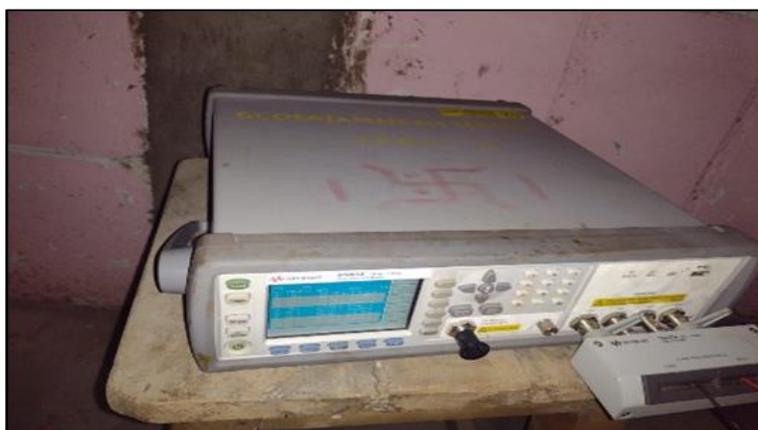
**Fig.2** LCR Meter.
