CHARACTERIZATION OF AEROSPACE COMPOSITE LINERS USING NON- DESTRUCTIVE EVALUATION TECHNIQUES

K. Santosh Kumar, B.Sunderlal Naik

Dept of Mechanical Engineering, GMRP, GAJWEL.

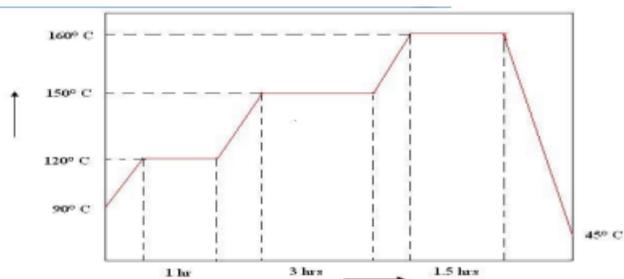
Fig 1: Curing cycle of high silica phenolic.

The laid-up component and mandrel are stored in a vacuum bag. The bag is fitted to the component size to reduce creases. On lay up, the released fabric is coiled, followed by three layers of breather material. This breather-wrapped item is contained within a vacuum bag. A vacuum port is supplied for sucking out air and volatile compounds from the vacuum bag. Curing is done in an autoclave at a pressure of 4 bar, a maximum temperature of 150-160°C, and a vacuum of 0.9.

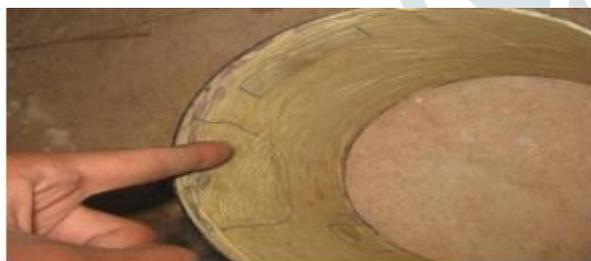
Fig 2: EPDM rubber bonded inside to Maraging steel casing

The abrasion technique is used to achieve a rough surface finishing on the Maraging steel's inner surface. The inside surface is coated with epoxy resin. The EPDM rubber liner is epoxy resin-bonded within the metal shell and permitted to bind securely. The de-bonding zones are made artificially for the investigation using an external source.

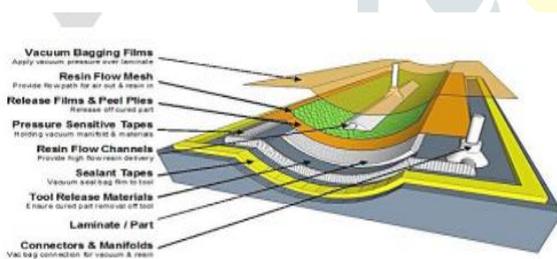
Fig 3: Resin Transfer Moulding

a method of forming both surfaces of a panel utilising a two-sided mould set The bottom is a rigid mould. The upper side might be either hard or flexible. Composite materials, silicone, and extruded polymer films like as nylon can all be used to create flexible moulds. The two halves are joined to create a mould chamber. The reinforcing materials are inserted into this cavity and the mould set is sealed before to the entrance of matrix material, which distinguishes resin transfer moulding. There are several types of resin transfer moulding, that vary in the mechanics of the way the resin is transferred to the reinforcement in the mould cavity. Vacuum infusion (for further details on resin infusion, view boat) is one of these different variants. Vacuum infusion and vacuum aided resin transfer moulding are two examples (VARTM).

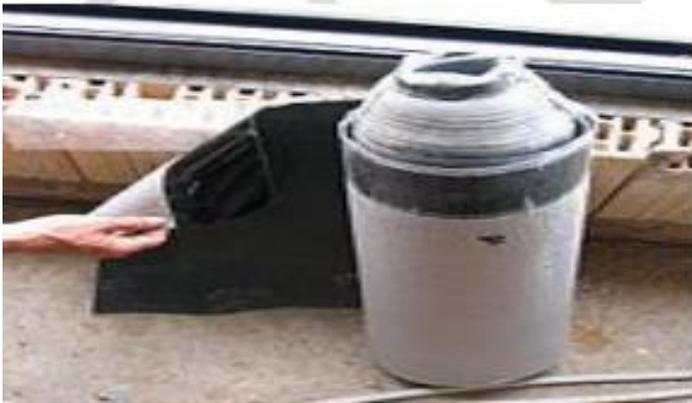
Fig 4: EPDM foil

An elastomer is a form of synthetic rubber that has a diverse range of uses. The E stands for ethylene, the P stands for propylene, the D stands for diene, and the M stands for its categorization in ASTM standard D-1418. Rubbers with a polyethylene saturated chain are classified as "M." The diene(s) presently employed in the manufacturing of EPDM rubbers are DCPD (dicyclopentadiene), ENB (ethylidene norbornene), and VNB (vinyl norbornene).

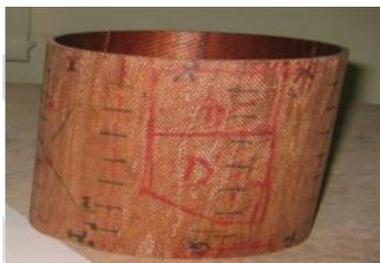
Fig 5: High silica phenolic liner.

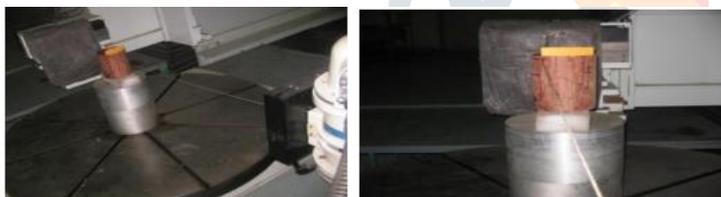
Fig 6: Normal Radiography experimental setup

The radiograph shows no defects in the standard process. Because the defects are not parallel to the path of travel of the X-ray beam, they are not identified with this procedure. As a result, tangential radiography is used.

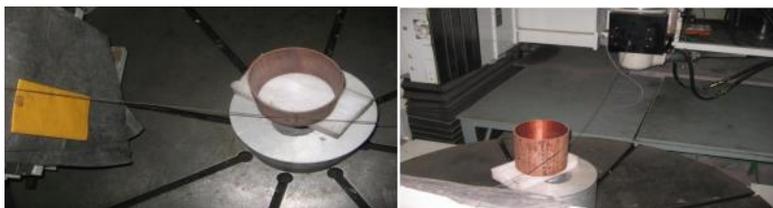
Fig 7: Tangential Radiography experimental set up

The test was carried out on a Pantak 450kV X-ray machine. The liner is zone indicated with lines and placed perpendicular to the X-ray beam in this technique. The machine parameters have been established to X-ray. The voltage is 85kV, the current through the tube is 2.7mA, and the exposure time is 2 mins. To monitor the differential absorption of the radiation, the T200 (Kodak) X-ray film is positioned perpendicular to the tangent derived from the source to the film centre. The experiment is carried out individually at each tangent around the component. The film is analysed and observed in a film viewer that uses an automatic film processing device. At last, films are computerised using an AGFA Film Digitizer to preserve the data, and the outcomes are as follows.

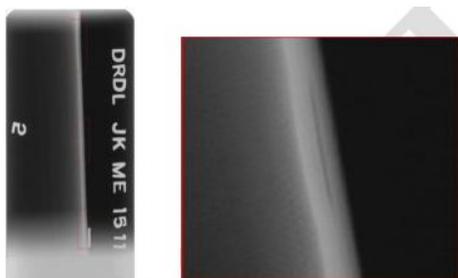
Fig 8: De-laminations are observed Tangential Radiograph of High Silica Phenolic liner

The radiograph certainly illustrates the de-laminations in the High Silica Phenolic liner as dark lines, as demonstrated by the arrow.

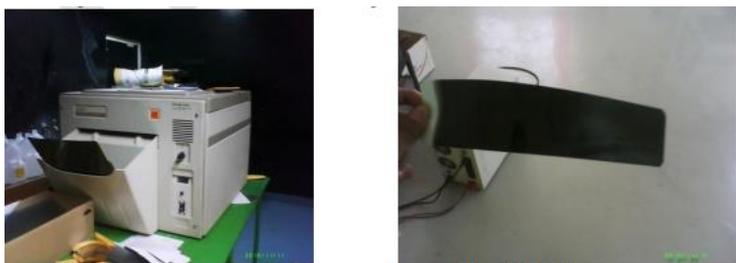
Fig 9: Automatic film processing machine (Kodak)

The invisible resulting image in the film by exposed to X-rays, Gamma rays, or light is made transparent and permanent during the processing process. The film is processed under restrained light of a colour where it is relatively insensitive. The film will be initially immersed in a developer solution, that darkens the radiation-exposed areas. The level of darkening for a provided stage of growth is determined by the amount of exposure. Upon progress, and occasionally following a treatment designed to suddenly stop the developer's reaction, the film is placed in a fixing bath. The fixer's job is to dissolve the darkened segments of the sensitive salt. The film is therefore cleaned and dried to delete the fixing chemicals and solubilized salts. There are two types of processing methods: manual processing and automated film processing.

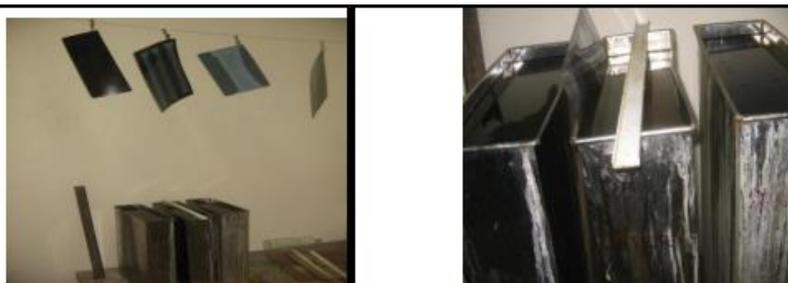
Fig 10: Manual film processing setup

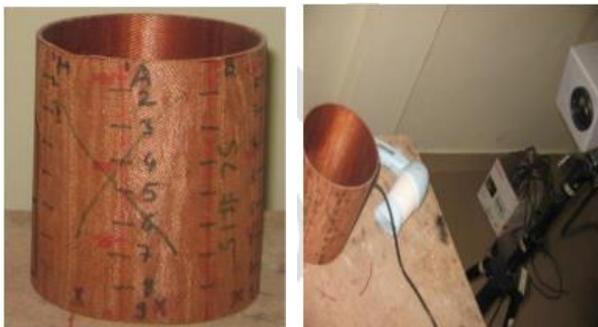
Fig 11: High Silica Phenolic Through Transmission experimental set up

The test was conducted using a transmission method in which the specimen was located on a table, the camera was correctly concentrated for a clear image, and it was positioned at a distance of 2 metres from the specimen. For 120 seconds, the specimen was evenly heated with a blower. A 1000W blower was applied to heat the specimen from within. The heating source is adjusted to assure heat distribution of the specimen. To identify defects, both the camera and the specimens's excitation (heating) began at the same time. from the experiment, the distances between the sample, IR camera, and heating source were kept constant. Thermal images were obtained at regular intervals of time during the heating and cooling stages of the specimen, as seen below.

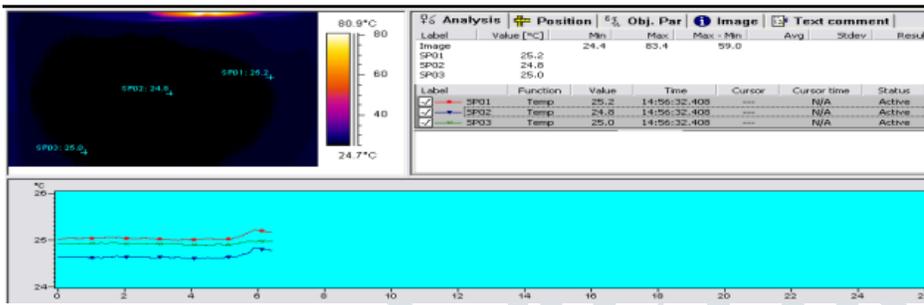
Fig 13: Thermal image after 6 seconds

The above thermograms simply illustrate that there is a temperature difference between the de-laminated (defect) region and the defect free area. Because the temperature in the defect region is lower (because of heat transfer characteristics) than in the defect free area, it is that the defect region has been recognised. The delaminated sections that occur within the first skin surface and the core exhibit the same thermal signature as the neighboring regions all through heating since they are burried deep within the heated surface. It is discovered that as the de-laminations move away from the heated surface, it takes longer for a thermal gradient to appear. While in heating process, thermal contrast was quite low in such delaminations. The existence of an airgap in between second skin face and the core material reduces thermal contrast while cooling. Such differences in thermal contrast can be seen in relation to time and temperature. It clearly shows temperature variation in the delaminated and defect-free areas.

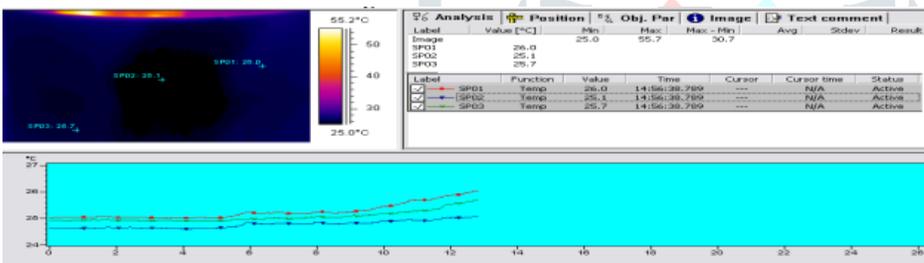
Fig 14: Thermal image after 12 seconds

The temperature increase and decay curve shows that now the delaminated area had a lower temperature than the defect-free region of the liner. The defect-free region takes 14 seconds to attain the temperature of 26.8°C, while

the delaminated area requires 20 seconds. As a result, the presence of delamination in the liner was analyzed quantitatively.

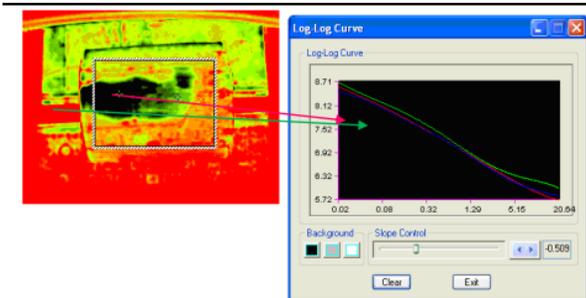
Fig 15: Log-Log curve for High Silica Phenolic liner

The red line denotes a non-defect. The green line represents defect-de-lamination at a shallow depth, while the blue line represents defect-de-lamination at a deeper depth.

The temperature difference of the defect and non-defect areas is fully evident in the first derivative images. A logarithmic time-temperature graph can be used to explain this data.

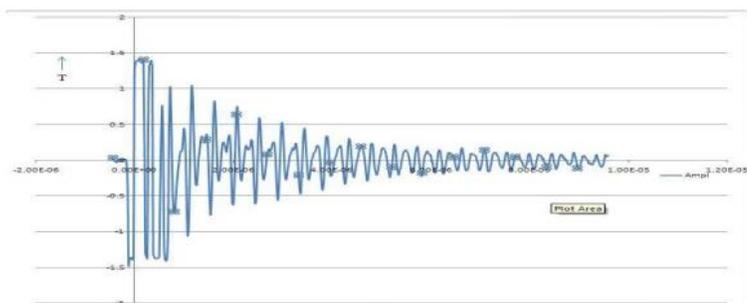
Fig 18: Debond side graph of the casing

Part of the energy is transferred and a portion of it is reflected throughout multiple reflection examination. An air gap, a large mismatch in acoustic impedance, and the maximum amplitude of reflections from the debond point all contribute to debonding (bonding interface).

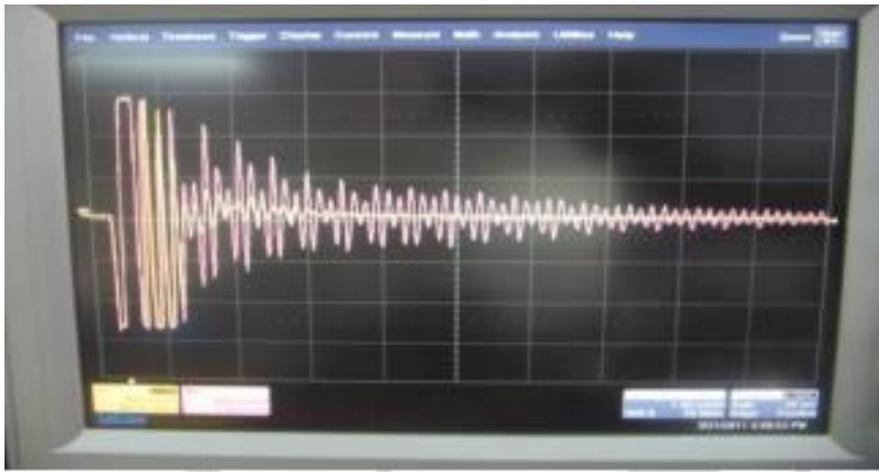
Fig 19: Oscilloscope image

The Fig clearly indicates that the yellow signal (output signal) is not attempting to follow the pink signal (reference signal), resulting in less signal (amplitude) than would be expected at a good bond point.
