## MANAGEMENT OF THE HORIZONTAL ROOT FRACTURE USING FIBER POST AS AN INTRARADICULAR SPLINT

CASE REPORT: This paper describes a case of complicated horizontal root fracture at the middle third of the maxillary right central incisor. After receiving an endodontic treatment, the fractured root fragments of the maxillary right central incisors were united with the help of a glass fibre post.

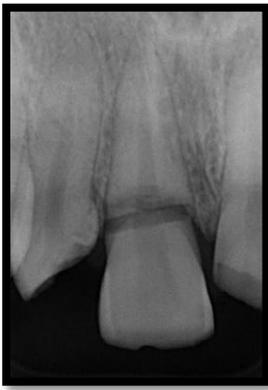
FIGURE 1 Pre-operative radiograph shows horizontal root fracture with the maxillary right central incisor

A 30-year-old male patient who suffered trauma to the maxillary anterior region in a car accident around five weeks ago has been referred to the Department of Conservative Dentistry and Endodontics. He described having intense, shooting pain in the maxillary right central incisor for eight days. Clinical examination of the patient revealed extruded and buccally displaced maxillary right central incisor with Grade I mobility. The tooth was tender on percussion. In the middle third of the root of the maxillary right central incisor, a radiographic examination revealed oblique radiolucent lines that suggested a horizontal root fracture. **“Fig.1”**

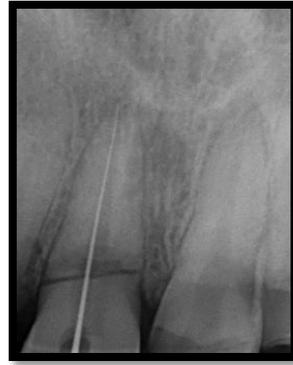
FIGURE 2 Working length determination using #15 k file

The access was established with the maxillary right central incisor. The working length was correctly determined radiographically using #15 K file **“Fig.2”** (Mani Inc., Japan) and confirmed with an apex locator (Root ZX mini, Tokyo, Japan), followed by chemomechanical preparation using K files (Mani Inc., Japan) in an exceedingly step-back manner to an apical file size #40 under copious irrigation using 2 ml of 5.25% NaOCl (Prime Dental Products Pvt. Ltd. Thane, India) and saline (Eurolife Healthcare Pvt. Ltd. Mumbai) after every instrument. The remainder of the canal was shaped to get an identical taper from the apex toward coronal. Using lentulospiral (Mani Inc., Japan), an inter-appointment calcium hydroxide dressing (Prime Dental Products Pvt. Ltd. Thane, India) was applied, and the patient was summoned back seven days later. It has been suggested to brush your teeth gently, use chlorhexidine mouthwash, eat soft foods, and refrain from chewing on your maxillary right central incisor. On the second visit, after removal of calcium hydroxide dressing, 2 ml of 17% EDTA (MAARC ENDO-L, Palghar, Mumbai, Maharashtra, India) for five min was used for final rinse followed by saline. The canal was dried using sterile paper points (DENTSPLY MAILLEFER, Ballaigues, Switzerland) of appropriate size. The root canal was sectionally obturated using gutta-percha cone (DENTSPLY MAILLEFER, Ballaigues, Switzerland) and AH plus sealer (Dentsply DeTrey GmbH, Konstanz, Germany). A gutta-percha cone of the same size of the prepared root canal (size #40, with a taper of 2%) was selected and tried into the canal to obtain a close fit **“Fig.3”**. It was then cut to obtain a section that would be 4 mm in length from the apex of the root canal **“Fig.4”**. A suitable plugger (Mani Inc., Japan) that loosely fits 4 mm short of the apical root fragment was selected and a stopper was set at this length. The obturation was carried out with sectioned gutta-percha coated with AH plus sealer. The sectioned end of gutta-percha was mounted to a heated plugger so carried into the canal to the specified length. After this, gutta-percha was disengaged from the plugger by slightly rotating the plugger in an anticlockwise direction. On the subsequent day, an appropriate glass fiber post (Dentsply Maillefer, Ballaigues, Switzerland) was tried into the canal, adjusted to the specified length until post just passively touched the apical gutta-percha. The root canal was etched with 37% phosphoric acid gel, rinsed, and dried with paper points. The canal was coated with a bonding agent and light cured for 40 s **“Fig.5”**. The fiber post was luted with dual-cure resin cement (Ivoclar Vivadent Marketing [India] Pvt. Ltd. Andheri [West], Mumbai), inserted into the canal without applying any pressure, and so light-cured for 40 s. The resin was used cautiously to lute the post only within the amount necessary to realize a desirable bond between the post and the dentin. Coating the root canal walls with resin cement was avoided to inhibit the flow of excess cement laterally between the root fragments. These fiber posts served as an intraradicular splint, stabilizing the fractured fragments in position. Following post cementation composite restoration (Ivoclar Vivadent Marketing [India] Pvt. Ltd. Andheri [West], Mumbai) was done. The splint was retained for 4 weeks and then removed. The patient was re-evaluated regularly. After 6 months of recall, the patient presented with the fractured root fragments well retained with the aid of a post and esthetically pleasing results along with sound periodontium.

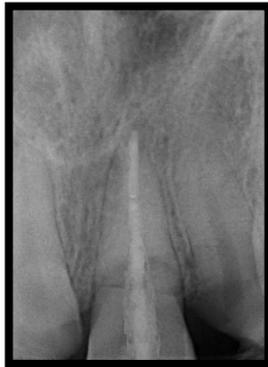
FIGURE 3 Master cone selection

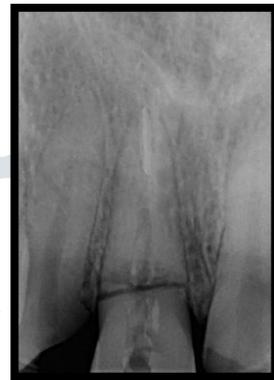
FIGURE 4 Sectional obturation

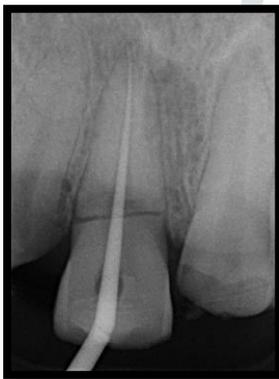
FIGURE 5 Fiber post-cementation
