“To study of crack behavior and settlement with remedial measure for bituminous road failure”

This study is about the Identification of Defects and Cracks and Maintenance of roads. Case Study on road failure of ODR from pencil chowk to sangha petrol-pump, MIDC, Baramati. In this study the most frequently occurring types of cracks and the defects on road will be considered, by visiting the site and thorough examination will be analyzed. After which, the reasons which cause defects in the pavement are studied.

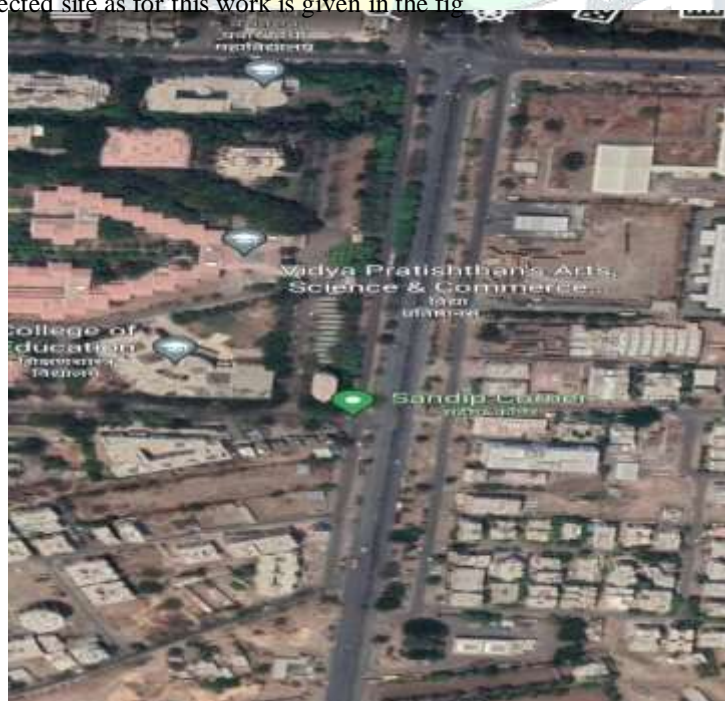
Fig: Photograph of Selected Site

We have selected the 0.5 km portion of other district road (ODR) for our case study of identification of the failures from pencil chowk to sangha petrol-pump, MIDC, Baramati. We had selected this site for inspection because there are many failure occurring in this portion for long time. we are going to carrying out road inspection as well as other laboratory tests forgetting some conclusion for this project work. The selected site as for this work is given in the fig

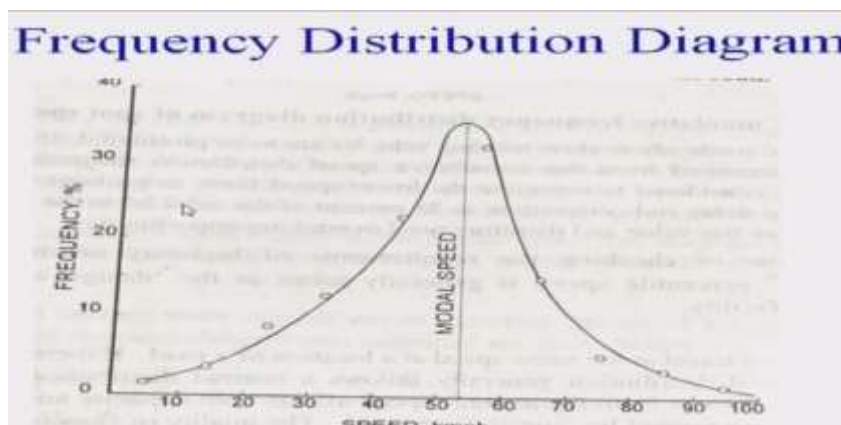
Fig: Frequency Distribution Diagram

Speed Range Kmph	Mid Speed Kmph	Frequency (f)	Frequency %
0-10	5	12	12/850=1.41
10-20	15	18	2.11
20-30	25	68	8.00
30-40	35	89	10.47
40-50	45	204	24
50-60	55	255	30
60-70	65	119	14
70-80	75	43	5.06
80-90	85	33	3.88
90-100	95	9	1.06
	Σ	850

As reference to table no (a) we get the different speed at which vehicles are travelling are mentioned by using the graph in fig no (b) . According to the graph the maximum number of vehicles is travelling at the speed of 52-53 and their frequency is about 35 % .

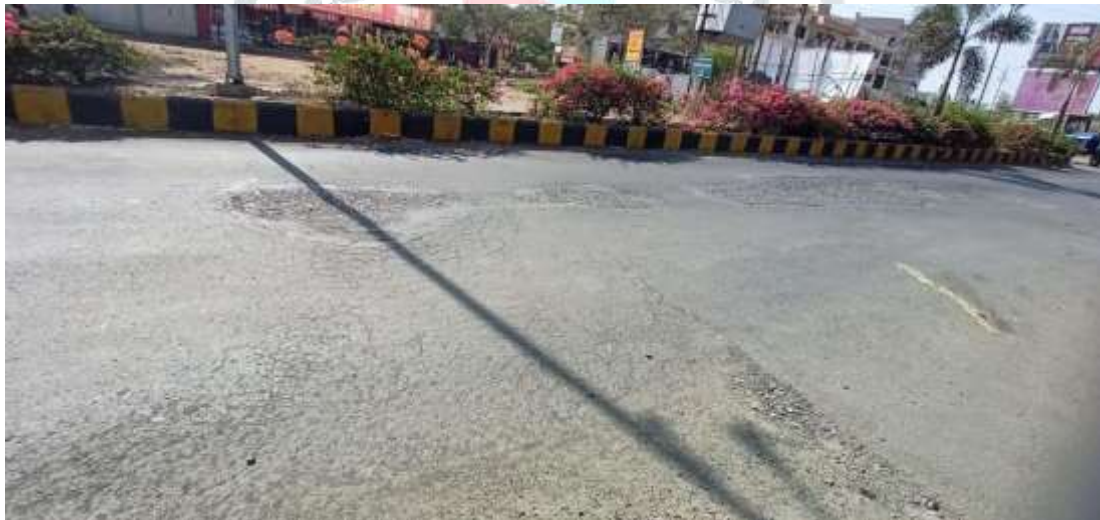
Fig: Alligator cracking

Alligator cracking is the type of cracking that is associated with load and structural distresses. Alligator cracks are extensively found at intersections where the vehicles are stopped for a relatively long period because these cracks start to form when the sub-grade and base compress due to the excessive imposed wheel load. It indicates the structural failure that may further deteriorate to a pothole. The causes of this cracking are inadequate structure, poor drainage, etc. Maintenance taken such as carpeting is used for normal alligator cracking, but patching is carried out for effective alligator cracking.

1. Weakness in base, surface or sub-grade
2. Thinning of a surface course or base course
3. Poor Drainage System
4. A combination of all of the above

1. Restricting the movement of heavy load vehicles like trucks or semis on the pavement.
2. Designing the concrete pavement as per the expected loads.
3. Improving the drainage of the pavement so that water can flow out of the sub-base.

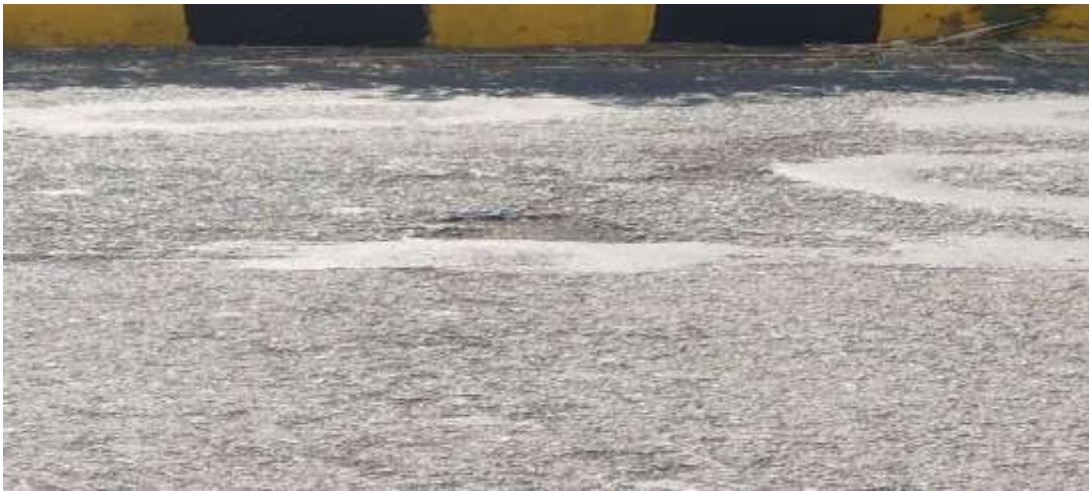
Fig: Pot hole

Small, bowl-shaped depressions in the pavement surface that penetrate all the way through the asphalt layer down to the base course. They generally have sharp edges and vertical sides near the top of the hole. Potholes are the result of moisture infiltration and usually the end result of untreated alligator cracking. As alligator cracking becomes severe, the interconnected cracks create small chunks of pavement, which can be dislodged as vehicles drive over them. The remaining hole after the pavement chunk is dislodged. The fig shows the causes.

1. Pavement fatigue
2. Untreated alligator cracks
3. expansion and contraction of groundwater after the water has entered into the ground under the pavement

1. Clean the area along the hole with the broom.
2. Trim it vertically to a regular geometrical shape like square or rectangle.
3. Level the bottom of the hole and remove loose aggregate and foreign materials.
4. Apply tack coat on bottom and sides of holes.
5. Now, apply the patching layer and compact it properly by tapping or roller.
6. If the depth of the hole is greater than 7.5cm, Patching layer should be provided in 2 or more layers where each layer should be tamped or rolled properly.

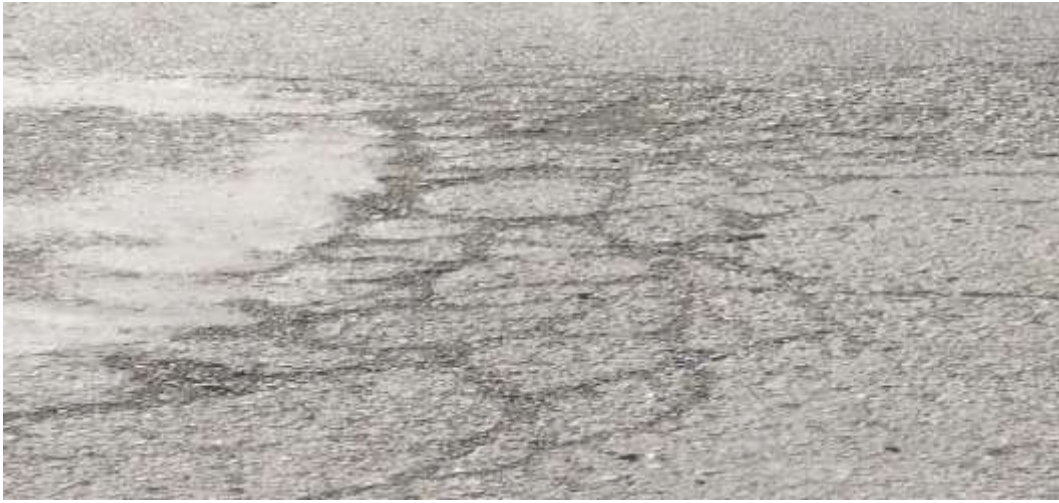
Fig: Block cracking

Block cracking is another type of cracking seen on highway pavements that form a box-like crack on the surface. This type of cracking is associated with the unusual expansion and contraction of concrete. Block cracks look like large interconnected rectangles (roughly).

Block cracking is not load-associated, but generally caused by shrinkage of the asphalt pavement due to an inability of asphalt binder to expand and contract with temperature cycles. This can be because the mix was mixed and placed too dry. Fine aggregate mix with low penetration asphalt & absorptive aggregates, poor choice of asphalt binder in the mix design or aging dried out asphalt. The fig shows the block cracking observed in the selected site.

1. Use of improper mix.
2. Fine aggregates mixed with low penetration asphalt.
3. Poor asphalt binder.
4. Ageing of asphalt.

1. In case of Block Cracking, the deteriorated pavement must be removed and replaced by an overlay.
2. Sealing method of repair can be used for cracks less than ½ inch or lesser.
3. prevent the ingress of moisture to the subgrade.

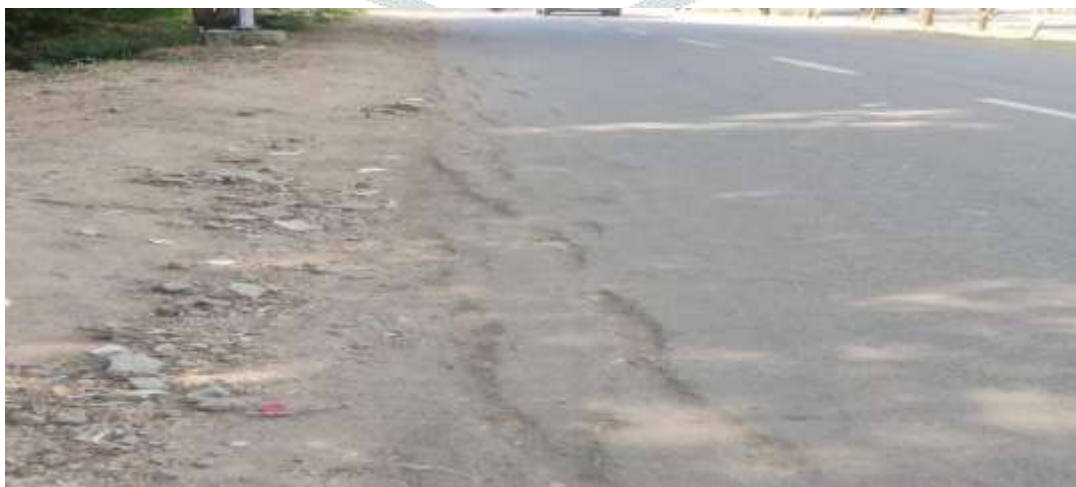
Fig: Linear cracking (longitudinal)

Longitudinal cracking are cracks that are parallel to the pavement's centerline or laydown direction. These can be a result of both pavement fatigue, reflective cracking, and/or poor joint construction. Joints are generally the least dense areas of a pavement. It is caused due to unstable base, poor construction. Surface dressing is used to repair this crack. The cracks observed between selected site as shown in the fig

1. Pavement fatigue
2. Reflective cracking
3. Poor construction of joints

1. It can be repaired by sealing or replacement.
2. For less severe cracks, sealing of the cracks may be done.
3. For severe cracks, replacement by an overlay may be carried out.

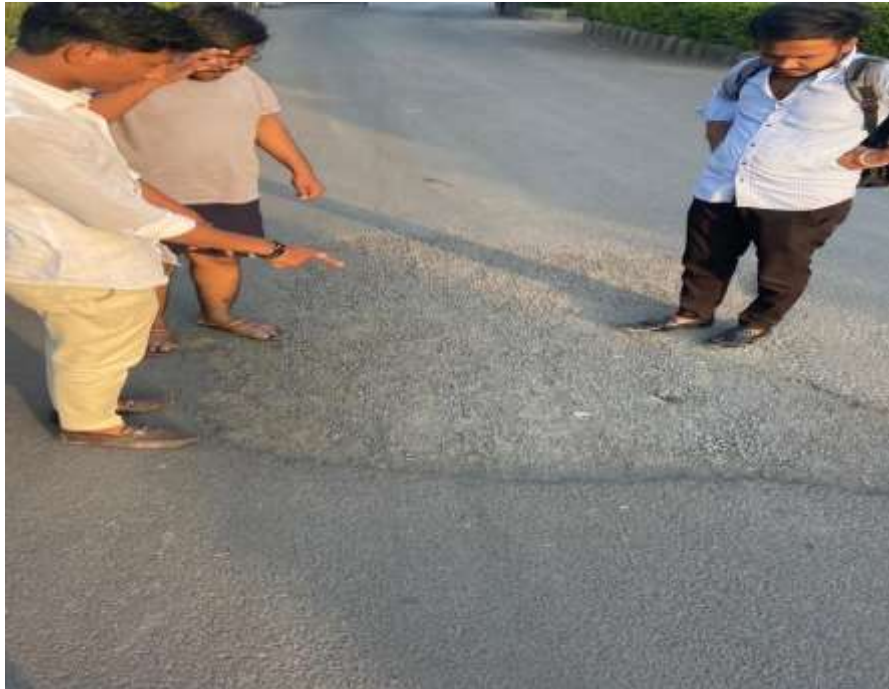
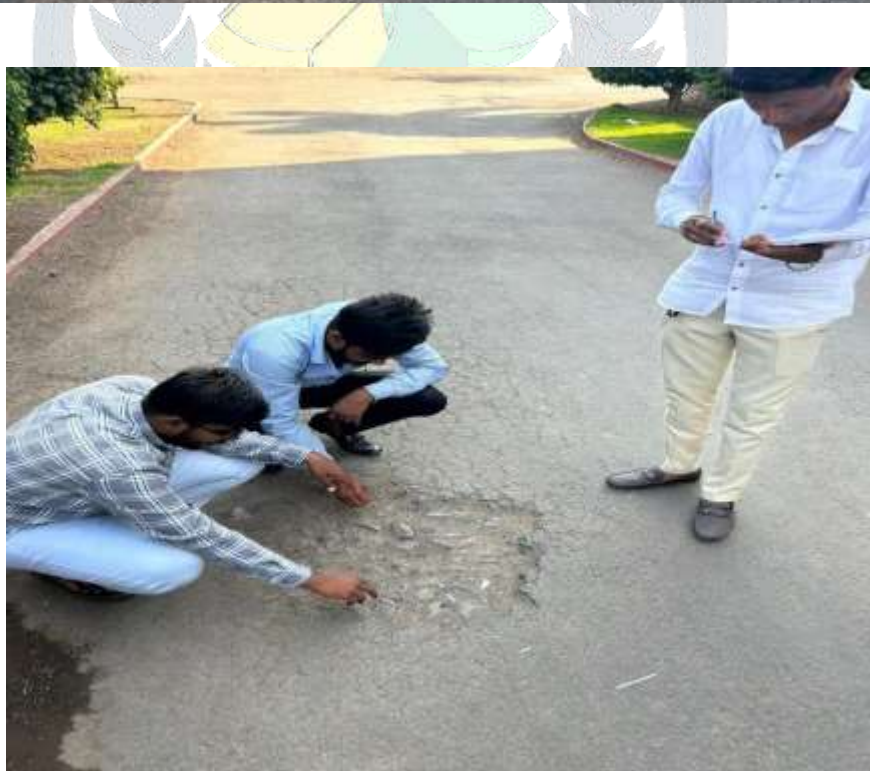
- Selected Location from Belhe Gulanchwadi Road. (3/5/2023)

We were visited the selected location for the inspection of the road. In this visit we collected the data like location of the cracks, what type of vehicles are travelling, and many more was collected.
