Investigation of Naseeb Singh Slide at Dharamthal Village along NH-44, Jammu and Kashmir (India): A Case Study

Yudhbir Singh

Department of Geology, University of Jammu, Jammu- 180006

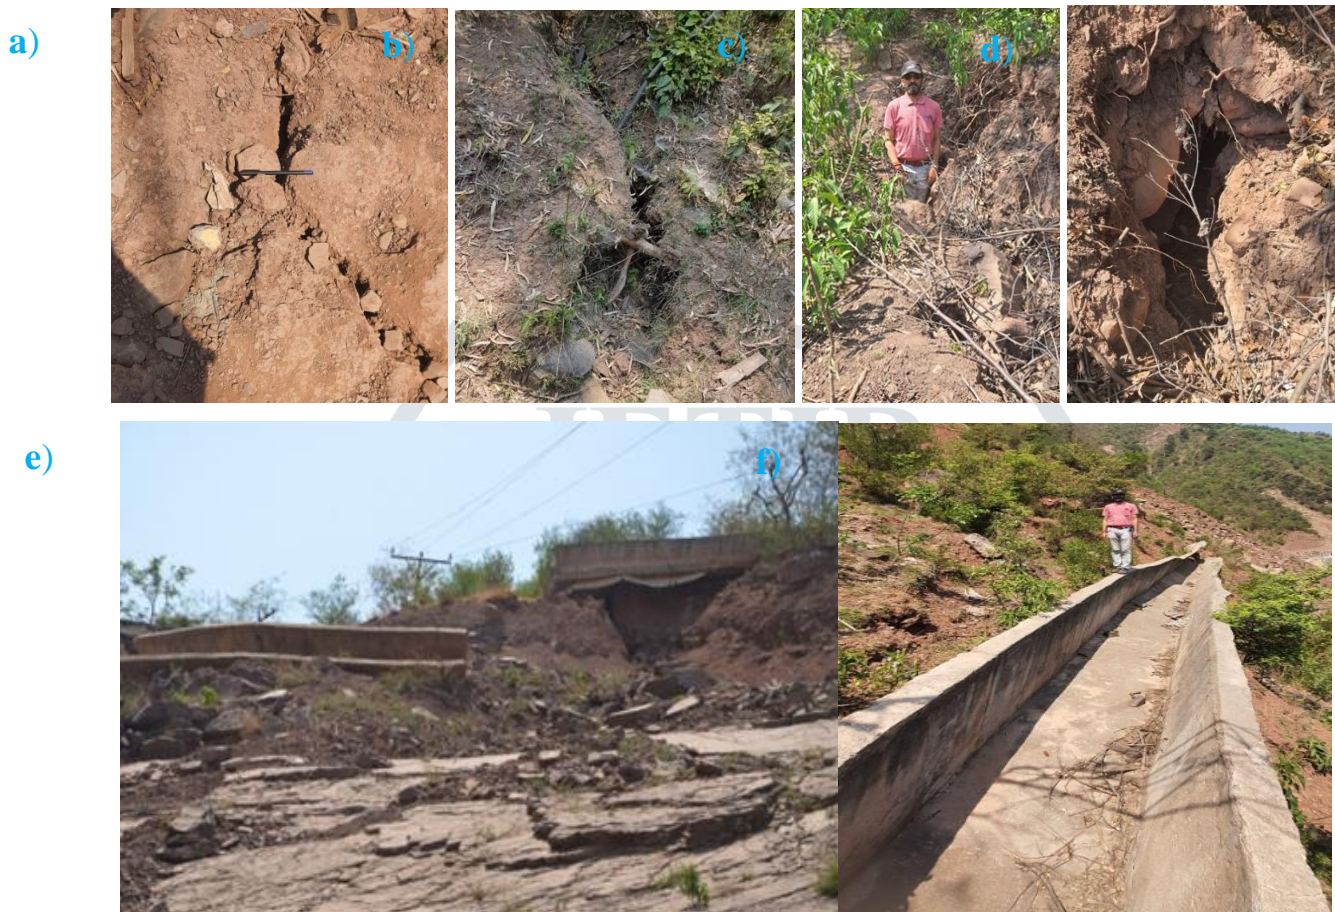
The rocks exposed in this area consist of highly weathered sandstone with brownish and maroon colored mudstone. The slide situated on the left side of the national highway (NH-44), while heading towards Srinagar from Jammu. The sliding area primarily comprises terraced deposits and agricultural land and covers an area of approximately 12,000 m², and based on its areal extent, it is classified as a medium-sized landslide (Van Schalkwyk and Thomas, 1991). Moreover, considering the type of movement and the geological material involved, it falls under the category of an earth slide (Varnes, 1978). The slope angle within the sliding area varies from 46 to 69 degrees. As a result of the recent sliding, extensive wide-open transverse and longitudinal cracks have been observed along the slope, with depths ranging from 75cm to 1.5m and widths from 10cm to 76cm (Fig. 1.2a-d). These cracks were traced uphill up to the crown of the slide and extend into the residential complex of Naseeb Singh as well. Additionally, there has been lateral and vertical displacement of approximately 35cm and 45cm, respectively, observed around the water tank located at the crown of the slide. The ongoing excavation work for road widening at the base of the slope coincided with subsequent rainfall. During the investigation, it was noted that water was still flowing in the sliding area at a rate of 200ml/second, originated from the stream running adjacent to the slide. This excessive water presence oversaturated the material and the space created by the

ongoing excavation at the base facilitated outward movement, leading to the failure of the slide. The landslide caused significant damage to one of the drainage channels constructed to divert water (Fig.1.2e). Moreover, another drainage channel, intended to redirect water away from the slide, has been left incomplete in the middle of the slide (Fig.1.2f) has further aggravated the situation.

Fig. 1.2: Field photographs (a-d) showing wide open and deep cracks at the different portion of the slide; e) displaced drainage channels and f) incomplete drainage left in the sliding area.

1. The space created by road widening activities at the base of Nasseb Singh slide should be carefully managed to avoid exacerbating outward movement.

2. It is important to limit water ingress into the slope by controlling surface runoff and properly directing water away from the slope.
3. The detailed geotechnical assessment of the site is required for appropriate mitigation measures.
