Investigating Pin Tick Noise and Bushing Wear in Heavy-Duty Applications: A Root Cause Analysis

Author: Vikrant Rayate
Powertrain Design Release Engineer
vikrant.rayate3086@gmail.com

Abstract

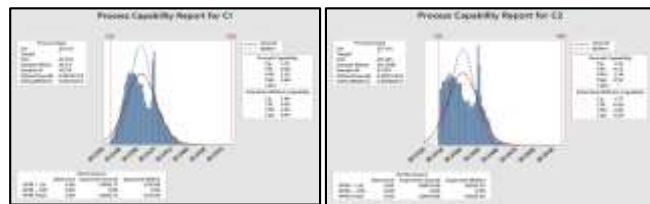
Figure 1: Rod Parent Bore Long Term Capability (Average Diameter)

First, we had assumed that the source of the problem might be in the small end-dimensions of the rod. We therefore decided to study the dimensions at the small ends of these rods. Some interesting observations showed from the long-term capability data for both the housing diameter and the roundness of the rods. They seemed to favor one side of the limit.

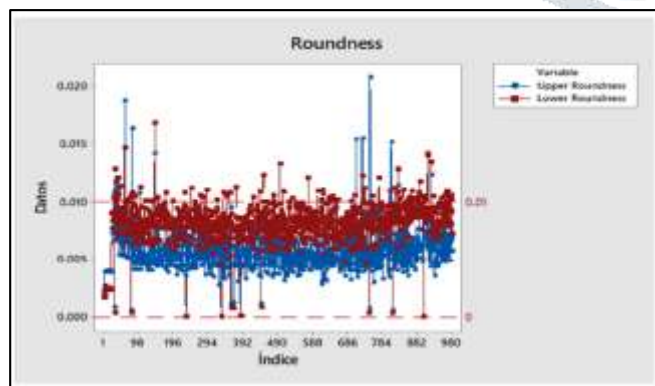
Figure 3: Parent Bore Roundness Long Term Capability

The dimensions of the rod-bore housing surpassed the standard limit of 10 μm, which is typically considered to be the upper limit for this type of component.

Because of the massive difference in data and the increased allowance for roundness, we tried to evaluate the interaction of the housing bore with the bushing that was latter inserted. In this test, we used four various levels of rod parent bore roundness: 10, 20, 30, and 40 μm. The result of the test indicated that the housing roundness showed an increased contact while that of the rod bore roundness decreased.

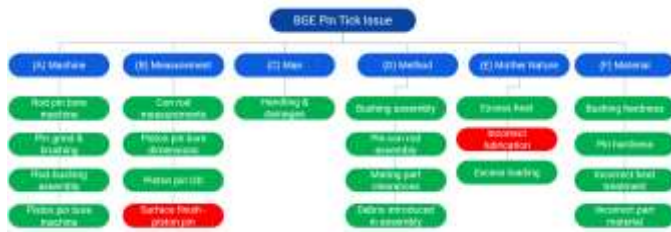
Figure 8: Root Cause Analysis Tree

Doubtless, our team agreed to re-think the situation with a more structured approach and relevant problem-solving techniques. For this purpose, we developed a root cause analysis tree in which all possible failure causes were incorporated [13]. Every part of the machine, measurement, man, method, mother nature, and material that would have caused that problem under discussion was critically analyzed. For each such parameter, we assessed the data and the information associated with it and transformed the said parameter into green status if enough information is available. Unfortunately, two items remain somewhat unclear, yet the finish of the piston pin and incorrect lubrication cause two bodies to be marked out in red, indicating that they need inquiry.

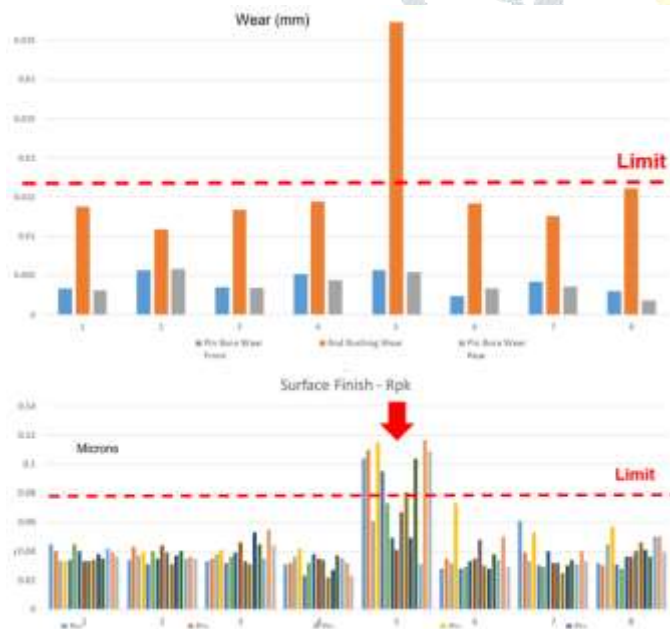
Figure 13: Rod Bushing Wear Vs. Piston Pin Surface Finish (Rpk)

Although the DOE effort with various piston-pin surface combinations was unsuccessful, our team went back to warranty engines and focused on pins from engines that generated customer complaints. As indicated below, the individual piston pins from all returned engines were closely analyzed by measuring the pin surface finish at 16 locations per pin. The results of this detailed analysis were very interesting: the Rpk of the pin surface finish was higher than the acceptable limits in some engines. More precisely, these very pins had connecting rod bushings with significant wear situations, correlating directly with pin-tick noise complaints. It explained that the pin surface finish has a critical influence on bushing wear and correspondingly noise issues, so we can hope to target improvements in pin manufacture and finishing processes to assist in enhancing the general reliability of engines.

This has brought us to visiting the premises of the supplier, where it was found that, in actuality, the cleanliness of the cleaning phase after the application of the DLC coating for the process of producing the

piston pins was poor and that the cleaning condition of that area and the brushing equipment was not good. It is an essential process to ensure that the nodules created with the DLC coating process grind and the surface is smooth. If proper control of cleanliness is not ensured, the chances are high that the nodules may not be fully grounded, hence <precising> a surface that is not smooth as expected. To address this issue, an audit of the process was conducted, and later 5S procedure was undertaken. Changes implemented as part of the 5S process: Floor cleaning was done once every 2 days. Cleaning of equipment, workstations - every day All tools must be in their designated place The carts and dummy bins should be maintained, organized, and cleaned.

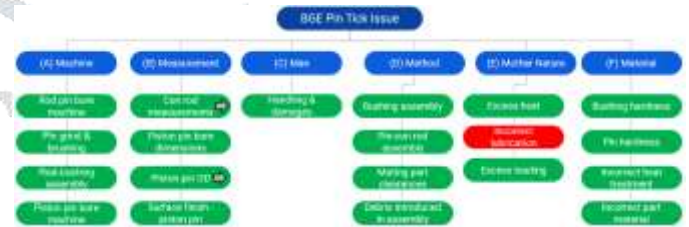
Figure 14: Root Cause Analysis Tree Updated

The manufacturing process of piston pins was improved for better cleanliness, which helped the problem to some extent; however, it could not be completely resolved as the wrong lubrication continued as a major problem that needed further improvement.

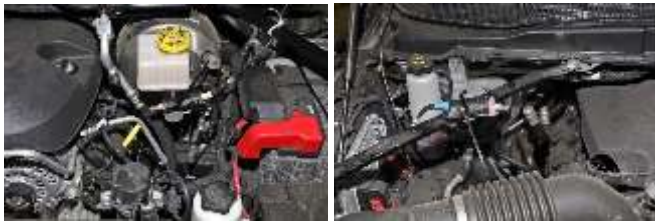
Figure 15: Left & Right Engine Bay Mic

Instrumentation: Eight accelerometers were mounted on the outer walls of the left and right cylinder banks to measure the ticking noise between a complaint engine supplied by CQI and noncompliant engine. There are also microphones inside the engine bay at left and right locations, a vehicle exterior microphone, and interior microphones.
