REVIEW OF GEOPHYSICAL INVESTIGATION USING SEISMIC REFRACTION METHOD TO DETERMINE THE CAUSES OF ROAD FAILURE AT ODUKPANI, CROSS RIVER STATE IN NIGERIA

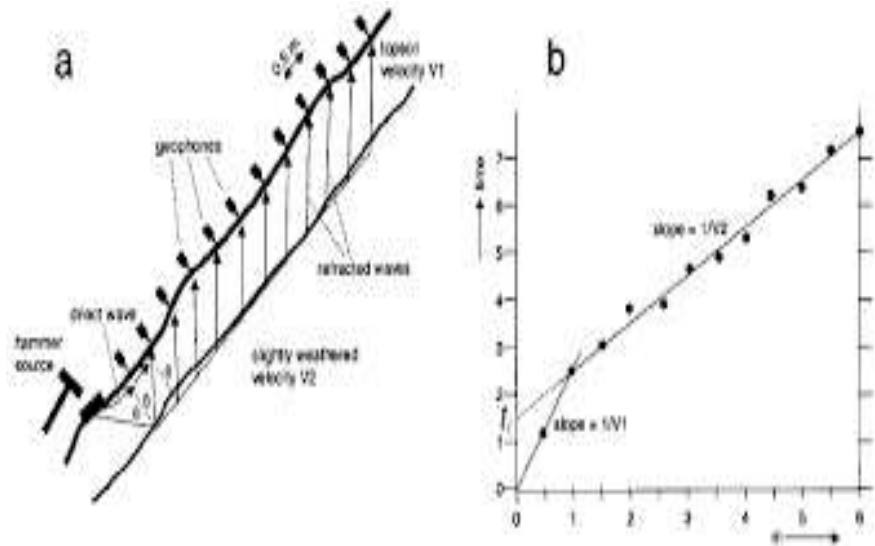
Figure 1: Seismic Wave Paths in a Refraction Survey

Figure 1 illustrates the seismic wave refraction process.

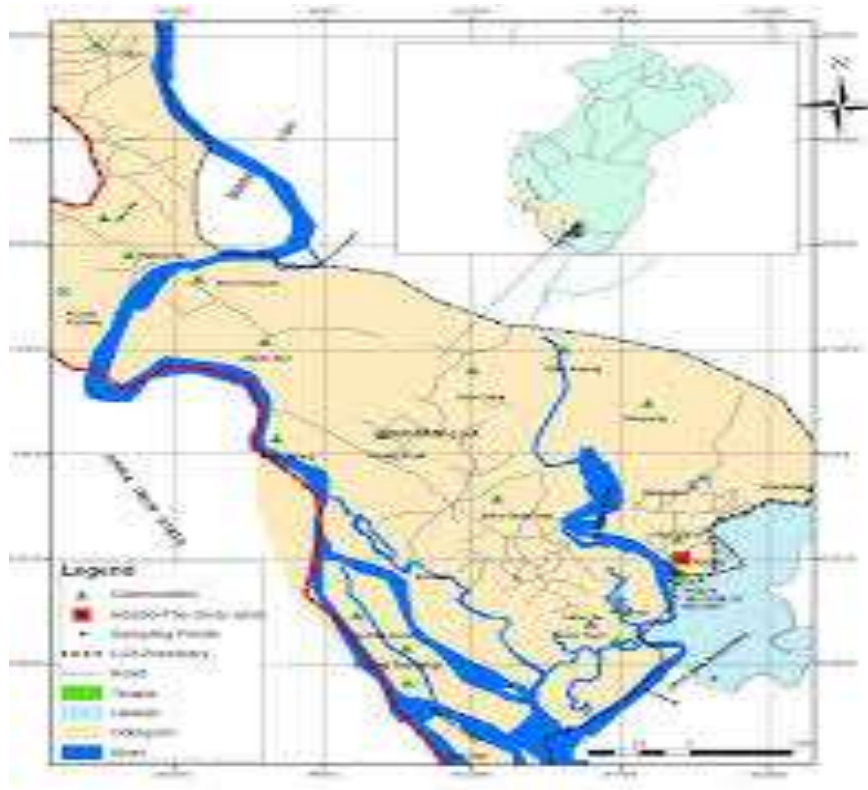
Figure 3.1: Map of Odukpani Showing Road Failure Sites

Figure 3.1 shows the map of the study area, highlighting major road failure zones.

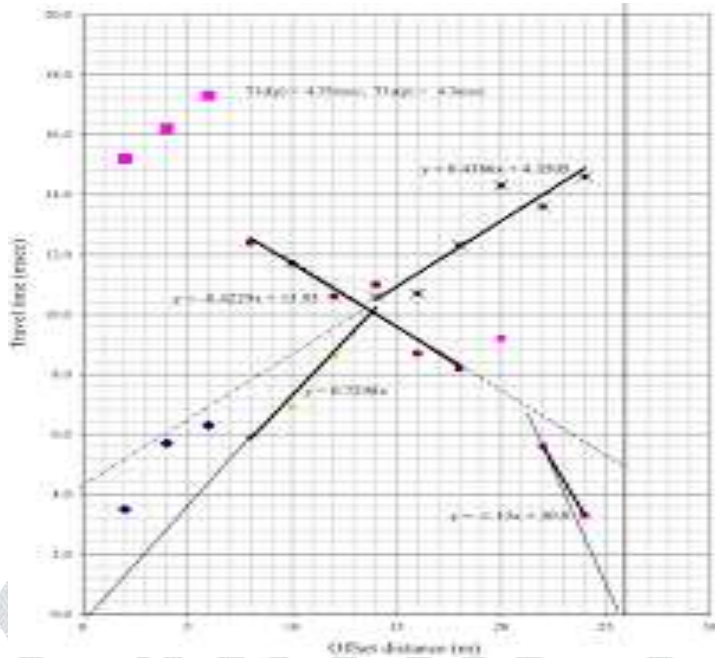
Figure 4.1: Seismic Travel-Time Graph for Odukpani Road Section

The first arrival times of seismic waves recorded at the survey locations were analyzed to determine subsurface layer properties. The travel-time curves exhibit a three-layer structure, indicating distinct geologic formations beneath the failed roads.

Figure 4.1 shows a sample travel-time graph from one of the surveyed sites.

- The first segment has a gentle slope, indicating low-velocity loose topsoil.
- The second segment shows a moderate slope, corresponding to weathered lateritic soil.
- The third segment exhibits a steep slope, representing higher-velocity fractured sandstone and bedrock.
