# Pavement Failures and Their Remedies

**Mahadeva M<sup>1</sup>, E Pavan Kumar<sup>2</sup>**

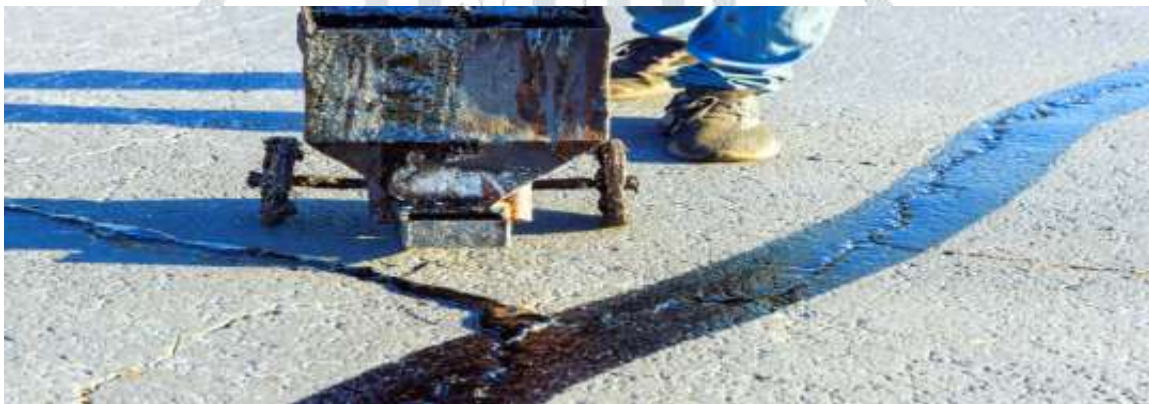
Figure 3: Poor Quality of Construction.

Construction quality plays a vital role in pavement performance. Improper compaction of subgrade, sub-base, and base layers can lead to differential settlements and eventual cracking. Similarly, inadequate bonding between layers, improper laying of bituminous mix, or insufficient curing in concrete pavements weakens the structural integrity.

Temperature control during asphalt laying is critical; if the bitumen cools before compaction, the resulting pavement is weak and porous. Similarly, improper joint construction in concrete pavements can lead to faulting and pumping. Many pavement failures in India have been traced back to construction lapses caused by time pressure, lack of skilled labor, or poor supervision during execution Rao et al., (2017) [2].
