COMPARATIVE STRUCTURAL ANALYSIS AND REHABILITATION OF RCC BOX CULVERT USING CFRP VS. GFRP COMPOSITES: A CASE STUDY ON NH-6

Abstract : This research focuses on the structural health assessment and subsequent rehabilitation of a reinforced concrete (RCC) box culvert (3 x 6.0m span) situated on the Odisha Border-Aurang section of NH-6. Initial inspections revealed flexural cracking, prompting a deeper investigation to determine the root causes and current structural safety. The study adopted a combined approach, utilizing theoretical design analysis alongside on-site diagnostic testing. A full-scale Bridge Load Test was executed using a 45-tonne vehicle (IRC Class A) following IRC SP-51 guidelines, supplemented by Non-Destructive Testing (NDT) methods including Ultrasonic Pulse Velocity (UPV), Rebound Hammer, and Carbonation depth analysis. While the load test indicated excellent elastic recovery (100%), surpassing the mandatory 75% limit, the structure failed serviceability requirements due to tension cracks exceeding the permissible 0.3 mm width. Based on these results, the study evaluates two retrofitting options: Carbon Fiber Reinforced Polymer (CFRP) and Glass Fiber Reinforced P

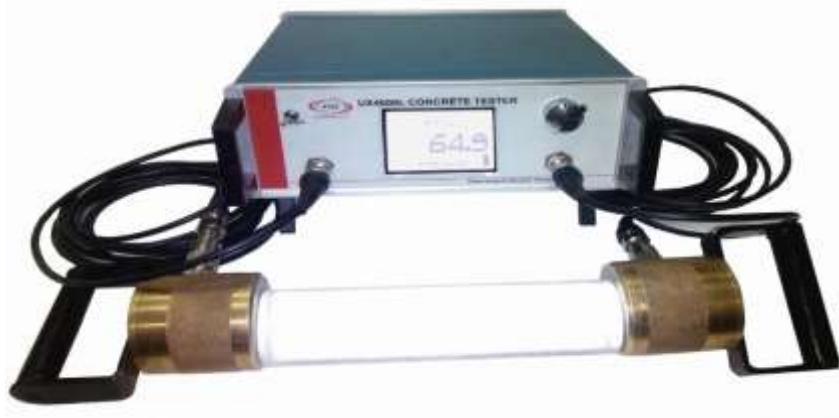
Figure:3.2: UPV Test Instrument

Ultrasonic Pulse Velocity (UPV) Test is used to measure the concrete integrity and homogeneity of concrete. This non destructive testing technique is mainly based on the velocity of pulse velocity transmitted through the concrete. It measure the time taken to transmitted pulse from the transmitter probe to receiver probe. The Velocity of concrete mainly depends upon the concrete density, uniformity, voids and cracks if presents inside concrete. The quality of concrete is measured in relation to the specified standard requirements given in IS 516-2019, (Part 5, Section 1) Non-destructive testing of concrete - Methods of test: Ultra-Sonic Pulse Velocity. The acceptance criteria are explained in image 3.3 taken from the mentioned Indian standard. There are two methods of testing surface probing and direct transmission, the detailed procedure is explained in IS 516 part5 section1.

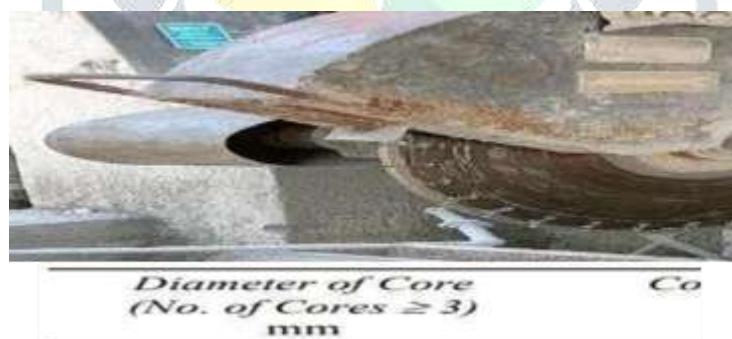
Figure 3.6: High quality concrete cutting machine

- The concrete cores are smooth at both ends using high quality concrete cutting machine shown in Figure 5.3.2 By using this machine, we can easily get a smooth surface within the flatness tolerance limit ± 0.05 mm as specified in Cl. 7.5 of IS 516(Part 4):2018. Vernier Calipers and scale was used for measuring the dimensions and flatness tolerance specified in Cl. 7.6 of IS 516 (Part 4):2018 and shown in Figure 5.3.3.

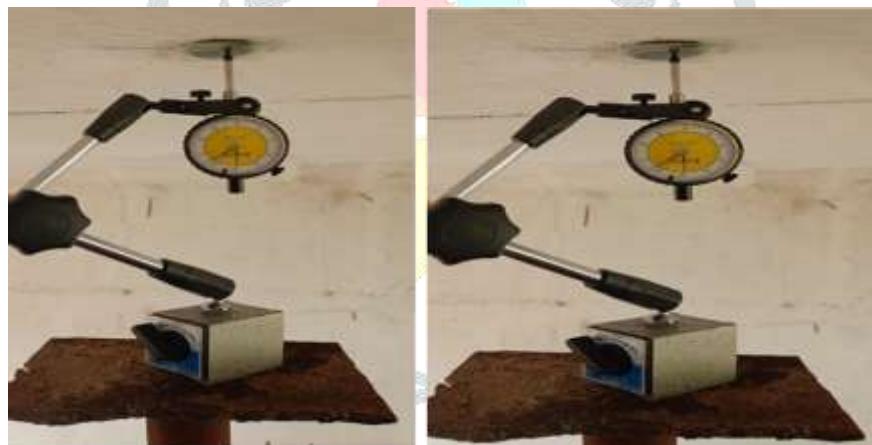
Note: During the temperature correction, temperature ranges from 17.7 to 32.0 degree Celsius. The temperature deflection characteristics was taken from the graph below which is the linear line drawn between points of minimum temperature- least deflection and maximum temperature- most deflection.
