ANTHROPOGENIC DRIVERS OF COASTAL MORPHOLOGY ALONG WESTERN SECTION OF THE PURBA MEDINIPUR COASTAL TRACT, WEST BENGAL, INDIA

Dr. Kartik Chandra Rishi

State Aided College Teacher-I, Department of Geography, Hijli College, Kharagpur, West Bengal, India

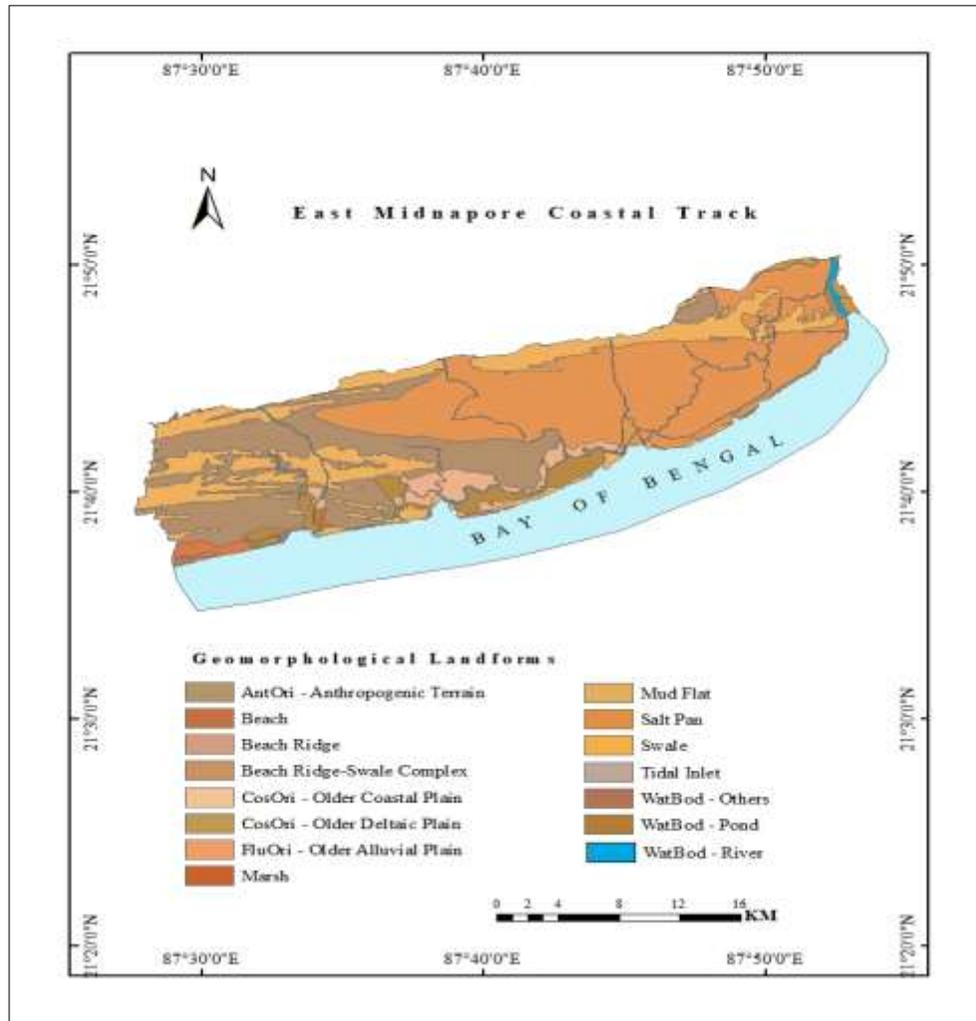
This coastal tract is characterized by low-lying terrain with extensive fluvial and marine plains, several creeks, coastal estuaries, beach ridges, mudflats, sandy beach plains, and dune ridges, all of which are subject to continuous geomorphological changes. This coastal belt has been rich in a variety of habitats, and it provides a

distinctive shelter for an enormous diversity of flora and fauna species (Paul, 1987). This variety of flora and fauna plays an important role in regulating climate change and influencing geomorphic processes (FIGURE 2).

FIGURE 2: Geomorphology map of the study area (Source: GSI)

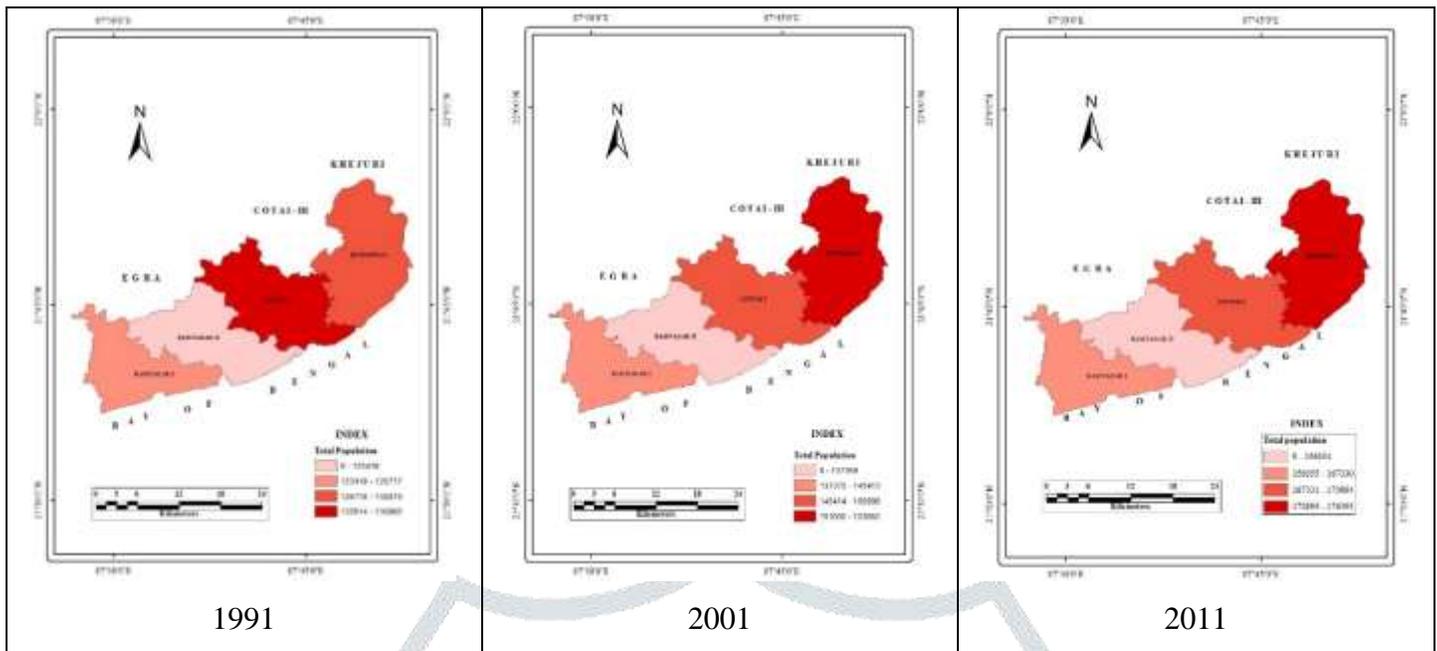
From census data of 1991, 2001, and 2011 of Ramnagar I & II, Contai I, and Deshopran administrative blocks have been considered for the present study to make out the types of occupation practices by local people (FIGURE 2). According to the census data, there has been a huge change in the socioeconomic condition of local people, especially in the coastal areas. Due to the location of the Salt Factory in Mania mouza, with a big scope for livelihood, which is considered as dwelling in Purushottampur (Dakshin) villages. So, in the following three decades, the maximum population resides in this area. Generally, the increased population in Ramnagar I & II, Contai I, and Deshopran CD blocks is due to the availability of coastal resources practices. Some mouzas are gradually decreasing their own importance due to the encroachment by tourism sectors.

FIGURE 3: Showing the block-wise population distribution map (1991-2011) of the study area

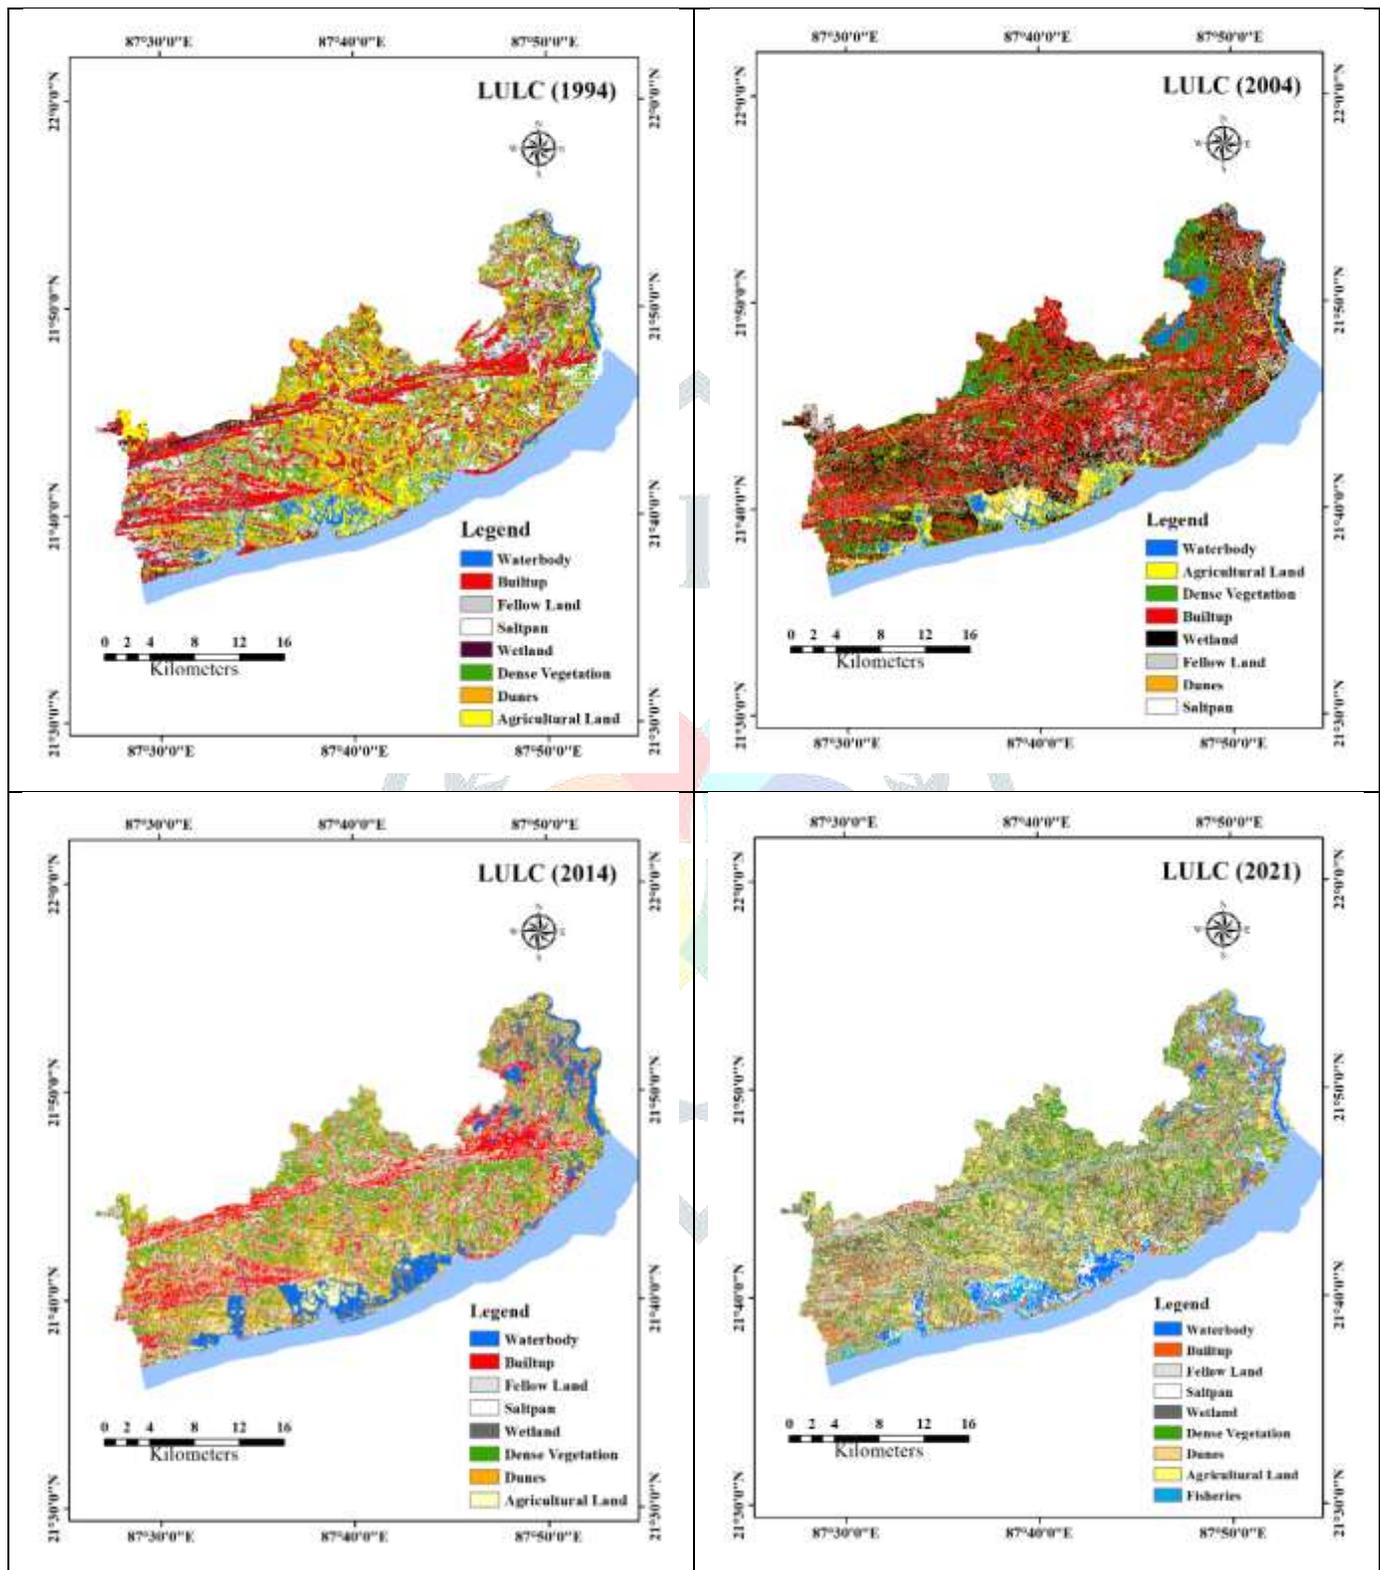
Agricultural and forest land conversion is mainly found in the coastal belt between Mandarmoni and Dadanpatrabar coast, whereas wet land conversion is found in the Digha, Shankarpur and Tajpur coast. The landscape of the Junput coast under Contai-I block, which was covered with dense forests and rich in vegetation before 10 to 15 years back, presently converted in to tidal playground. Land conversion is mainly takes place due to saline incursion from tidal waters that increases the pH level in the soil. Loss of forest land in this area has also been recorded. The problems of landscape degradation due to waterlogging and soil salinity are directly related to the geological and hydrological formations. The problem of waterlogging has been defined as the retention of the area under water for a considerable period. The agricultural land has been said to be waterlogged as its productivity or fertility has been adversely affected by tidal saline water ingress. Conversion of fertile agricultural

land into sat pans, aquaculture ponds, and shrimp farming ponds has been contributing to the land degradation process by a change in physiochemical properties of soil and groundwater.

FIGURE 5: Showing the block-wise LULC change map (1994-2021) of the study area (Source: LANDSAT 5, 7 & 8)

The Land Use/Land Cover maps are prepared from satellite imagery by Landsat-5 & 7 for 1994 and 2004, and Landsat-8 for both 2014 and 2021. The maps showed an area coverage of 632.69 sq km of the total study area. Water bodies, built-up area, farmland, saltpan, wetland, dense vegetation, dunes, and agricultural land are mentioned in LULC by the supervised classification. Where dense vegetation was 17.97% in 1994, it decreases in 11.69% by 2021. Where the built-up area and wetland were 18.41% and 7.75% respectively in 1994, it change in 44.22% and 0.43% by 2021. Where saltpan was 15.66% in 1994, it decreases in 3.71% by 2021. Where dunes were 16.77% in 1994, it decreases in 0.52% by 2021. There have been tremendous changes in LULC after three decades in this study area (FIGURE 5). A primary survey is done in almost 363 hotels, and almost 95% hotels are situated in Digha. A list is collected from DSDA, where 376 hotels are listed. According to the primary survey, almost 363 hotels could be constructed, but among these 363 hotels, many do not have proper features according to the DSDA list. Hotel owners are avoiding the legal process to build up the hotels. Only a few hotels are built up legally, having sarai license (FIGURE 4).

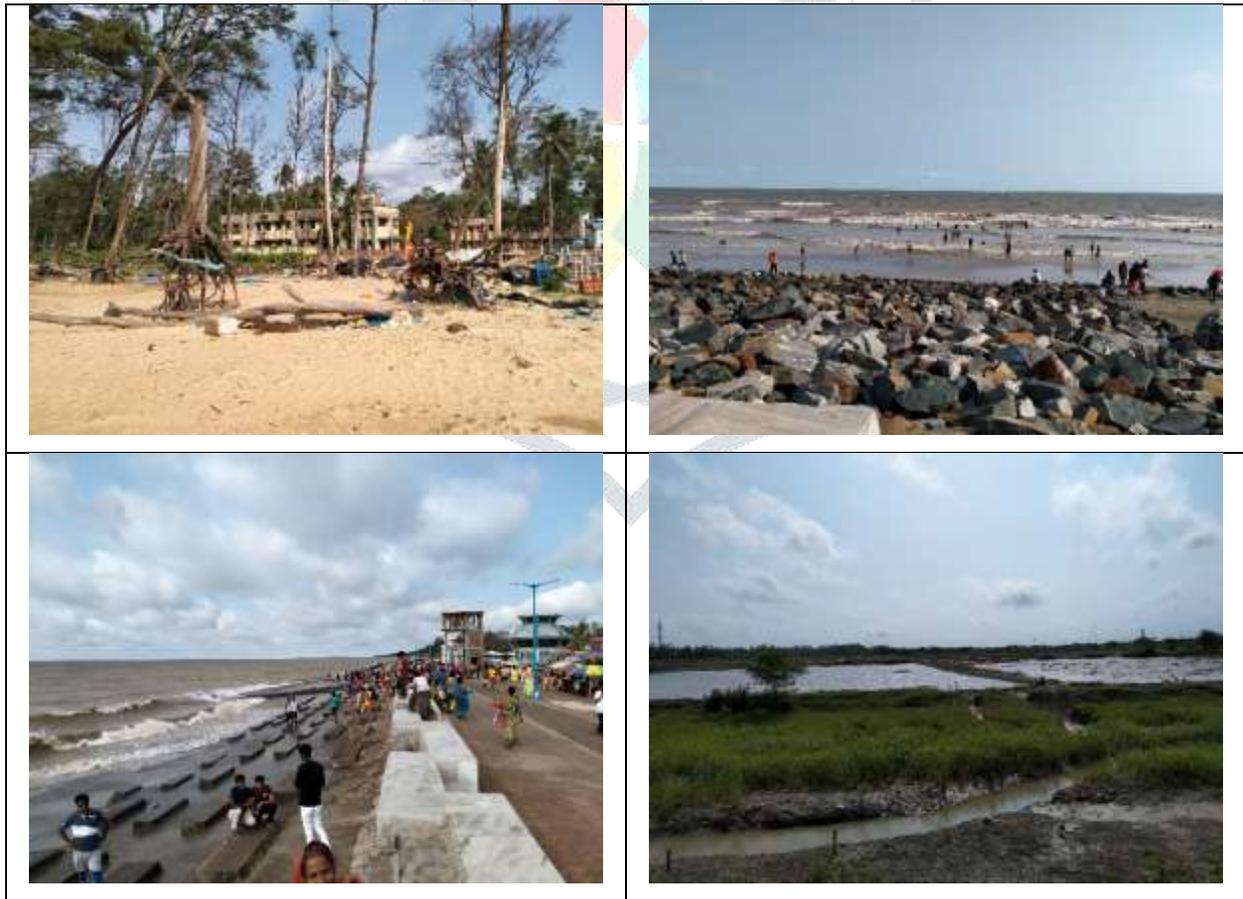
The embankment breaching is very common in flood years and at the time of high tide, full moon tides, and cyclonic disturbances over the Bay of Bengal. It takes place through overtopping, poor maintenance of the embankment, and other anthropogenic activities. It has an adverse impact on the geomorphic landscape over time. In the southern and eastern portion of the study area, which extends from the Rasulpur channel to Udaipur beach, there exist extremely complicated systems of embankments. The embankments of the estuary face of the Rasulpur River, Pechaboni channel, and Jaldah channel have less value in keeping out salt water inundation caused by high tides and storm wave actions. Human interventions are also responsible for the damage to these embankments. Embankments parallel to the coast have increased seasonal silt deposition within the Rasulpur river bed, channel bed of Pechaboni, and Jaldah, etc. Coastal sand dunes and beach ridges are not sufficient to resist coastal erosion and are not adequate to prevent the entrance of marine water directly into coastal lowlands. Damages to the embankment in the southern part of the Shankarpur Mouza may connect the creek at any moment through a newly developed channel, resulting in which the Shankarpur creek will be filled with sand, and the whole hydrological and geomorphological process will be disrupted and affect the geo-environment of this area (FIGURE 6).

FIGURE 6: Anthropogenic activities of the study area
