Slurry erosion of ceramic thermal spray coatings

¹Hitesh Vasudev, School of Mechanical Engineering, Lovely professional University-India-144411

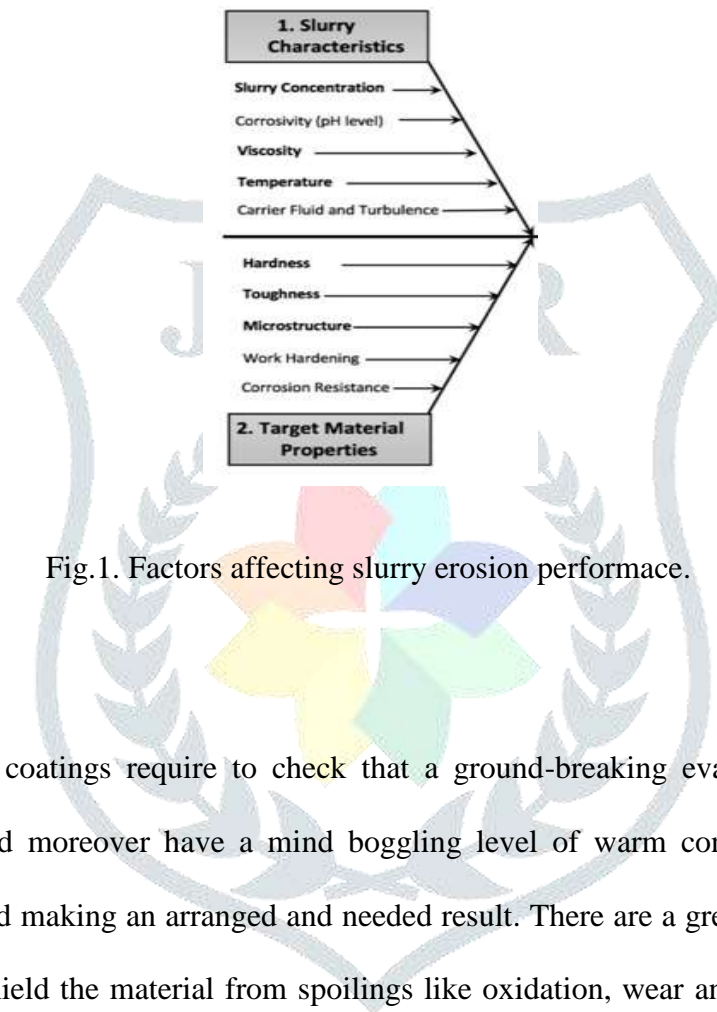
Fig.1. Factors affecting slurry erosion performance.

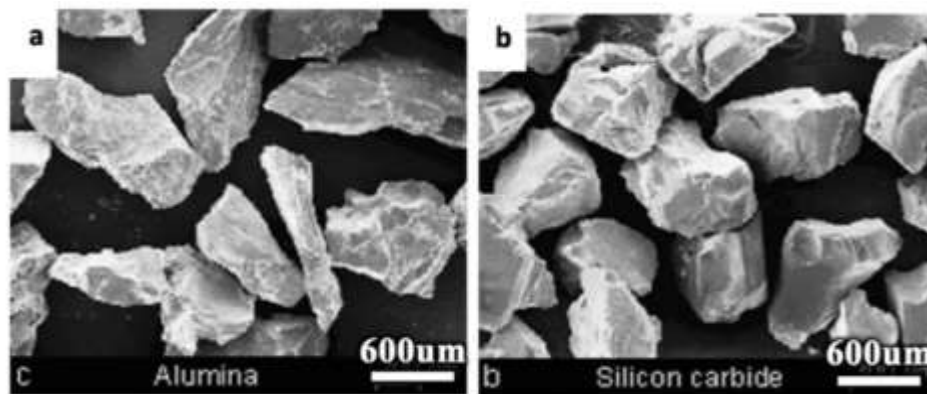
The powder used for the coating and slurry is presented in Figure.2. The SEM micrograph represents a powder with sharp morphology and with $50\mu\text{m}$ particle size as presented in fig.2a, whereas the morphology

of the silica which is used as a slurry presents a angular morphology with same particle size as that of powder used for coating.

Fig.2. SEM micrograph of (a) alumina and, (b) silica.
